Post-Earthquake Rapid Damage Assessment of Road Bridges in Glina County

Source / Izvornik: **Buildings, 2022, 12(1)**

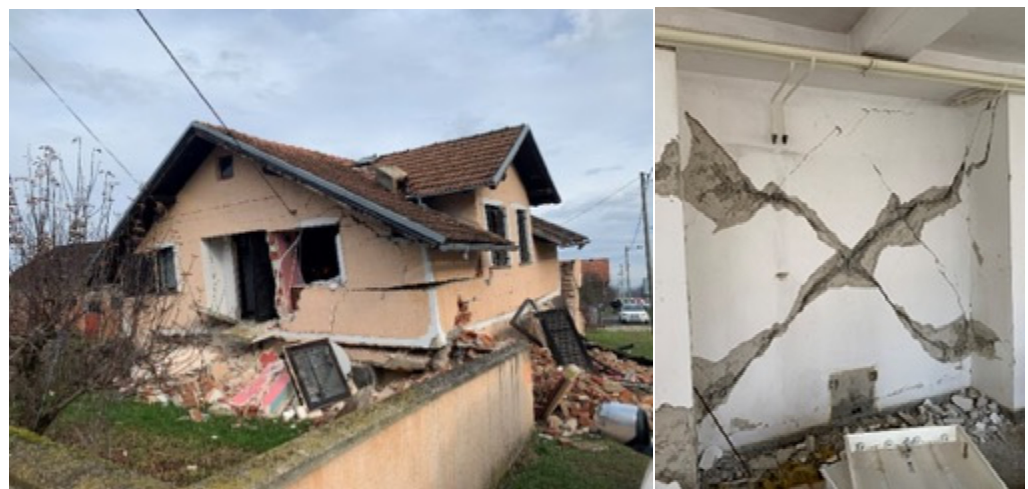
Figure 1. DG4 and DG5 damage from the December 2020 earthquake in Sisak-Moslavina county.
