# Post-Earthquake Rapid Damage Assessment of Road Bridges in Glina County

Source / Izvornik: **Buildings, 2022, 12(1)**

**Journal article, Published version**

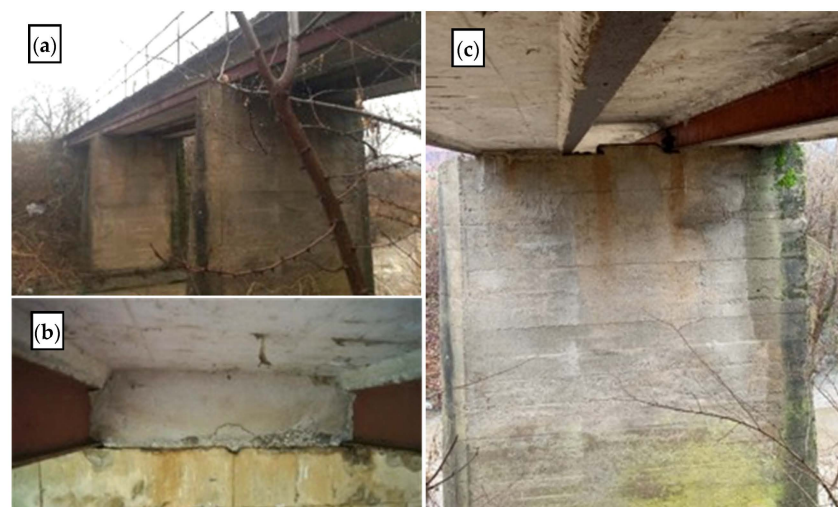
**Figure 12.** Nikola Tesla street bridge: (a) view of the bridge; (b) main girders to abutment support; (c) superstructure under view.

Abutment walls are 1.4 m high, and abutment wings are 2.9 m long. The bridge superstructure was found to be in a moderate-to-poor condition, with problems regarding structural steel corrosion and water leakage due to non-existent waterproofing and drainage. The asphalt layer was heavily worn out and almost completely missing in the footway area. The edges of superstructure consoles were missing a cornice, and reinforcement bars were protruding out of the concrete. Columns and abutments were found to be in fairly good condition, with no visible cracks or concrete spalling. Discoloration was visible due to water leakage from the superstructure onto columns, thus causing long-term damage to the column concrete and possibly reinforcement corrosion (Figure 12c). The bridge showed no signs of serious damage caused by the earthquake on the superstructure, substructure, or embankment slopes around abutments. Visible cracks were detected in the area of connection between the superstructure and abutment, where the superstructure is supported on the abutments, between the abutment wall and the cross girder (Figure 12b). Since this connection was not assumed as fixed in the statical system, it was expected that the opening of this crack occurred and was of no importance regarding bearing capacity. After inspection, the bridge was maintained for operation without restrictions. Further inspection and maintenance were recommended due to the poor state of the traffic surface (asphalt layer and footways), column reinforcement corrosion, failed waterproofing, and possible scour developing on column foundations.

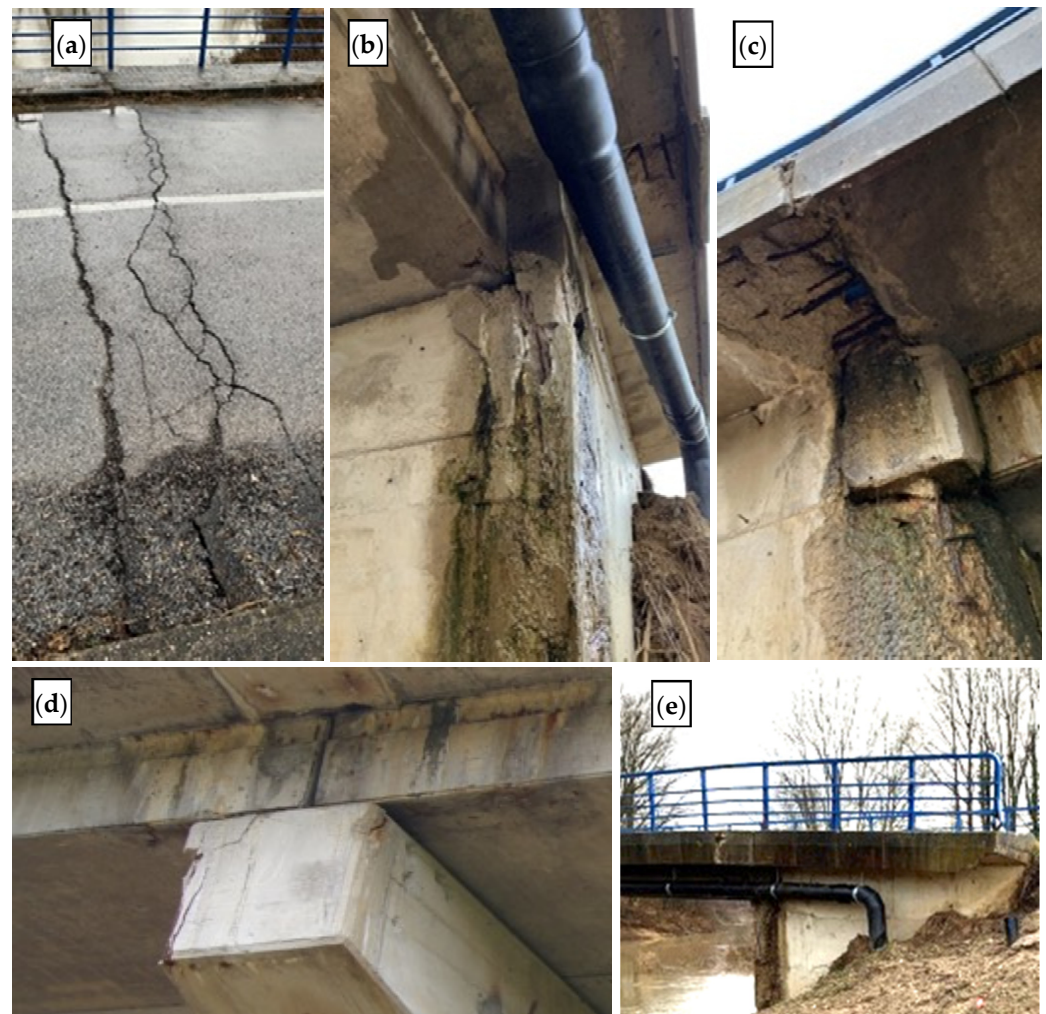
Earthquake-related damage was recorded on several elements of the bridge. It was evident that the bridge superstructure moved both longitudinally and transversely at a notable rate. The first proof of such movements could be seen on the asphalt layer at the ends of the bridge superstructure, which was heavily cracked, waved, and delaminated upwards (Figure 14a). This movement also caused the fracture of bridge cornice, which was executed without any dilatation between the abutment and superstructure (Figure 14c,e). It is surprising that a bridge this long does not have expansion joints at the ends that would accommodate for such movements without causing any damage. Secondly, transverse movements caused heavy damage to abutment side walls, thus cracking and completely fracturing parts of them (Figure 14b). It is also incorrect that the abutment side wall is so close to the superstructure with no tolerances for transverse movements of any degree (the abutment was found to be too narrow for this width of the superstructure). The structure of this bridge is very flexible due to tall single piers of circular cross-section, positioned centrally along bridge axis. Therefore, it is not surprising that the bridge exhibited large movements during the earthquake; it is more surprising that these movements were not accounted for in the design of both the expansion joints and spacing tolerances between the substructure and superstructure elements.

**Figure 14.** Hađer bridge: (a) damage caused by earthquake in the asphalt; (b) fractured abutment side wall due to the earthquake; (c) water leakage from superstructure end, causing damage to abutment; (d) uneven support length for the girders; (e) cracked cornice due to earthquake movement.

It is evident that all the damage due to the earthquake could have been easily avoided if proper design rules had been followed. Besides the described damage, which can be regarded as non-structural, the bridge performed well in this earthquake event. Further inspection and rehabilitation were recommended due to aforementioned earthquake damage and heavy reinforcement corrosion of column heads and abutment walls.

Regarding the recommendations for the other examined bridges, the Hađer Bridge most critically needs detailed inspection and rehabilitation following earthquake damage. Since this damage was caused by improper movement management, it is recommended that expansion joints allowing for seismic movements are added at the bridge ends and above the central dilatation column. The inelastic movements should also be checked by nonlinear calculations to determine if the safe tolerances against slippage of the girders are met.

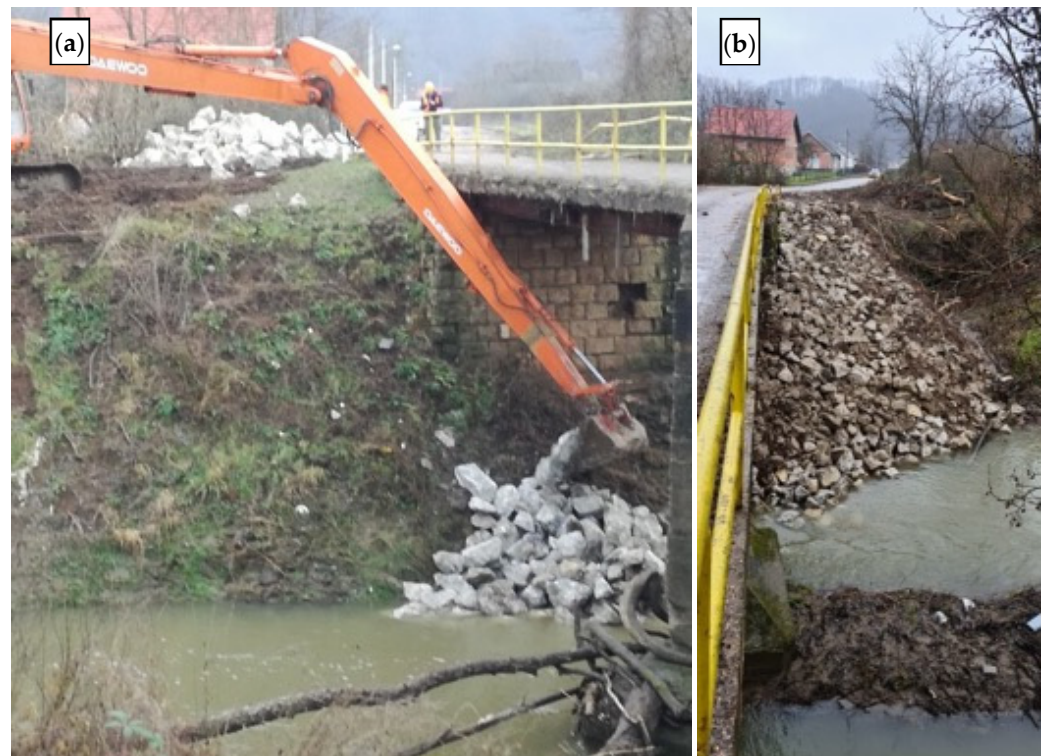
**Figure 15.** Immediate measures to secure the abutment of Matija Gubec street bridge: (a) beginning of the work; (b) completed infill.

Only one of the assessed bridges needed closure and immediate strengthening measures. As discussed in Section 4.2, Matija Gubec Street bridge leading to Majske Poljane showed signs of west abutment slippage and rotation, and its stability and integrity were compromised. Following the closure of the bridge for traffic, emergency measures were prescribed for the immediate strengthening of the abutment to prevent its total collapse. The immediate danger of collapse was even more emphasized due to heavy rains that followed in the days after the earthquake, which caused the water level to rise and further erode the west riverbank that had already shown scour signs under the abutment foundation. Additionally, multiple aftershocks threatened the unstable balance of the abutment wall. The decision was made to use large stone block material and to fill the slope of the riverbank up to the top of the abutment, around its wings, and as far as the middle columns in the riverbed (Figure 15a). The stone material needed to be of very large

fractions (from 50 to 100 cm) to prevent it from being washed away by the river flow. The abutment foundation, wall, and wings were enveloped by this stone infill, thus preventing the further erosion of the soil and acting as a support for the abutment (Figure 15b). The whole work was performed over just two days in hard working conditions due to soaked soil from continuous rains. The measure was proven to be effective since it stopped the further movement of the abutment. Nevertheless, the bridge was closed for traffic as a precautionary measure until it was to be evaluated further and permanent solutions were found.
