Post-Earthquake Rapid Damage Assessment of Road Bridges in Glina County

Abstract: In December 2020, a strong earthquake occurred in Northwestern Croatia with a magnitude of $M_L = 6.3$. The epicenter of this earthquake was located in the town of Petrinja, about 50 km from Zagreb, and caused severe structural damage throughout Sisak-Moslavina county. One of the biggest problems after this earthquake was the structural condition of the bridges, especially since most of them had to be used immediately for demolition, rescue, and the transport of mobile housing units in the affected areas. Teams of civil engineers were quickly formed to assess the damage and structural viability of these bridges and take necessary actions to make them operational again. This paper presents the results of the rapid post-earthquake assessment for a total of eight bridges, all located in or around the city of Glina. For the assessment, a visual inspection was performed according to a previously established methodology. Although most of the inspected bridges were found to be deteriorated due to old age and lack of maintenance, very few of them showed serious damage from the earthquake, with only one bridg

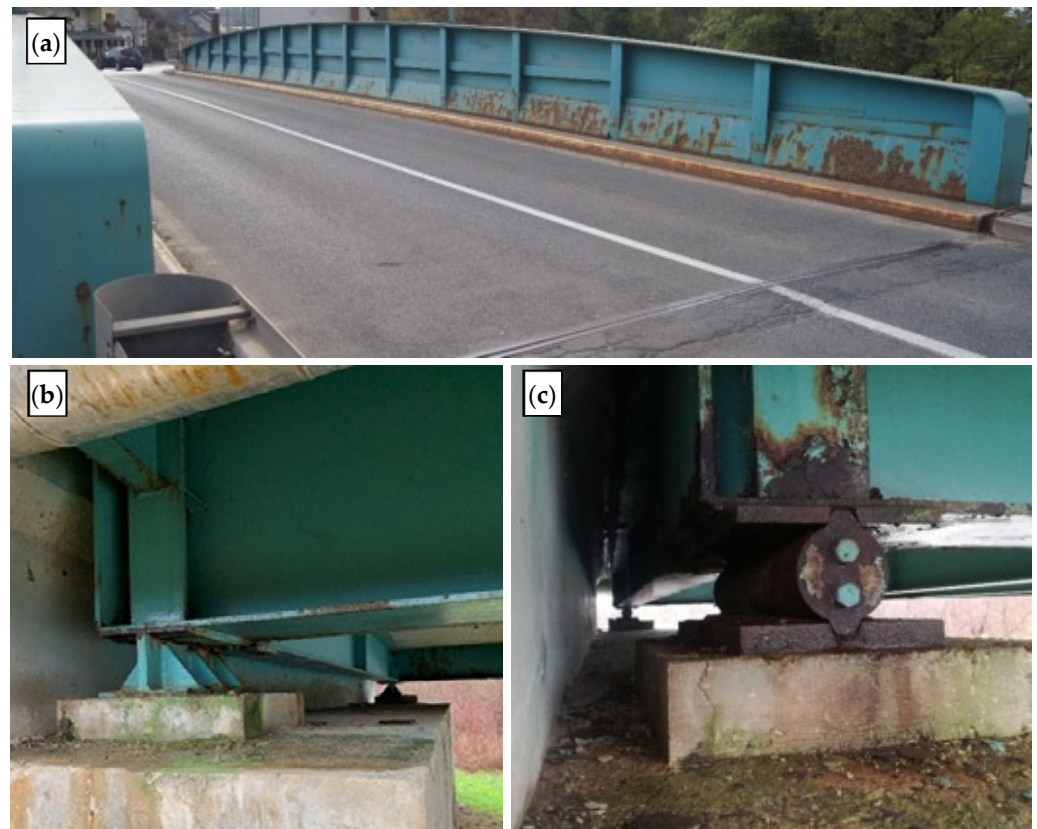
Figure 7. Glina bridge: (a) main girder and carriageway; (b) fixed bearing; (c) movable bearing.

Examination showed no damage due to the earthquake. There were no signs of abutment movements; the fixed bearing successfully transferred the horizontal force on the abutment wall without any damage to the bearing or the wall (Figure 7b,c). Abutment embankments showed no landslide signs, and foundations showed no rotations or settlements. There was no visible damage to the expansion joints other than existing cracking in the asphalt layer due to dynamic loads from traffic. The expansion joints were found to be clogged with dirt and gravel and should be maintained in the future. No further actions were required, and the bridge was maintained for traffic use without any restrictions.

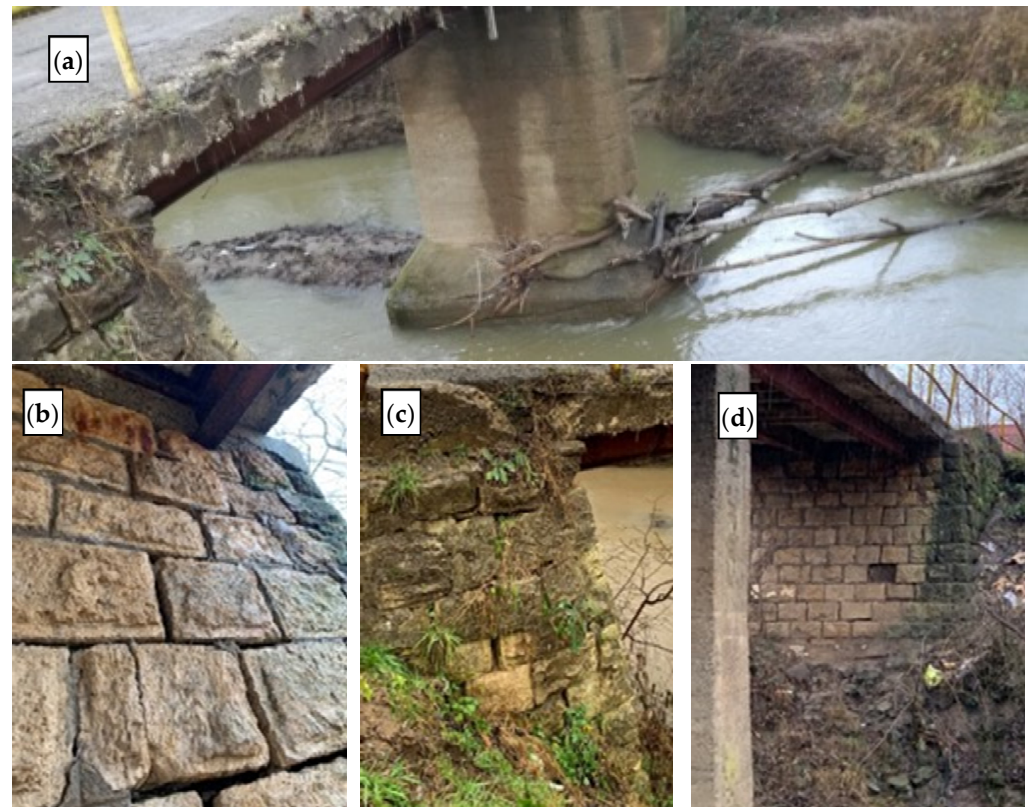
before the earthquake: main girders were shown to be heavily corroded, the concrete deck slab was spalling, the reinforcement bars were visible and corroded, the edges of the footways and the cornice were eroded and largely missing, a permanent deflection in the superstructure was evident due to overweight traffic load, and the railings were not anchored in the footways. Maja river has a highly variable water level and flow speed that caused the erosion of the west riverbank and scour developing under the west and east column foundations (Figure 8a,d).

Figure 8. Matija Gubec street bridge: (a) columns—large foundation for the column in the middle of the riverbed and scour visible on the east column; (b) abutment stone wall damage; (c) abutment sliding signs; (d) evidence of subsequent abutment sliding—stone wall integrity compromised.

The examination revealed serious deficiencies in the west abutment. Stone wall joints showed cracks and openings up to few centimeters, with mortar missing and stone block movements (Figure 8b). The whole abutment showed signs of translation and rotation towards span opening due to ground movements and soil erosion (Figure 8c). The soil around the abutment wings showed signs of land sliding (Figure 8d). The best course of action at this time was to close the bridge, but this action would have severed the connection to the nearby settlement that was the most affected by the earthquake and needed supplies and help at this time. It was reluctantly decided that the bridge could stay open with restrictions of only 5 ton vehicles at 5 km/h traveling speed. Only one vehicle was permitted on the bridge at the same time. Furthermore, emergency actions were ordered to strengthen the abutment and prevent its further damage (see Section 5). The bridge was placed under continuous monitoring due to aftershocks that were frequent in the coming days. Subsequent inspection the following day showed further degradation of the abutment in which the falling of the stone blocks occurred and the abutment integrity was compromised (Figure 8d). At this time, it was decided that the bridge safety could no longer be assumed, and the bridge was completely closed for traffic. Stabilization measures were undertaken at this time.

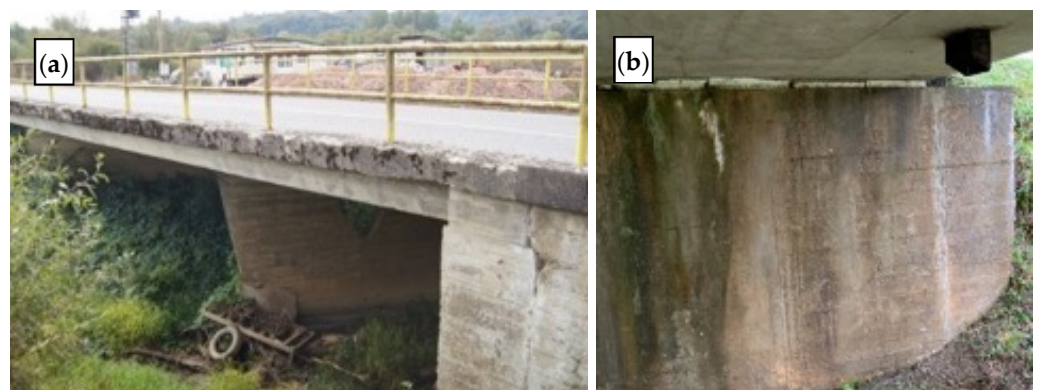
Maja bridge is located just south of previous Roviška bridge (Figure 5), and it is of similar type but smaller length. The bridge is also a continuous girder slab bridge with over two spans of 7.5 + 7.5 m (Figure 6). The slab girder is 35 cm thick and 7.7 m wide, with short consoles on both sides. The superstructure is skewed in regard to abutments, columns, and the riverbed (Figure 10a). Height of the columns and abutments is about 3.5 m. There were no bearings or expansion joints causing dilatation cracks in the asphalt. There was also a visible vertical dilatation crack between the abutment wall and wing, suggesting that they were not fixed together and moved separately. The superstructure concrete was seen to be in relatively good condition, without signs of progressive reinforcement corrosion or concrete spalling but with visible signs of discoloration due to water leakage. Although drainage was present on the bridge, gutters were clogged and caused water to seep through the concrete slab. The slab consoles (footways) were observed to be heavily degraded due to a lack of waterproofing and poor concrete quality. Abutment walls were exposed to water draining from above (Figure 10b). There was no visible damage due to the earthquake. No new cracks or movements of the substructure or superstructure elements were detected. No restrictions regarding traffic were given. Further inspection and maintenance were recommended due to the noticeable water leakage due to failed waterproofing and drainage.

Figure 10. Maja bridge: (a) side view of the bridge; (b) abutment wall.

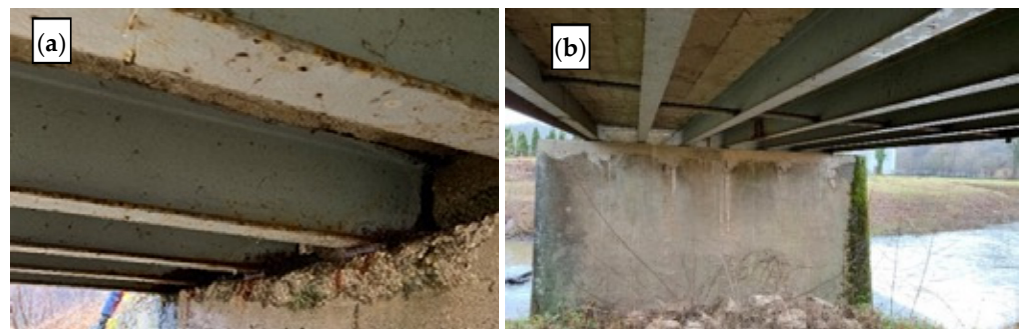
were visible in the asphalt at the end of the superstructure. The deck slab concrete was in good condition. The concrete columns showed signs of reinforcement corrosion, with protective layer only locally spalling. The main reason for this problem is heavy water leakage due to non-existent drainage and waterproofing. Since there was a dilatation in the superstructure above the central column, the water is draining through the asphalt directly onto the column. The spalling of concrete showed a different type of concrete underneath and occurred at the contact of these different materials, so it very likely that columns had undergone rehabilitation work in the past. There was no visible damage from the earthquake, either in permanent deformations or movements of the superstructure or substructure elements. Therefore, the bridge was maintained for operation without restrictions. Further inspection and maintenance were recommended due to steel girder corrosion and signs of column reinforcement corrosion.

Figure 11. Svračica bridge main girder support: (a) abutment; (b) column.

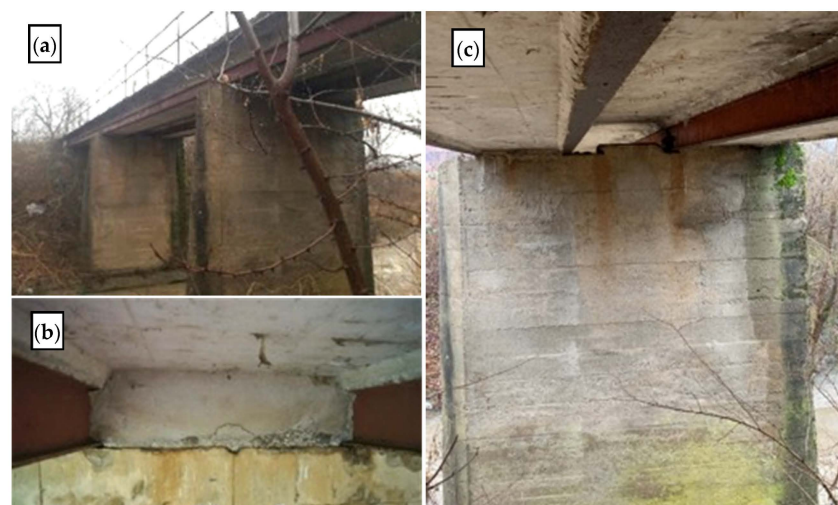
Figure 12. Nikola Tesla street bridge: (a) view of the bridge; (b) main girders to abutment support; (c) superstructure under view.

Abutment walls are 1.4 m high, and abutment wings are 2.9 m long. The bridge superstructure was found to be in a moderate-to-poor condition, with problems regarding structural steel corrosion and water leakage due to non-existent waterproofing and drainage. The asphalt layer was heavily worn out and almost completely missing in the footway area. The edges of superstructure consoles were missing a cornice, and reinforcement bars were protruding out of the concrete. Columns and abutments were found to be in fairly good condition, with no visible cracks or concrete spalling. Discoloration was visible due to water leakage from the superstructure onto columns, thus causing long-term damage to the column concrete and possibly reinforcement corrosion (Figure 12c). The bridge showed no signs of serious damage caused by the earthquake on the superstructure, substructure, or embankment slopes around abutments. Visible cracks were detected in the area of connection between the superstructure and abutment, where the superstructure is supported on the abutments, between the abutment wall and the cross girder (Figure 12b). Since this connection was not assumed as fixed in the statical system, it was expected that the opening of this crack occurred and was of no importance regarding bearing capacity. After inspection, the bridge was maintained for operation without restrictions. Further inspection and maintenance were recommended due to the poor state of the traffic surface (asphalt layer and footways), column reinforcement corrosion, failed waterproofing, and possible scour developing on column foundations.

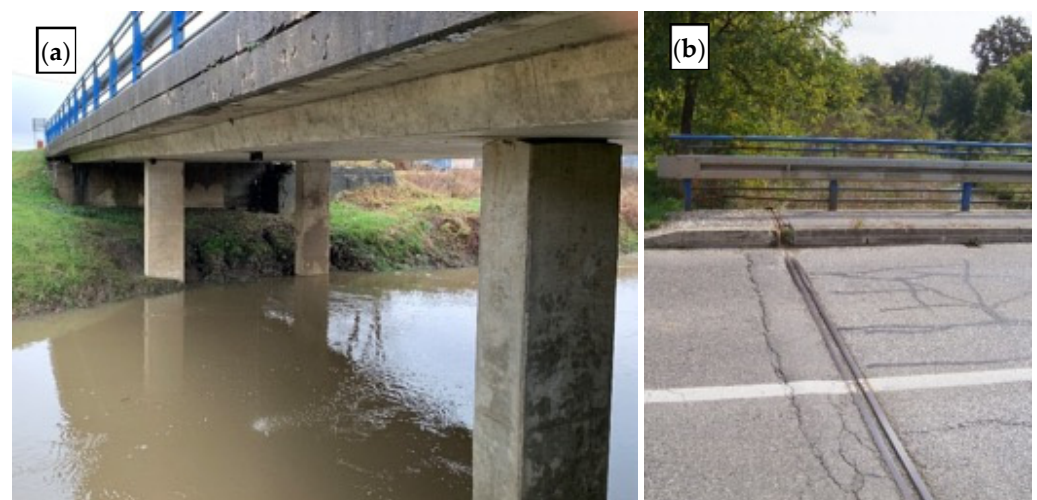
Figure 13. Prekopa bridge: (a) side view of the bridge; (b) expansion joint.

Only traces of water leakage were visible on the abutment wall, probably due to the failed waterproofing of expansion joints at the ends of the bridge. There were hints of reinforcement corrosion on the abutment wall due to this water leakage. Expansion joints were also found to be clogged with dirt and gravel, with visible cracks in the asphalt layer around them (Figure 13b). The bridge was reported to be in very good condition; the superstructure and substructure concrete showed no signs of degradation or reinforcement

corrosion. Except for expansion joints needing maintenance, no other notable problems were found. Due to it dating from a newer generation of bridges, it was certainly designed with seismic loads and seismic detailing, so no earthquake damage was expected nor found. This bridge performed exceptionally in this seismic event.

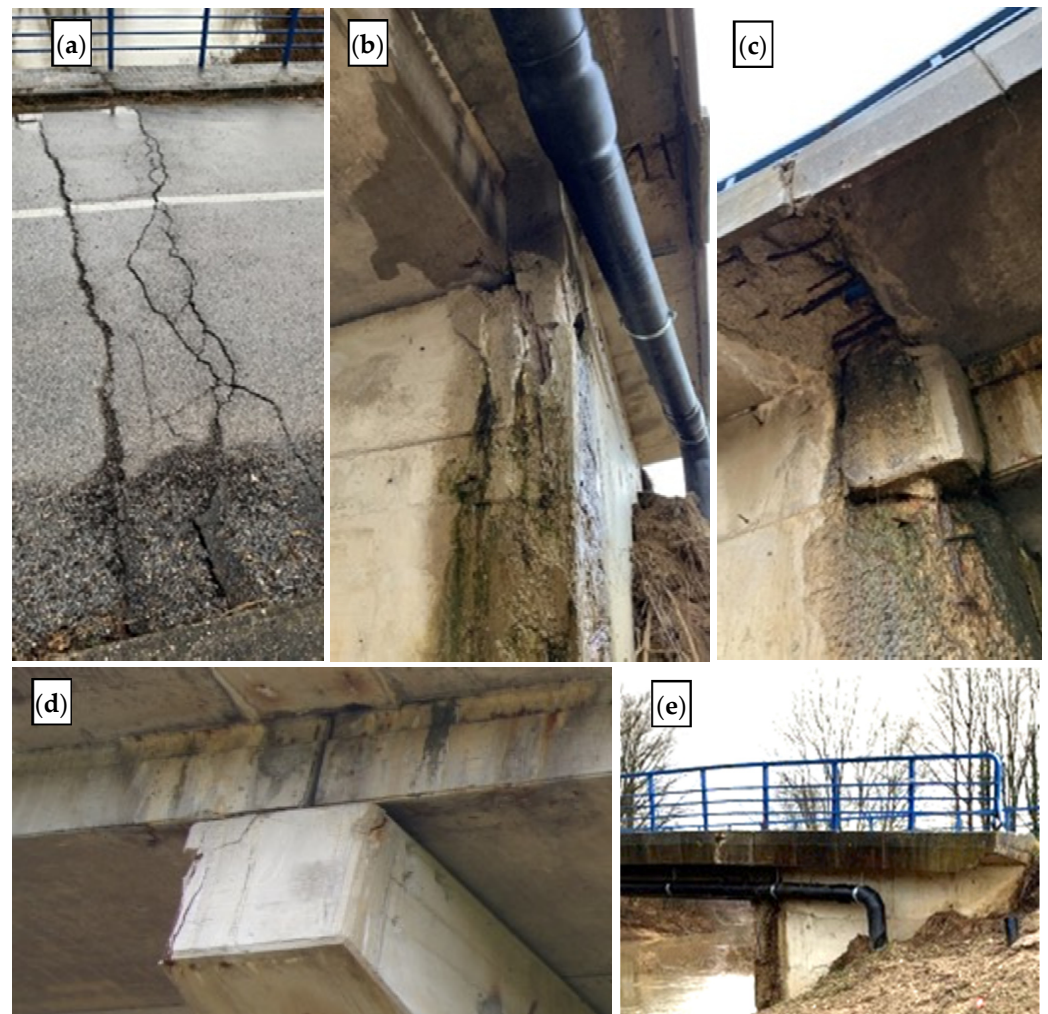
Earthquake-related damage was recorded on several elements of the bridge. It was evident that the bridge superstructure moved both longitudinally and transversely at a notable rate. The first proof of such movements could be seen on the asphalt layer at the ends of the bridge superstructure, which was heavily cracked, waved, and delaminated upwards (Figure 14a). This movement also caused the fracture of bridge cornice, which was executed without any dilatation between the abutment and superstructure (Figure 14c,e). It is surprising that a bridge this long does not have expansion joints at the ends that would accommodate for such movements without causing any damage. Secondly, transverse movements caused heavy damage to abutment side walls, thus cracking and completely fracturing parts of them (Figure 14b). It is also incorrect that the abutment side wall is so close to the superstructure with no tolerances for transverse movements of any degree (the abutment was found to be too narrow for this width of the superstructure). The structure of this bridge is very flexible due to tall single piers of circular cross-section, positioned centrally along bridge axis. Therefore, it is not surprising that the bridge exhibited large movements during the earthquake; it is more surprising that these movements were not accounted for in the design of both the expansion joints and spacing tolerances between the substructure and superstructure elements.

Figure 14. Hađer bridge: (a) damage caused by earthquake in the asphalt; (b) fractured abutment side wall due to the earthquake; (c) water leakage from superstructure end, causing damage to abutment; (d) uneven support length for the girders; (e) cracked cornice due to earthquake movement.

It is evident that all the damage due to the earthquake could have been easily avoided if proper design rules had been followed. Besides the described damage, which can be regarded as non-structural, the bridge performed well in this earthquake event. Further inspection and rehabilitation were recommended due to aforementioned earthquake damage and heavy reinforcement corrosion of column heads and abutment walls.

Regarding the recommendations for the other examined bridges, the Hađer Bridge most critically needs detailed inspection and rehabilitation following earthquake damage. Since this damage was caused by improper movement management, it is recommended that expansion joints allowing for seismic movements are added at the bridge ends and above the central dilatation column. The inelastic movements should also be checked by nonlinear calculations to determine if the safe tolerances against slippage of the girders are met.

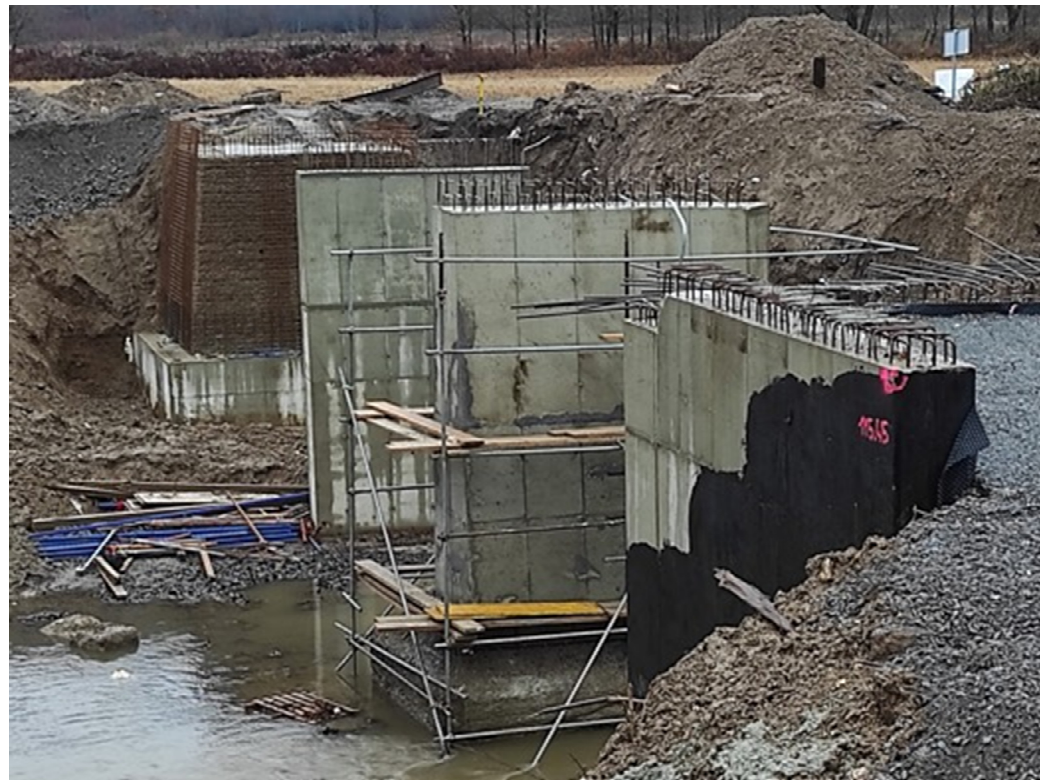
Figure 16. Progress of rehabilitation work of Matija Gubec street bridge.

Following the detailed evaluation and assessment of the previously strengthened bridge, it was concluded that extensive rehabilitation work was needed. The bridge stone wall abutment was deemed unsalvageable and to be replaced with new reinforced concrete abutment. The new reinforced concrete abutment will have a deeper and wider foundations, with the stone and shotcrete cladding of the embankment slope and river bank to prevent scour. One of the columns that showed scour signs and had an insufficient foundation-bearing capacity is also to be replaced. The new reinforced concrete column will have an 80×400 cm cross-section and a 300×550 cm, 100 cm thick foundation slab. This foundation will also be protected by stone and shotcrete cladding. One column and east abutment are to be salvaged and jacketed with a new 10 cm thick layer of reinforced concrete. Since the superstructure was heavily degraded, with progressive structural steel and reinforcement corrosion, missing parts of the footways, and low remaining load-bearing capacity, it was decided that it also needs to be replaced. The new 50 cm thick reinforced concrete slab superstructure will also be wider (600 cm), accommodating more traffic width for vehicles and pedestrians. The superstructure and substructure elements will be integrally connected without any bearings to achieve better durability. The bridge will be equipped with waterproofing and closed drainage system. Figure 16 shows the current progress of this rehabilitation.
