# Post-Earthquake Rapid Damage Assessment of Road Bridges in Glina County

Source / Izvornik: **Buildings, 2022, 12(1)**

**Journal article, Published version**

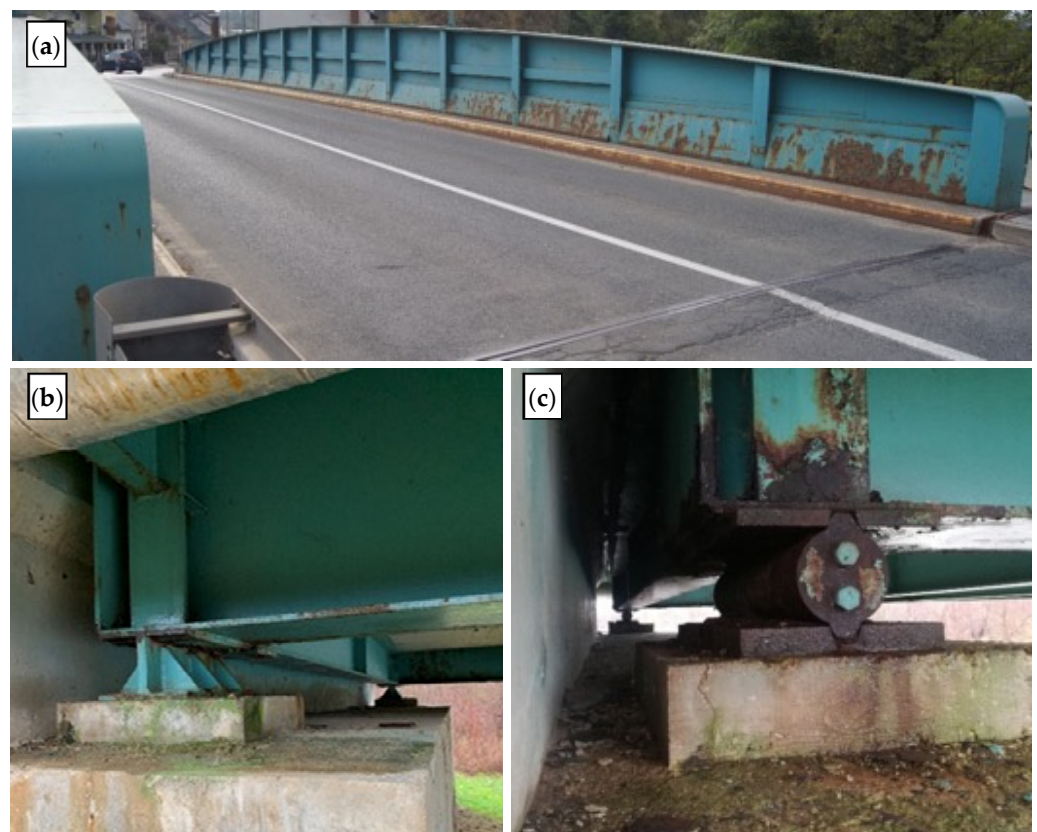
**Figure 7.** Glina bridge: (a) main girder and carriageway; (b) fixed bearing; (c) movable bearing.

Examination showed no damage due to the earthquake. There were no signs of abutment movements; the fixed bearing successfully transferred the horizontal force on the abutment wall without any damage to the bearing or the wall (Figure 7b,c). Abutment embankments showed no landslide signs, and foundations showed no rotations or settlements. There was no visible damage to the expansion joints other than existing cracking in the asphalt layer due to dynamic loads from traffic. The expansion joints were found to be clogged with dirt and gravel and should be maintained in the future. No further actions were required, and the bridge was maintained for traffic use without any restrictions.

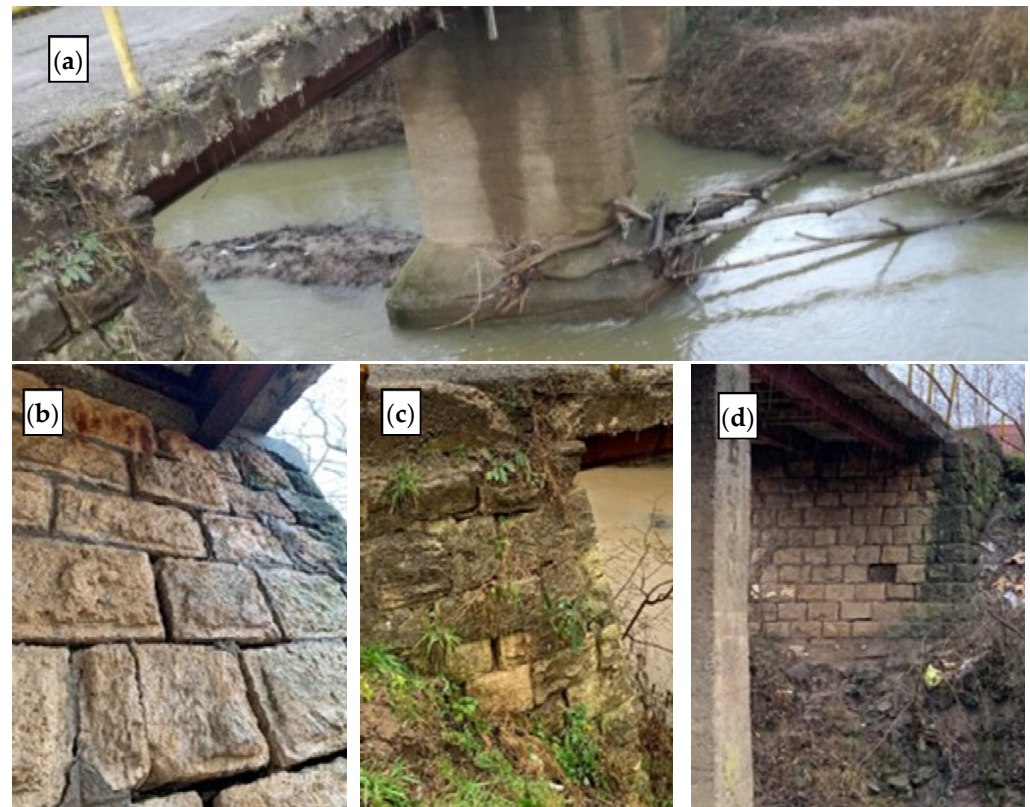
before the earthquake: main girders were shown to be heavily corroded, the concrete deck slab was spalling, the reinforcement bars were visible and corroded, the edges of the footways and the cornice were eroded and largely missing, a permanent deflection in the superstructure was evident due to overweight traffic load, and the railings were not anchored in the footways. Maja river has a highly variable water level and flow speed that caused the erosion of the west riverbank and scour developing under the west and east column foundations (Figure 8a,d).

**Figure 8.** Matija Gubec street bridge: (a) columns—large foundation for the column in the middle of the riverbed and scour visible on the east column; (b) abutment stone wall damage; (c) abutment sliding signs; (d) evidence of subsequent abutment sliding—stone wall integrity compromised.

The examination revealed serious deficiencies in the west abutment. Stone wall joints showed cracks and openings up to few centimeters, with mortar missing and stone block movements (Figure 8b). The whole abutment showed signs of translation and rotation towards span opening due to ground movements and soil erosion (Figure 8c). The soil around the abutment wings showed signs of land sliding (Figure 8d). The best course of action at this time was to close the bridge, but this action would have severed the connection to the nearby settlement that was the most affected by the earthquake and needed supplies and help at this time. It was reluctantly decided that the bridge could stay open with restrictions of only 5 ton vehicles at 5 km/h traveling speed. Only one vehicle was permitted on the bridge at the same time. Furthermore, emergency actions were ordered to strengthen the abutment and prevent its further damage (see Section 5). The bridge was placed under continuous monitoring due to aftershocks that were frequent in the coming days. Subsequent inspection the following day showed further degradation of the abutment in which the falling of the stone blocks occurred and the abutment integrity was compromised (Figure 8d). At this time, it was decided that the bridge safety could no longer be assumed, and the bridge was completely closed for traffic. Stabilization measures were undertaken at this time.

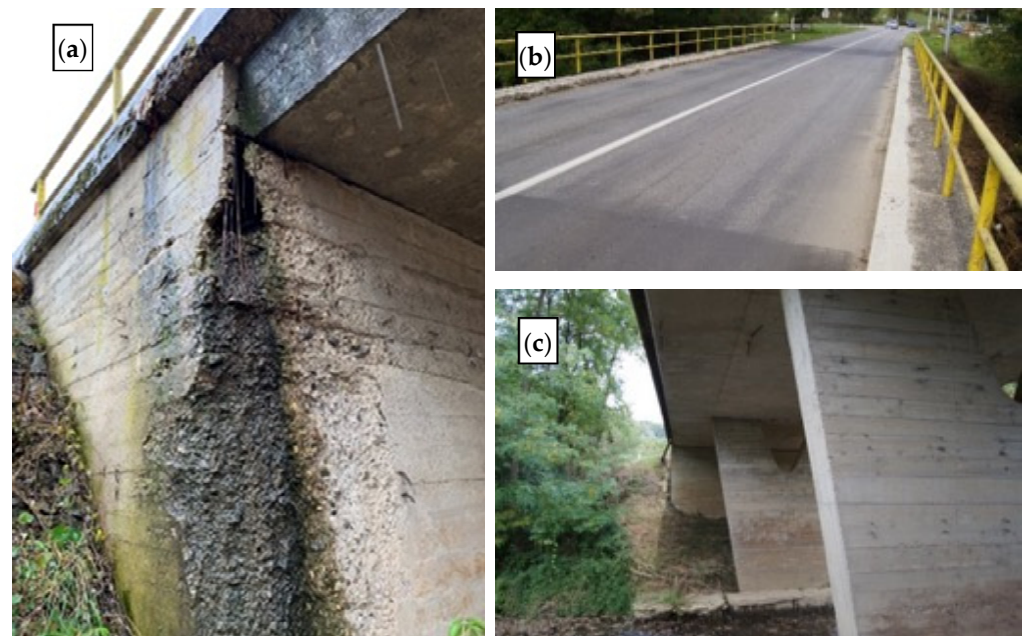
**Figure 9.** Roviška bridge: (a) damage to the abutment wall and wing, as well as drainage problems; (b) degraded footway (left) and new footway (right); (c) substructure without signs of earthquake damage.

Since the damaged parts of the wall showed heavy discolorations, traces of long-term water leakage, and algae sedimentations, it was evident that this damage was not caused by this earthquake. The quality of concrete in these fallen off parts of the abutment corners could be described as poor, exhibiting the local segregation of large fractions of aggregate and very low quantity of reinforcement. It is possible that this damage was a consequence of faults during erection since it resembled typical damage observed when improper concreting without vibration is performed. Since this damage was very localized and not in the main load transfer path, it was not considered serious at this stage of post-earthquake bridge evaluation. It did not compromise the load-bearing capacity of the abutment wall. One of the bridge footways and cornices were heavily degraded due to lack of waterproofing and reinforcement corrosion. The other footway had been rehabilitated in the past with a new concrete layer (Figure 9b).

Overall, the bridge was found to be in structurally good condition and showed no signs of damage due to the earthquake. There was no damage to the asphalt joint between the abutment and superstructure, and no displacements were recorded at the superstructure supports. Columns and abutments were without any major cracks, rotations, or settlements (Figure 9c). After the earthquake, the bridge was continued to be used for traffic without any restrictions. Further inspection and rehabilitation were recommended due to prior

abutment wall damage, visible reinforcement corrosion, and possible scour on foundation piers.

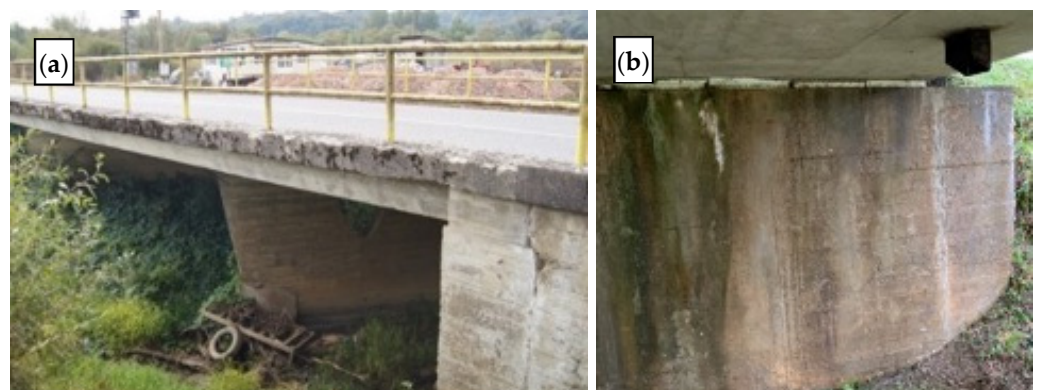
Maja bridge is located just south of previous Roviška bridge (Figure 5), and it is of similar type but smaller length. The bridge is also a continuous girder slab bridge with over two spans of 7.5 + 7.5 m (Figure 6). The slab girder is 35 cm thick and 7.7 m wide, with short consoles on both sides. The superstructure is skewed in regard to abutments, columns, and the riverbed (Figure 10a). Height of the columns and abutments is about 3.5 m. There were no bearings or expansion joints causing dilatation cracks in the asphalt. There was also a visible vertical dilatation crack between the abutment wall and wing, suggesting that they were not fixed together and moved separately. The superstructure concrete was seen to be in relatively good condition, without signs of progressive reinforcement corrosion or concrete spalling but with visible signs of discoloration due to water leakage. Although drainage was present on the bridge, gutters were clogged and caused water to seep through the concrete slab. The slab consoles (footways) were observed to be heavily degraded due to a lack of waterproofing and poor concrete quality. Abutment walls were exposed to water draining from above (Figure 10b). There was no visible damage due to the earthquake. No new cracks or movements of the substructure or superstructure elements were detected. No restrictions regarding traffic were given. Further inspection and maintenance were recommended due to the noticeable water leakage due to failed waterproofing and drainage.

**Figure 10.** Maja bridge: (a) side view of the bridge; (b) abutment wall.

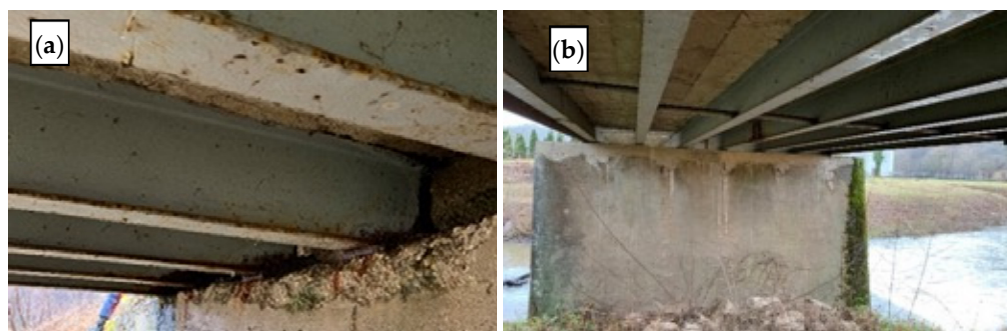
were visible in the asphalt at the end of the superstructure. The deck slab concrete was in good condition. The concrete columns showed signs of reinforcement corrosion, with protective layer only locally spalling. The main reason for this problem is heavy water leakage due to non-existent drainage and waterproofing. Since there was a dilatation in the superstructure above the central column, the water is draining through the asphalt directly onto the column. The spalling of concrete showed a different type of concrete underneath and occurred at the contact of these different materials, so it very likely that columns had undergone rehabilitation work in the past. There was no visible damage from the earthquake, either in permanent deformations or movements of the superstructure or substructure elements. Therefore, the bridge was maintained for operation without restrictions. Further inspection and maintenance were recommended due to steel girder corrosion and signs of column reinforcement corrosion.

**Figure 11.** Svračica bridge main girder support: (a) abutment; (b) column.

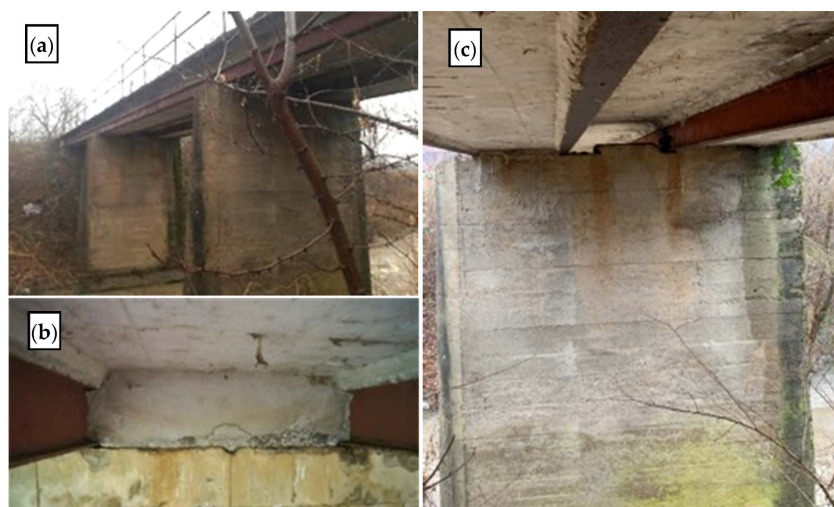
**Figure 12.** Nikola Tesla street bridge: (a) view of the bridge; (b) main girders to abutment support; (c) superstructure under view.

Abutment walls are 1.4 m high, and abutment wings are 2.9 m long. The bridge superstructure was found to be in a moderate-to-poor condition, with problems regarding structural steel corrosion and water leakage due to non-existent waterproofing and drainage. The asphalt layer was heavily worn out and almost completely missing in the footway area. The edges of superstructure consoles were missing a cornice, and reinforcement bars were protruding out of the concrete. Columns and abutments were found to be in fairly good condition, with no visible cracks or concrete spalling. Discoloration was visible due to water leakage from the superstructure onto columns, thus causing long-term damage to the column concrete and possibly reinforcement corrosion (Figure 12c). The bridge showed no signs of serious damage caused by the earthquake on the superstructure, substructure, or embankment slopes around abutments. Visible cracks were detected in the area of connection between the superstructure and abutment, where the superstructure is supported on the abutments, between the abutment wall and the cross girder (Figure 12b). Since this connection was not assumed as fixed in the statical system, it was expected that the opening of this crack occurred and was of no importance regarding bearing capacity. After inspection, the bridge was maintained for operation without restrictions. Further inspection and maintenance were recommended due to the poor state of the traffic surface (asphalt layer and footways), column reinforcement corrosion, failed waterproofing, and possible scour developing on column foundations.

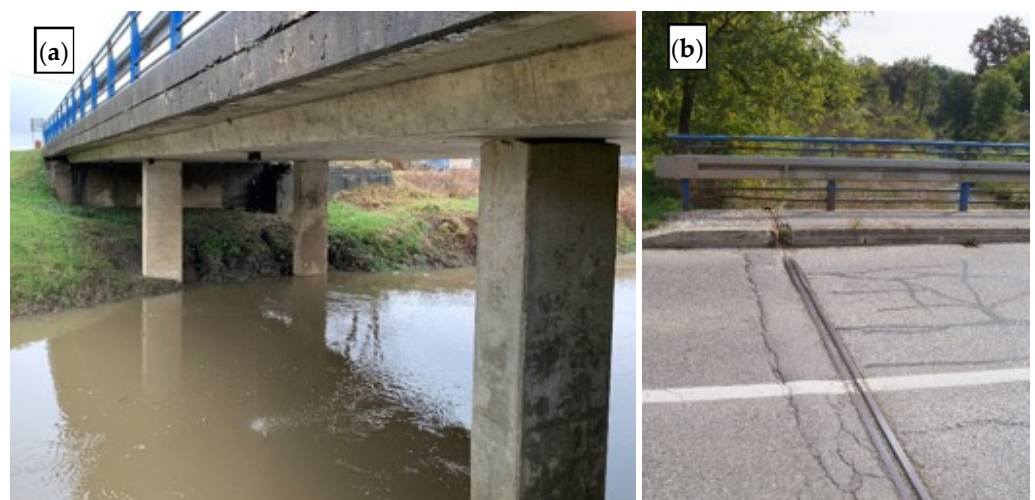
**Figure 13.** Prekopa bridge: (a) side view of the bridge; (b) expansion joint.

Only traces of water leakage were visible on the abutment wall, probably due to the failed waterproofing of expansion joints at the ends of the bridge. There were hints of reinforcement corrosion on the abutment wall due to this water leakage. Expansion joints were also found to be clogged with dirt and gravel, with visible cracks in the asphalt layer around them (Figure 13b). The bridge was reported to be in very good condition; the superstructure and substructure concrete showed no signs of degradation or reinforcement

corrosion. Except for expansion joints needing maintenance, no other notable problems were found. Due to it dating from a newer generation of bridges, it was certainly designed with seismic loads and seismic detailing, so no earthquake damage was expected nor found. This bridge performed exceptionally in this seismic event.

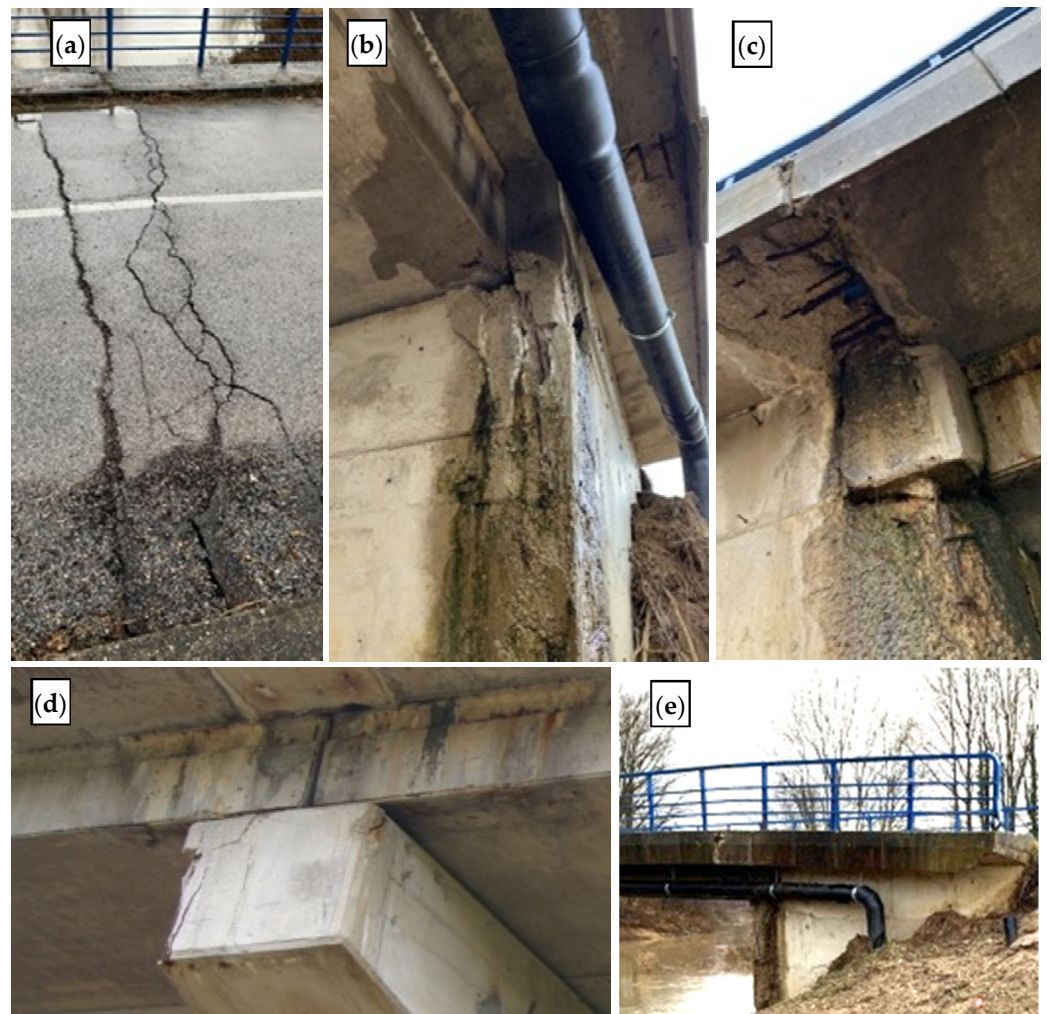
Earthquake-related damage was recorded on several elements of the bridge. It was evident that the bridge superstructure moved both longitudinally and transversely at a notable rate. The first proof of such movements could be seen on the asphalt layer at the ends of the bridge superstructure, which was heavily cracked, waved, and delaminated upwards (Figure 14a). This movement also caused the fracture of bridge cornice, which was executed without any dilatation between the abutment and superstructure (Figure 14c,e). It is surprising that a bridge this long does not have expansion joints at the ends that would accommodate for such movements without causing any damage. Secondly, transverse movements caused heavy damage to abutment side walls, thus cracking and completely fracturing parts of them (Figure 14b). It is also incorrect that the abutment side wall is so close to the superstructure with no tolerances for transverse movements of any degree (the abutment was found to be too narrow for this width of the superstructure). The structure of this bridge is very flexible due to tall single piers of circular cross-section, positioned centrally along bridge axis. Therefore, it is not surprising that the bridge exhibited large movements during the earthquake; it is more surprising that these movements were not accounted for in the design of both the expansion joints and spacing tolerances between the substructure and superstructure elements.

**Figure 14.** Hađer bridge: (a) damage caused by earthquake in the asphalt; (b) fractured abutment side wall due to the earthquake; (c) water leakage from superstructure end, causing damage to abutment; (d) uneven support length for the girders; (e) cracked cornice due to earthquake movement.

It is evident that all the damage due to the earthquake could have been easily avoided if proper design rules had been followed. Besides the described damage, which can be regarded as non-structural, the bridge performed well in this earthquake event. Further inspection and rehabilitation were recommended due to aforementioned earthquake damage and heavy reinforcement corrosion of column heads and abutment walls.

Regarding the recommendations for the other examined bridges, the Hađer Bridge most critically needs detailed inspection and rehabilitation following earthquake damage. Since this damage was caused by improper movement management, it is recommended that expansion joints allowing for seismic movements are added at the bridge ends and above the central dilatation column. The inelastic movements should also be checked by nonlinear calculations to determine if the safe tolerances against slippage of the girders are met.

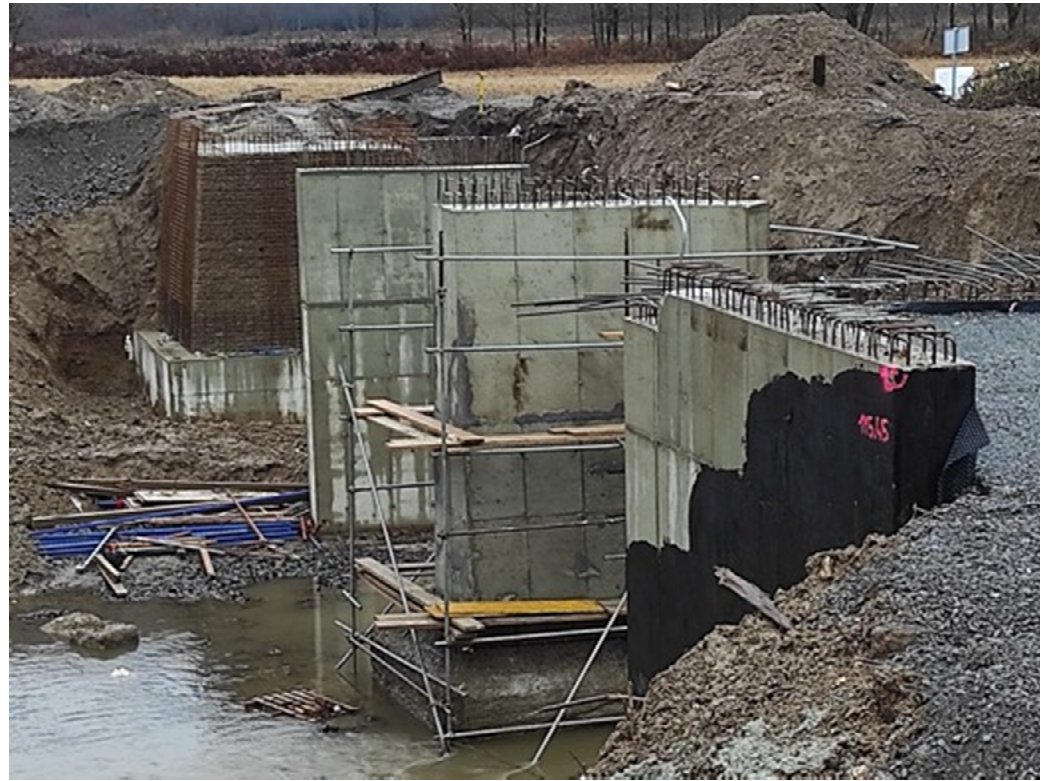
**Figure 16.** Progress of rehabilitation work of Matija Gubec street bridge.

Following the detailed evaluation and assessment of the previously strengthened bridge, it was concluded that extensive rehabilitation work was needed. The bridge stone wall abutment was deemed unsalvageable and to be replaced with new reinforced concrete abutment. The new reinforced concrete abutment will have a deeper and wider foundations, with the stone and shotcrete cladding of the embankment slope and river bank to prevent scour. One of the columns that showed scour signs and had an insufficient foundation-bearing capacity is also to be replaced. The new reinforced concrete column will have an  $80 \times 400$  cm cross-section and a  $300 \times 550$  cm, 100 cm thick foundation slab. This foundation will also be protected by stone and shotcrete cladding. One column and east abutment are to be salvaged and jacketed with a new 10 cm thick layer of reinforced concrete. Since the superstructure was heavily degraded, with progressive structural steel and reinforcement corrosion, missing parts of the footways, and low remaining load-bearing capacity, it was decided that it also needs to be replaced. The new 50 cm thick reinforced concrete slab superstructure will also be wider (600 cm), accommodating more traffic width for vehicles and pedestrians. The superstructure and substructure elements will be integrally connected without any bearings to achieve better durability. The bridge will be equipped with waterproofing and closed drainage system. Figure 16 shows the current progress of this rehabilitation.
