# Post-Earthquake Condition Assessment and Seismic Upgrading Strategies for a Heritage-Protected School in Petrinja, Croatia

Source / Izvornik: **Buildings, 2022, 12(12)**

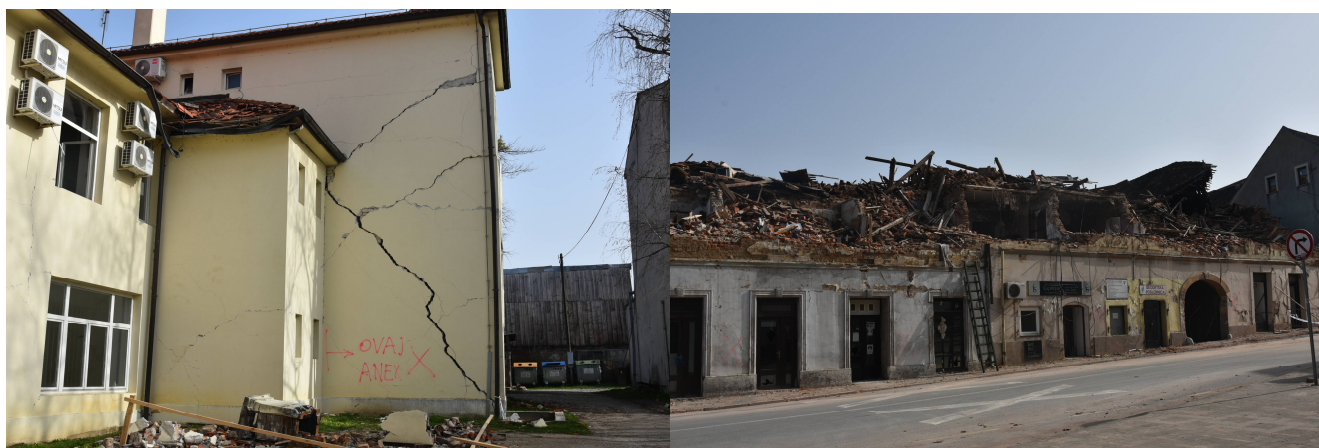
**Figure 2.** Damaged buildings in the historical center of Petrinja.

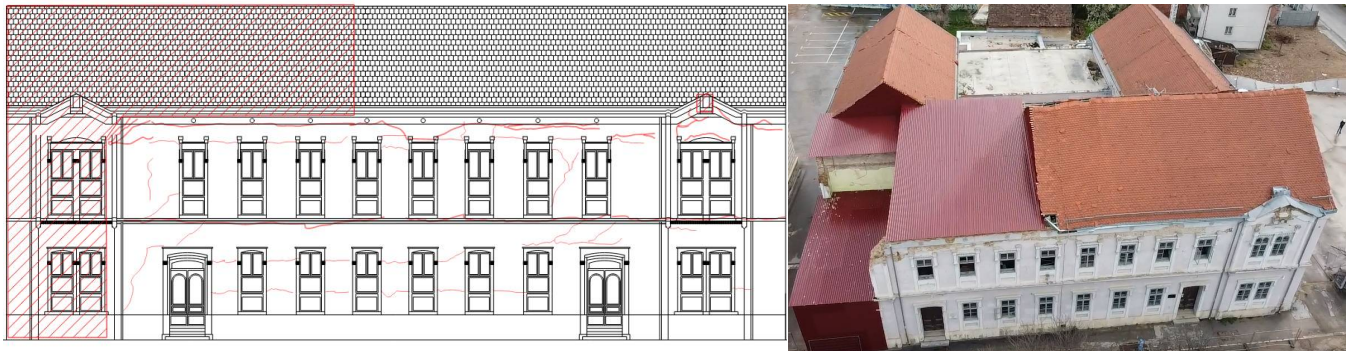
Figure 9. Southwestern façade plan with marked damage.

A more detailed inspection was carried out in April 2022 within the detailed condition assessment. The following damage was recorded: on the north-western side of the building the roof structure had collapsed, which also caused part of the timber floor structure below it to collapse; the north-western and south-eastern gable walls have collapsed; horizontal cracks are visible on the western gable walls, indicating out-of-plane damage (Figures 9–12). Furthermore, the masonry arches in the vicinity of the staircase on the ground floor were damaged, and part of the barrel vault on the first floor had collapsed. The collapsed vault is near the area of the building where the roof and timber floor structure had collapsed. More detailed failures are explained in Table 1.

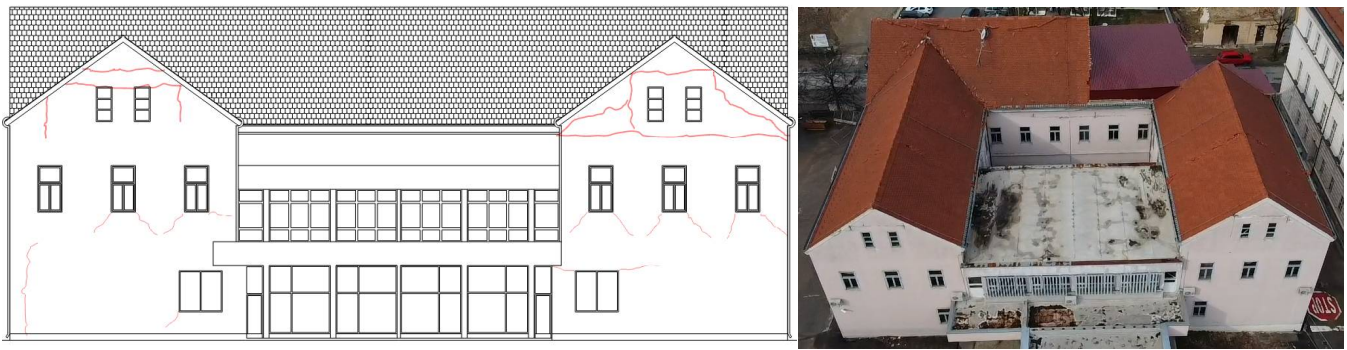
**Figure 12.** Northeastern façade plan with marked damage.

Considering the findings of the detailed inspection, the damage to the building is classified as Grade 4: very heavy damage (heavy structural damage, heavy non-structural damage), according to the EMS-98 classification [9] of damage.

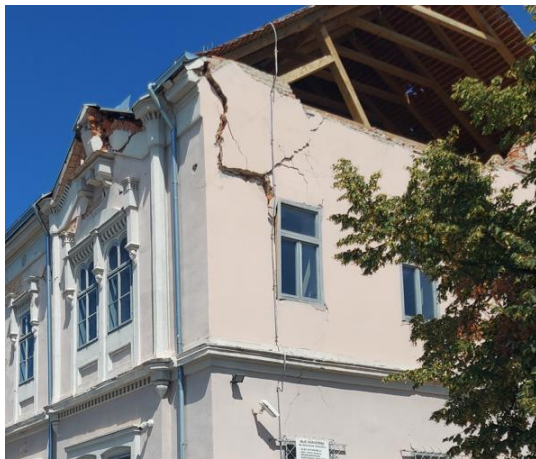
Out-of-plane failure of wall connections

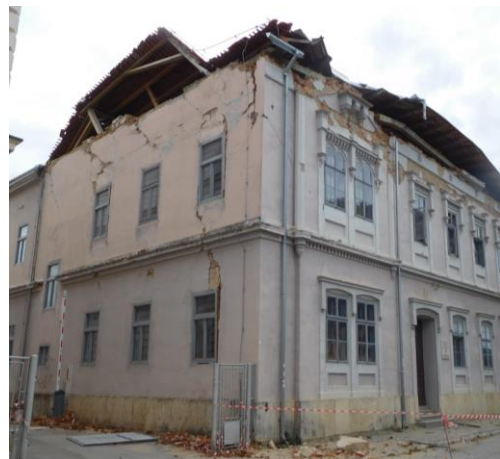
Partial overturning of the gable walls

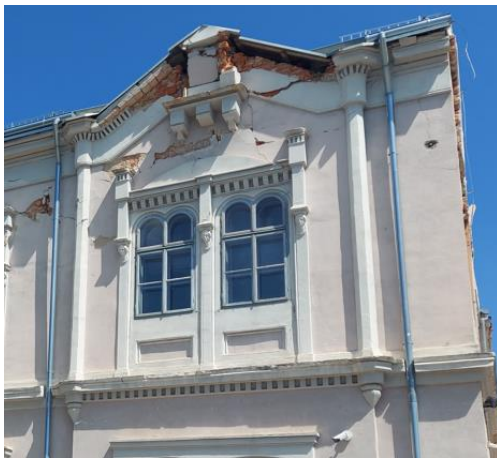
Out-of-plane wall failure in the attic

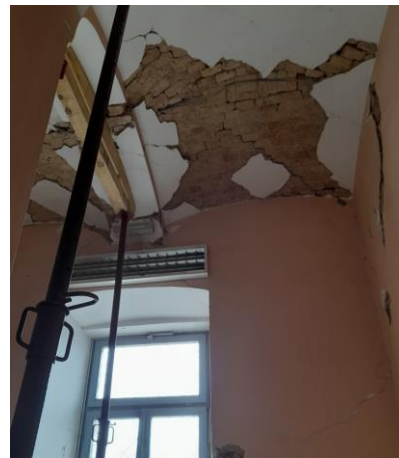
Vault damage/collapse

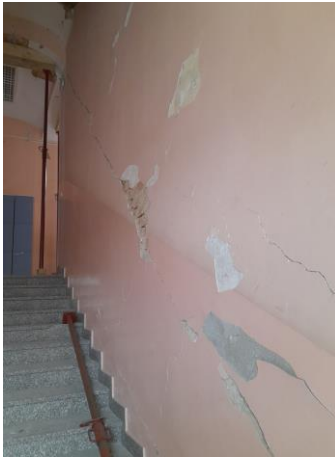
In-plane shear failure of interior walls

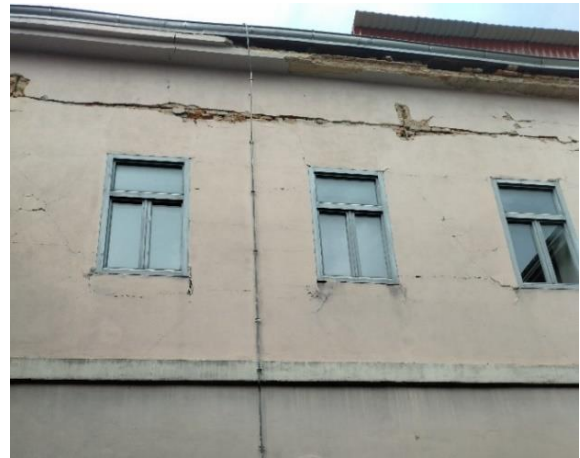
In-plane sliding failure (horizontal cracks)

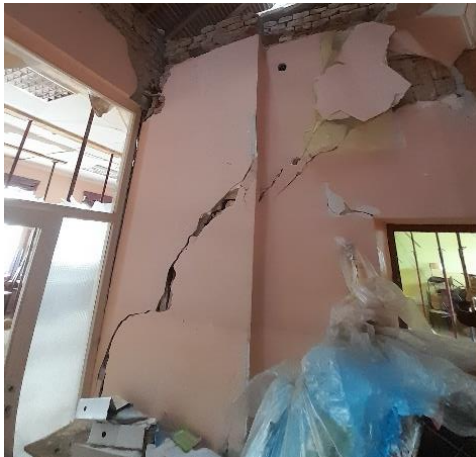
In-plane shear failure (diagonal cracks)

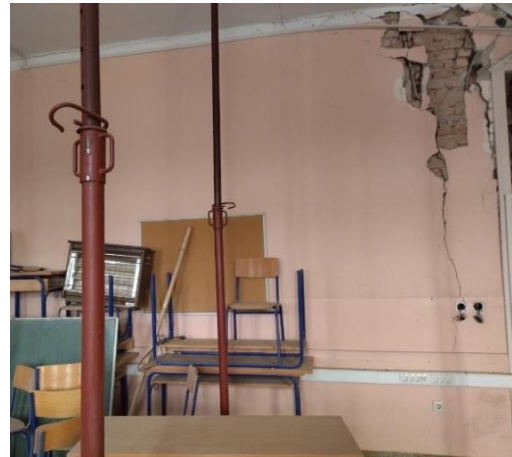
Tensile failure of masonry and vertical cracks at the corners

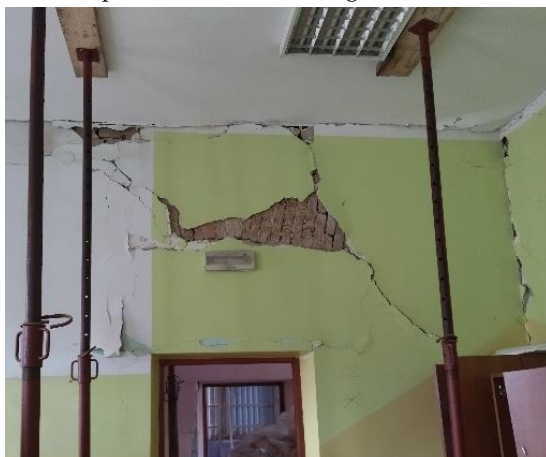
Shear failure of spandrels (diagonal cracks)

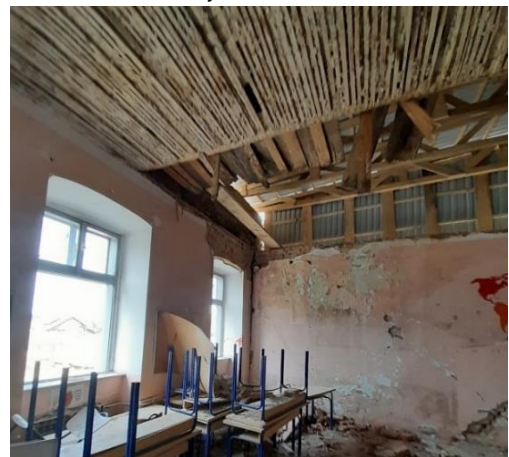
Partial collapse of the floor structure

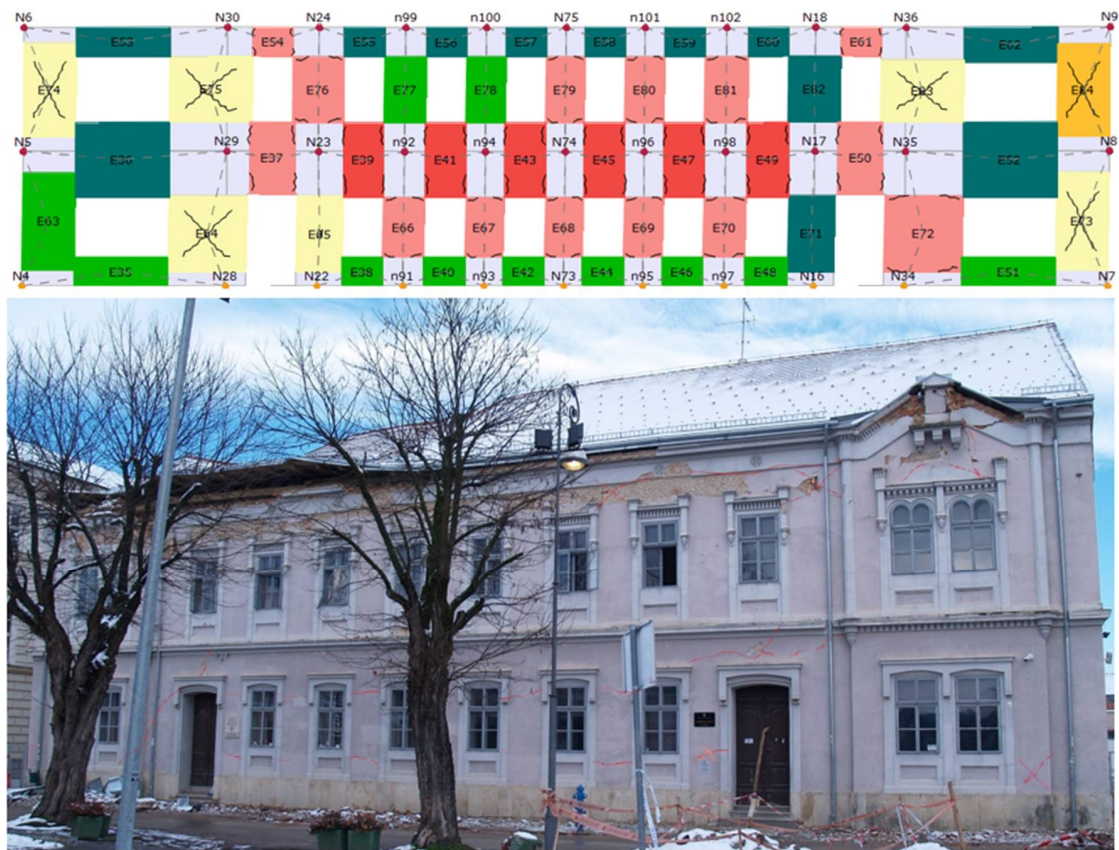
Figures 16 and 17 show the comparison of obtained failures by 3Muri and observed damage on the real case-study building.

**Figure 16.** Detailed display of street facade damage in the 3Muri software package and actual damage to the street facade of the building in question.

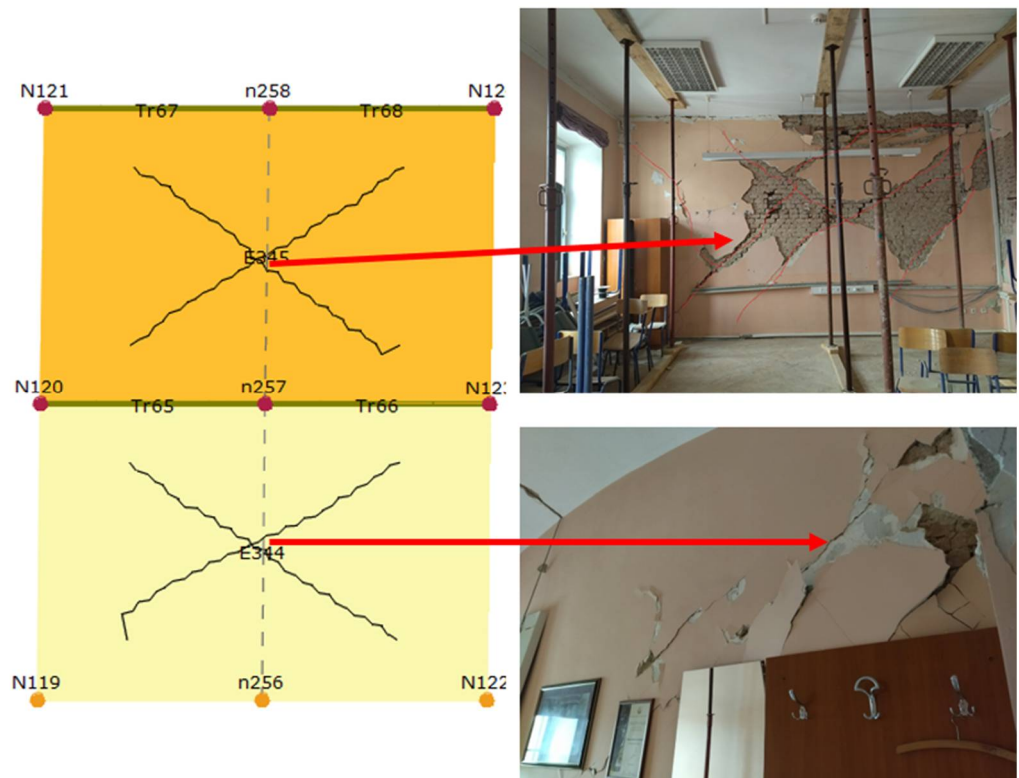
**Figure 17.** Detailed display of damage in the 3Muri software package and actual damage to the walls of the building in question.
