Post-Earthquake Condition Assessment and Seismic Upgrading Strategies for a Heritage-Protected School in Petrinja, Croatia

Post-Earthquake Condition Assessment and Seismic Upgrading Strategies for a Heritage-Protected School in Petrinja, Croatia. *Buildings* **2022**, *12*, 2263. <https://doi.org/10.3390/buildings12122263>

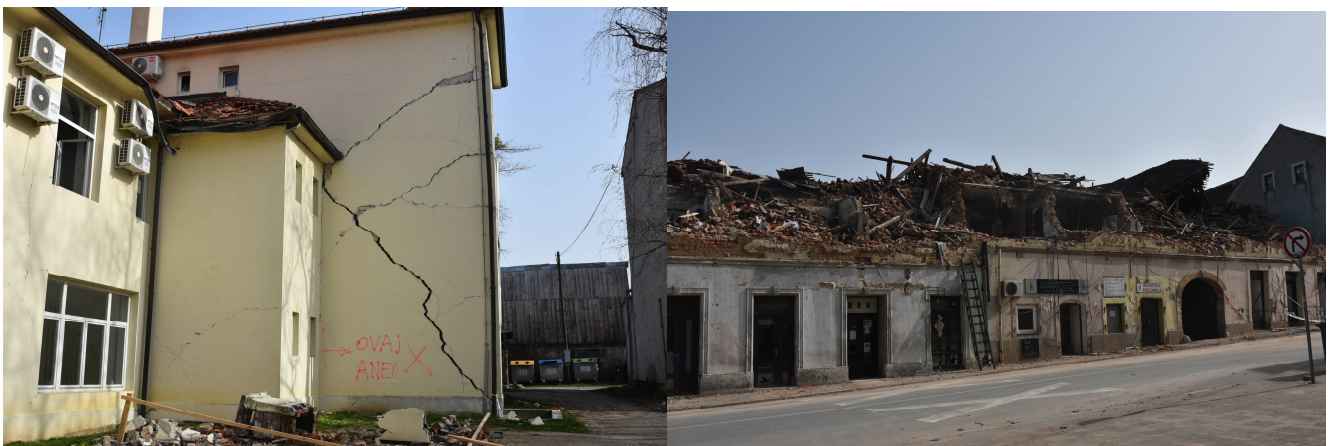
Figure 2. Damaged buildings in the historical center of Petrinja.

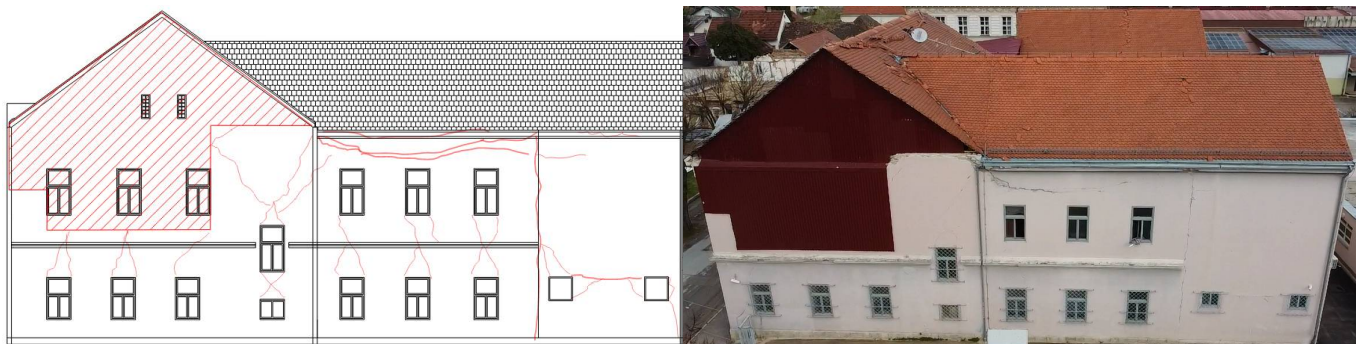
Figure 10. Southeastern façade plan with marked damage.

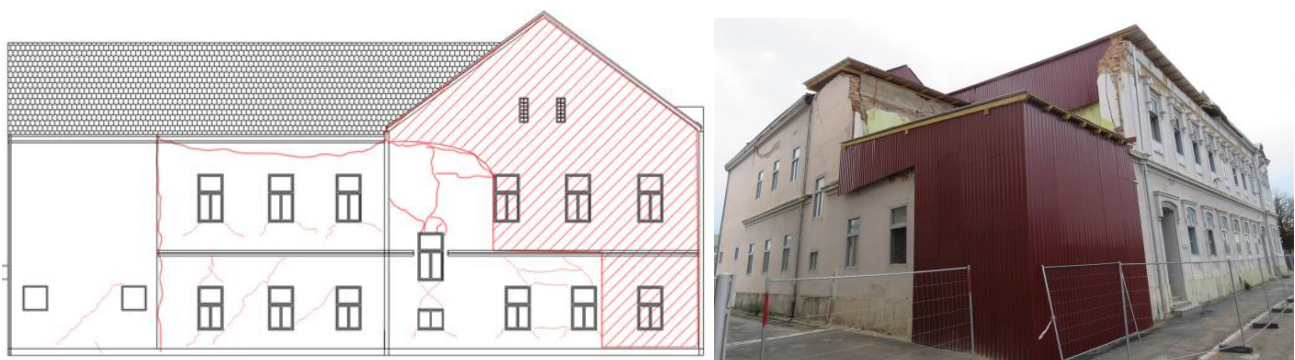
Figure 11. Northwestern façade plan with marked damage.

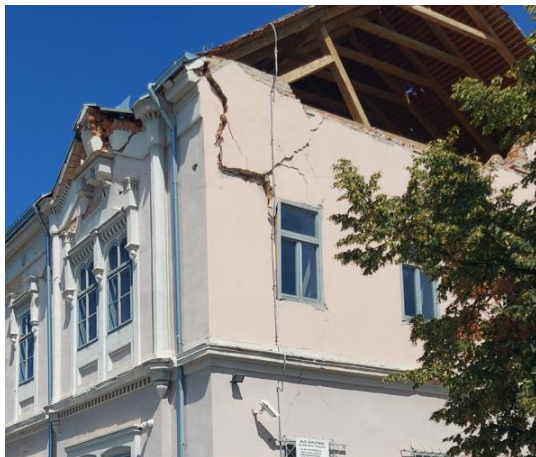
Out-of-plane failure of wall connections

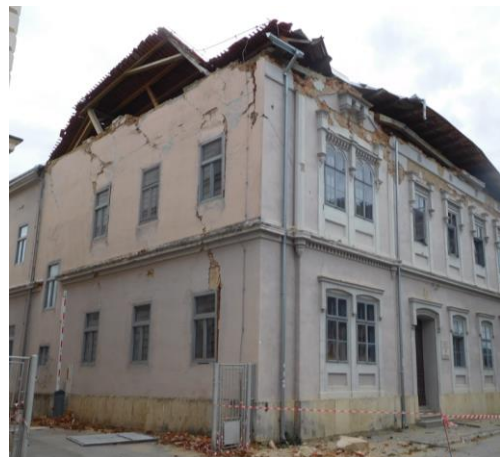
Partial overturning of the gable walls

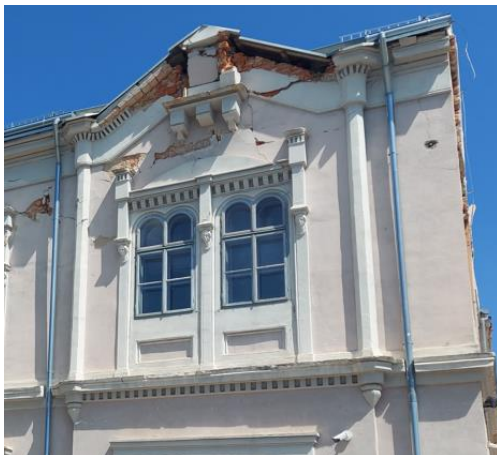
Out-of-plane wall failure in the attic

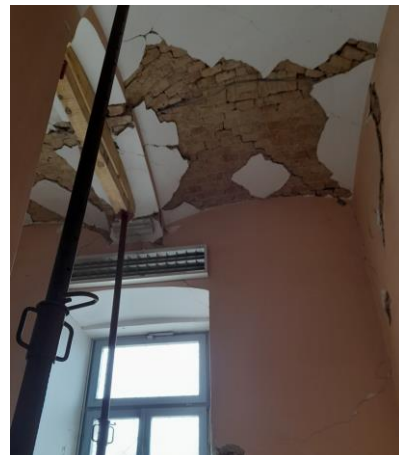
Vault damage/collapse
