# The Assessment and Retrofitting of Cultural Heritage—A Case Study of a Residential Building in Glina

**Abstract:** The focus of the study is on the renovation of a specific case study, which is a 19th century building under cultural heritage protection. It highlights the particular challenges faced by civil engineers in the structural renovation of buildings that are under heritage protection. Preserving the identity of these buildings limits the available methods for strengthening their seismic capacity. At the beginning, information about the seismic activity and the different post-earthquake evaluation procedures are presented to identify the damage and take appropriate further steps. Then, basic information about the building is given and supported by graphic attachments. In the following, the methods and materials are explained, focusing on in situ testing with the semi-destructive flat-jack method and the analysis of the structure with the nonlinear method implemented in the software. Subsequently, the obtained results are presented and discussed, accompanied by graphics. An approach for strengthening the structure is presented, which includes a combination of traditional

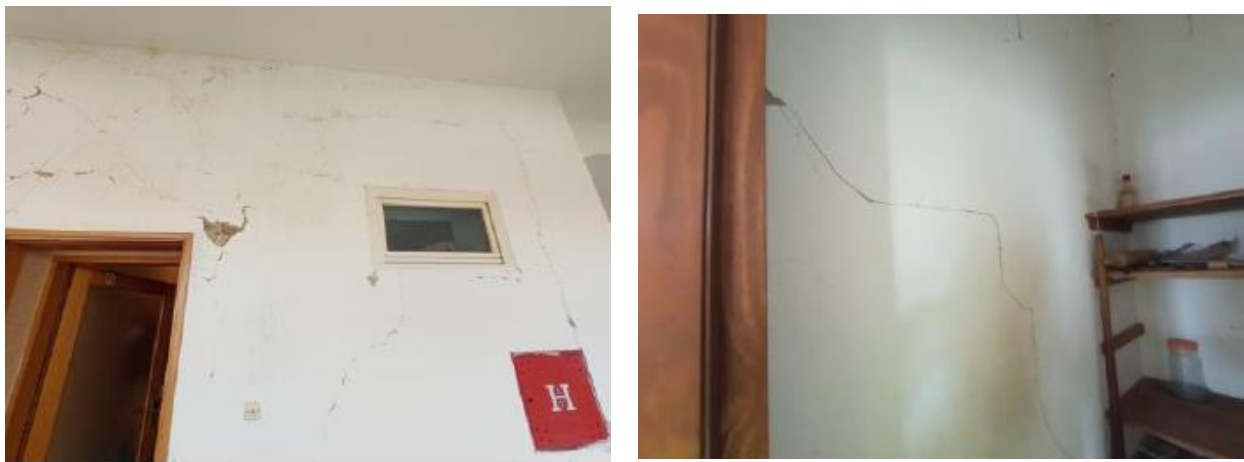
Detailed inspections of the residential building (former gymnasium building) revealed the following recorded instances of damage: on the ground floor, there is visible damage in the form of cracks in the wall coverings (Figure 8), arches, vaults and ceilings, as well as separation and localized falling off of the plaster. Minor local damage to structural elements (walls, columns, and arches) is also visible. Damage is visible on all floors in the form of cracks and falling plaster on the walls. Minor local damage to the walls is also visible, and there are locally visible cracks at the junctions of load-bearing walls and ceilings (Figure 9). At the edges of the building, oblique cracks are visible on the load-bearing walls, and can also be seen on the facade of the building. In addition to the previously documented damage to the construction elements of the building, damage to other elements was observed. The partition walls are mostly damaged. Other instances of damage include the chipping of plaster on structural and non-structural elements, damage to the finishing coverings on the walls and floors, and the collapse of part of the cornice and other decorative elements (Figure 10). The roof was damaged in several places, and the roof covering near the chimneys collapsed (Figure 11).

**Figure 8.** Cracks on the load-bearing walls on the first floor.

Based on the detailed assessment, the entirety of the building necessitates rehabilitation and retrofitting measures. Subsequently, it is imperative to conduct a comprehensive examination encompassing both static and dynamic analyses of the existing structural conditions. Before that, it is necessary to carry out investigative work to determine the characteristics of the walls and other necessary data for the analysis of the structure.

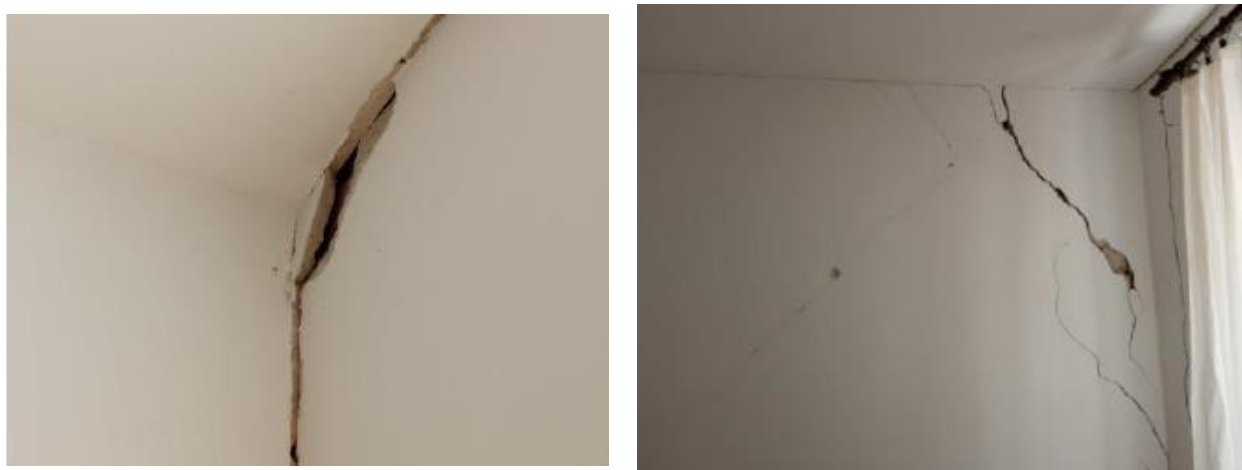
**Figure 9.** Cracks at the junctions of load-bearing walls.

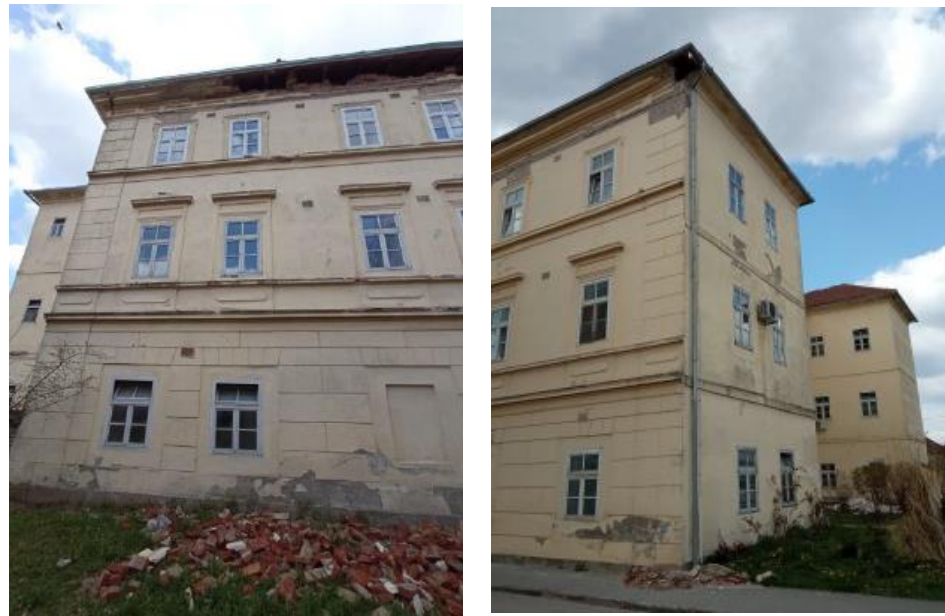
**Figure 10.** Damage to the facade.

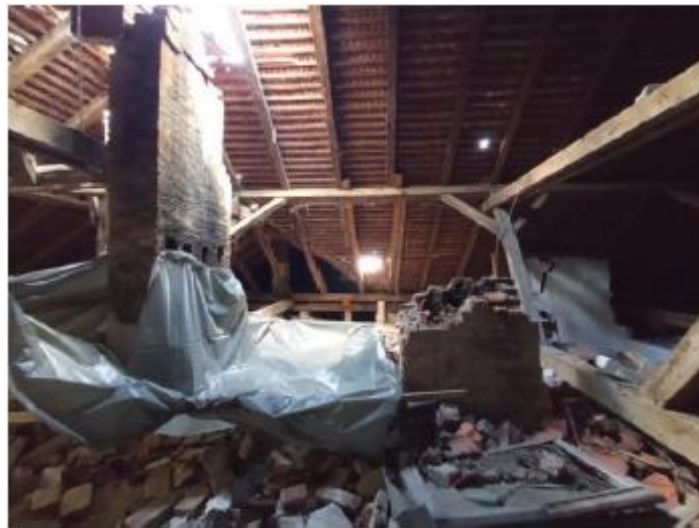
**Figure 11.** Collapsed chimney and damaged roof covering.

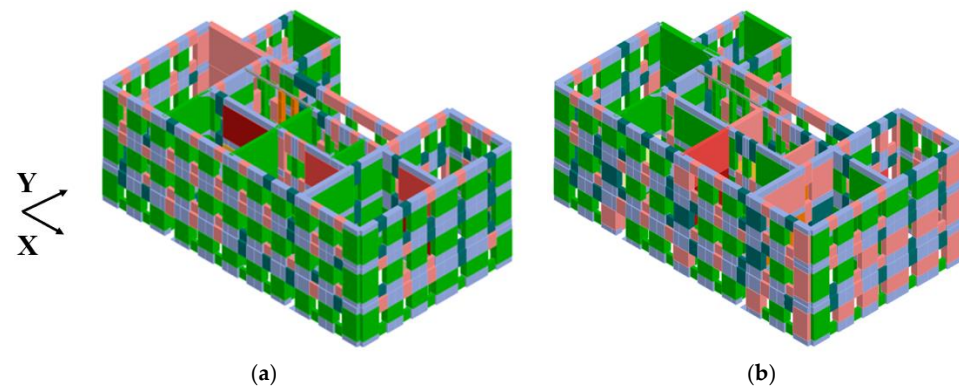
A visualization of the damage from the critical analyses is displayed in Figure 16. The images highlight the critical parts of the structure, which correspond to the actual damage scenarios (damaged spandrels and load-bearing walls in the longitudinal and transversal direction of the central part). Figure 17 displays the capacity curves in the X and Y direction, which are derived from the pushover curves with the lowest risk indices. The radial lines defined by the slope of the first part of the capacity curve represent the elastic structural period  $T^*$ . The intersecting point of the period and the seismic demand is the elastic displacement of the SDoF. It is visible that the seismic capacity is equal in both directions. Still, the seismic demand is lower for the Y direction than the X direction. The latter justifies the higher risk indices in the Y direction, which are shown in Table 6. Accordingly, the structure does not satisfy the seismic requirements.

Figure 16. Damage visualization for the most critical analysis in the (a) X direction and (b) Y direction.
