Source / Izvornik: **Buildings**, 2023, 1798 (13)

The Assessment and Retrofitting of Cultural Heritage—A Case Study of a Residential Building in Glina

Abstract: The focus of the study is on the renovation of a specific case study, which is a 19th century building under cultural heritage protection. It highlights the particular challenges faced by civil engineers in the structural renovation of buildings that are under heritage protection. Preserving the identity of these buildings limits the available methods for strengthening their seismic capacity. At the beginning, information about the seismic activity and the different post-earthquake evaluation procedures are presented to identify the damage and take appropriate further steps. Then, basic information about the building is given and supported by graphic attachments. In the following, the methods and materials are explained, focusing on in situ testing with the semi-destructive flat-jack method and the analysis of the structure with the nonlinear method implemented in the software. Subsequently, the obtained results are presented and discussed, accompanied by graphics. An approach for strengthening the structure is presented,

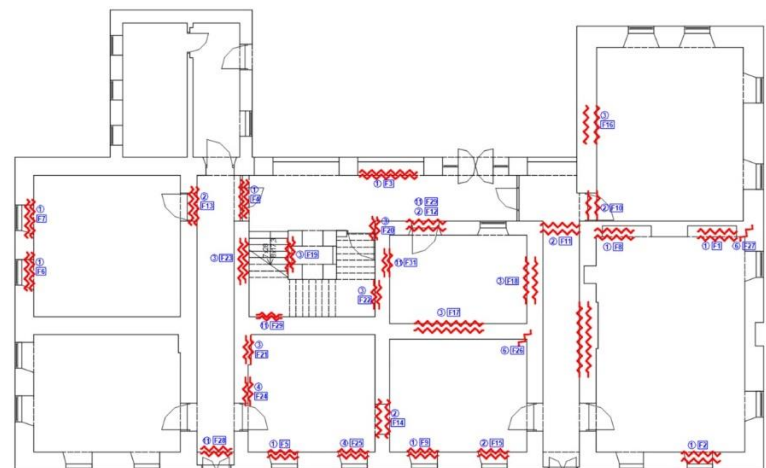
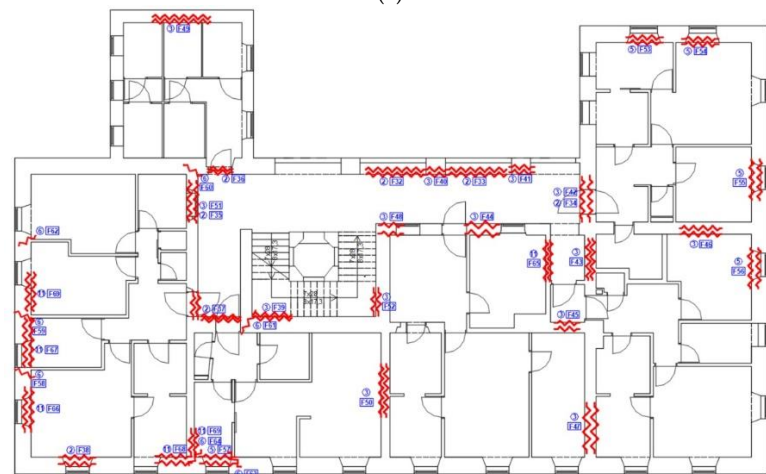
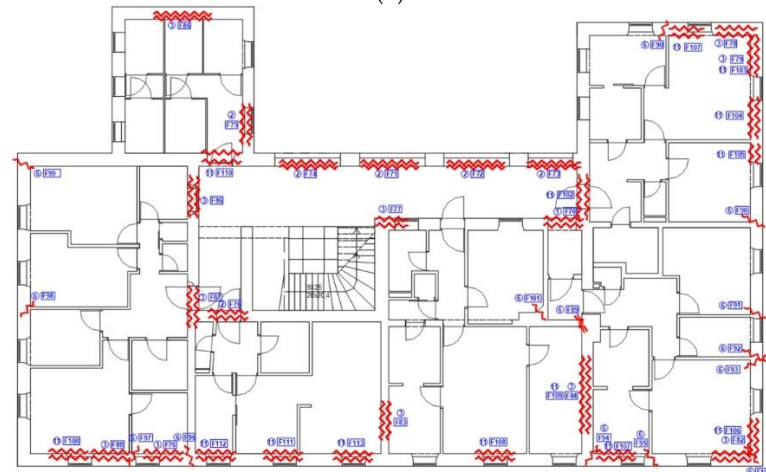
After a rapid inspection, a detailed inspection of the building was carried out in May 2022. All instances of damage, structural and non-structural (Figure 7), were photographed and described in reports on the floors of the building and the individual rooms in which they are located, and proposed measures for their repair were given. A detailed recording of the existing condition was also made for the purpose of creating digital floor plans of the building.

Figure 7. Damage patterns (red marks): (a) ground floor, (b) first floor, and (c) second floor.

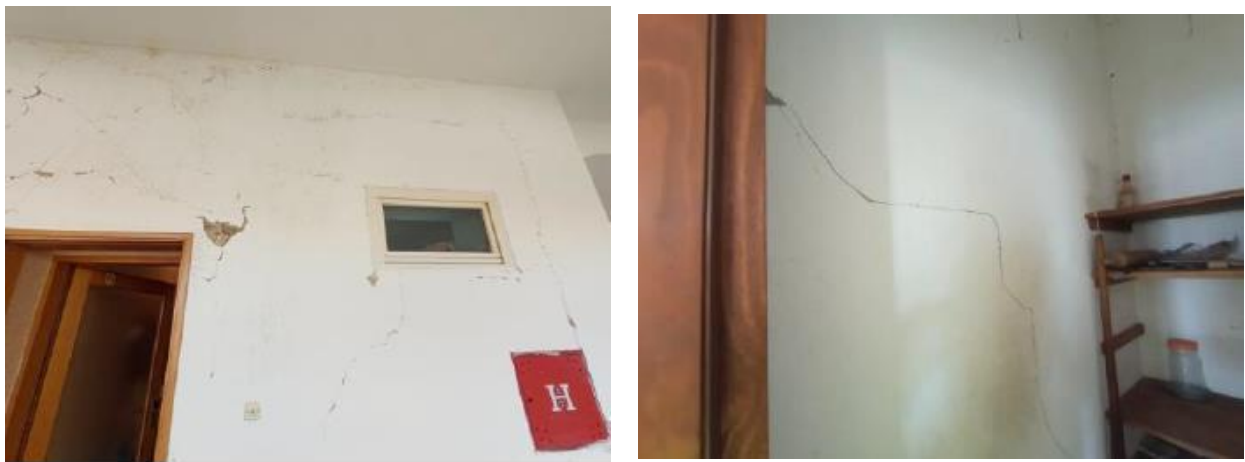
Detailed inspections of the residential building (former gymnasium building) revealed the following recorded instances of damage: on the ground floor, there is visible damage in the form of cracks in the wall coverings (Figure 8), arches, vaults and ceilings, as well as separation and localized falling off of the plaster. Minor local damage to structural elements (walls, columns, and arches) is also visible. Damage is visible on all floors in the form of cracks and falling plaster on the walls. Minor local damage to the walls is also visible, and there are locally visible cracks at the junctions of load-bearing walls and ceilings (Figure 9). At the edges of the building, oblique cracks are visible on the load-bearing walls, and can also be seen on the facade of the building. In addition to the previously documented damage to the construction elements of the building, damage to other elements was observed. The partition walls are mostly damaged. Other instances of damage include the chipping of plaster on structural and non-structural elements, damage to the finishing coverings on the walls and floors, and the collapse of part of the cornice and other decorative elements (Figure 10). The roof was damaged in several places, and the roof covering near the chimneys collapsed (Figure 11).

Figure 8. Cracks on the load-bearing walls on the first floor.

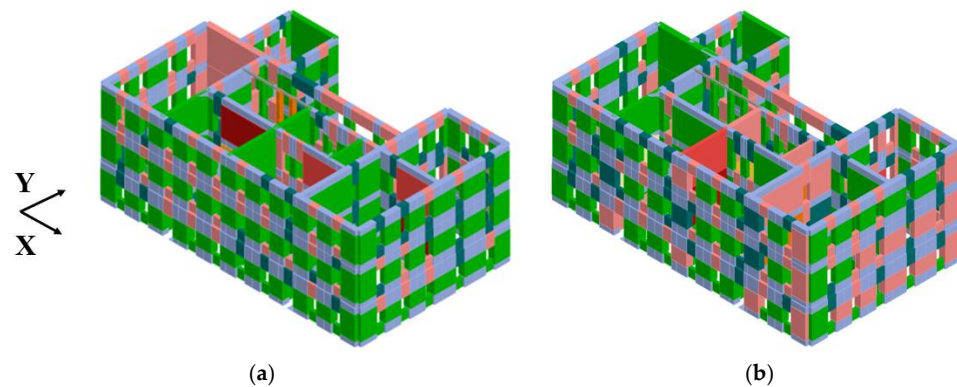
A visualization of the damage from the critical analyses is displayed in Figure 16. The images highlight the critical parts of the structure, which correspond to the actual damage scenarios (damaged spandrels and load-bearing walls in the longitudinal and transversal direction of the central part). Figure 17 displays the capacity curves in the X and Y direction, which are derived from the pushover curves with the lowest risk indices. The radial lines defined by the slope of the first part of the capacity curve represent the elastic structural period T^* . The intersecting point of the period and the seismic demand is the elastic displacement of the SDoF. It is visible that the seismic capacity is equal in both directions. Still, the seismic demand is lower for the Y direction than the X direction. The latter justifies the higher risk indices in the Y direction, which are shown in Table 6. Accordingly, the structure does not satisfy the seismic requirements.

Figure 16. Damage visualization for the most critical analysis in the (a) X direction and (b) Y direction.
