Source / Izvornik: **Buildings, 2023, 1798 (13)**

The Assessment and Retrofitting of Cultural Heritage—A Case Study of a Residential Building in Glina

Karlo Ožić¹, Ivan Markić², Antonela Moretić^{1,*} and Luka Lulić¹

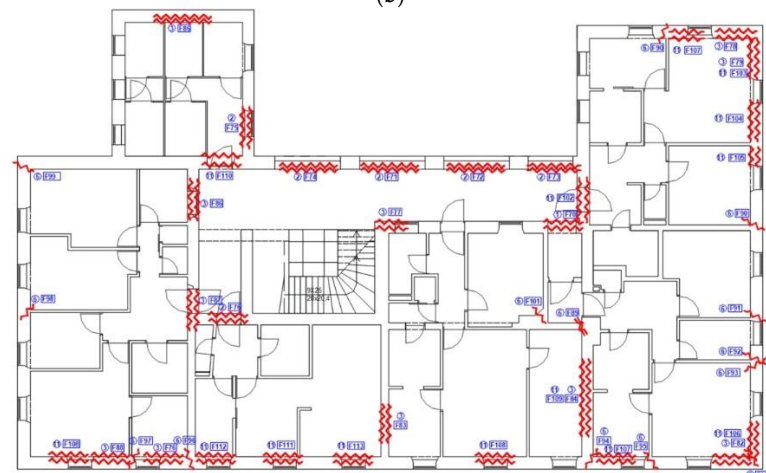
After a rapid inspection, a detailed inspection of the building was carried out in May 2022. All instances of damage, structural and non-structural (Figure 7), were photographed and described in reports on the floors of the building and the individual rooms in which they are located, and proposed measures for their repair were given. A detailed recording of the existing condition was also made for the purpose of creating digital floor plans of the building.

Figure 7. Damage patterns (red marks): (a) ground floor, (b) first floor, and (c) second floor.
