The Assessment and Retrofitting of Cultural Heritage—A Case Study of a Residential Building in Glina

Karlo Ožić¹, Ivan Markić², Antonela Moretić^{1,*} and Luka Lulić¹

Keywords: earthquake; structural strengthening; cultural heritage; nonlinear static analysis; in situ tests

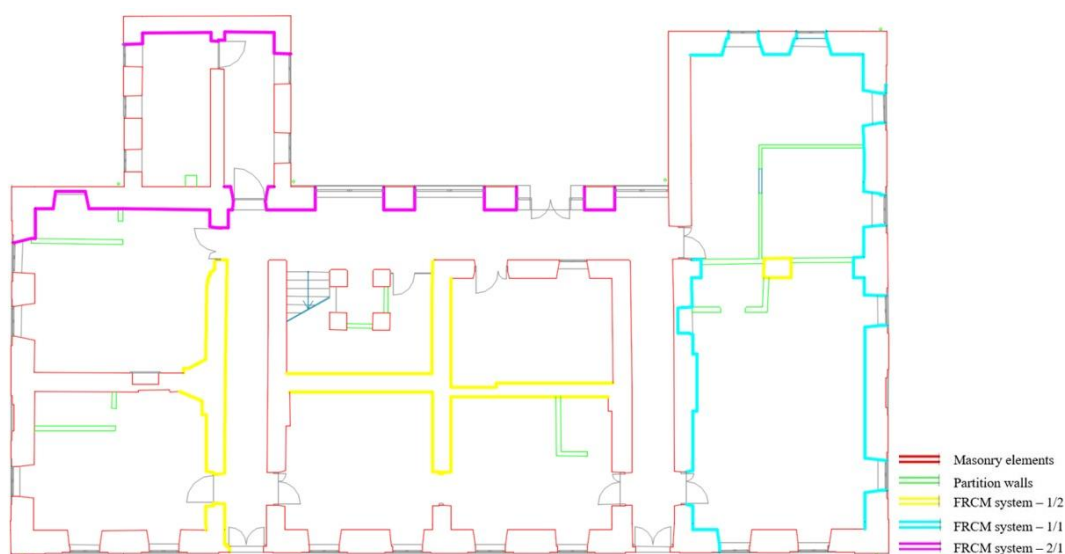
Figure 19. Strengthened structure of the ground floor.

The required number of layers was calculated according to the values of internal forces. The resistance of the element was calculated, including the shear and bending failure. Shear failure includes both diagonal and sliding failure, while the bending failure

is characterized by crushing in the compression area. The minimum value of the three is considered the resistance of the element. If the internal forces are higher than the resistance, the FRCM composite has been applied to the wall. The contribution of the FRCM system to the resistance of the wall layer was calculated. The number of layers is increased until a resistance greater than the internal forces is achieved. The FRCM composite was applied to the walls in the software, which caused the redistribution of the internal forces. Hence, the calculation of the strengthening is an iterative procedure. The proposed solution is displayed in Figures 19 and 20. The walls on which the FRCM system is applied are marked according to the legend, and denoted 1/n. 1 represents the number of layers applied per side of the wall, while n indicates if the FRCM system is applied to a single side of the wall ($n = 1$) [45,46] or on both sides ($n = 2$). Although the system is placed asymmetrically regarding the floor plan, the solution does not cause additional torsion, as the fibers have a low individual weight, and 0.5 cm of the cementitious matrix is applied per layer of the fibers. The system exclusively affects the in-plane capacity.

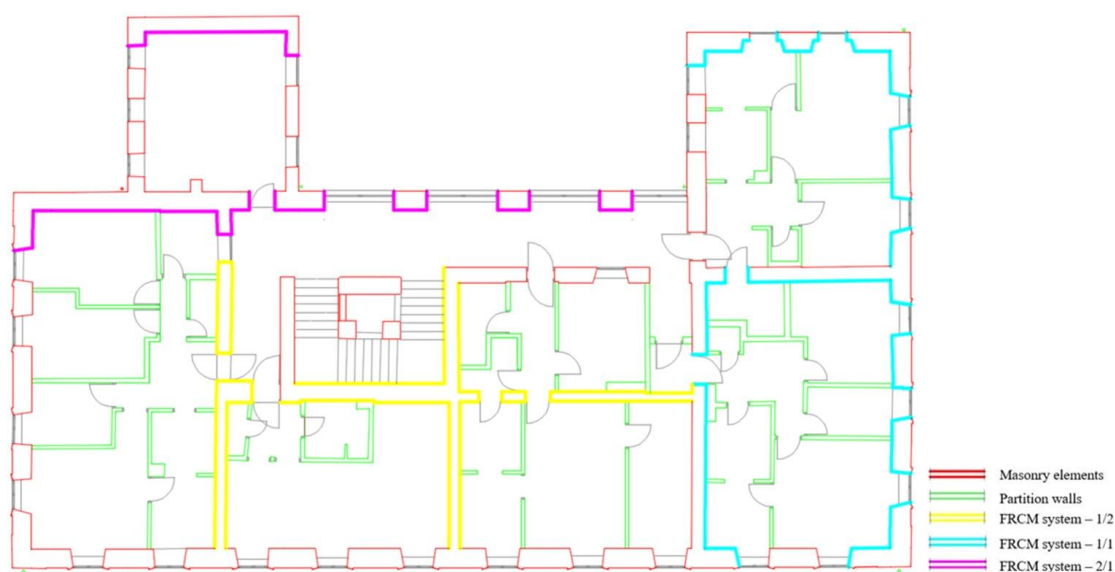
Figure 20. Strengthened structure of the first and second floor.
