Seismic Retrofitting of Dual Structural Systems-A Case Study of an Educational Building in Croatia

Seismic Retrofitting of Dual Structural Systems—A Case Study of an Educational Building in Croatia

The building of the higher education institution in Petrinja, Croatia, was built in 1963 and underwent energy renovation in 2018. The building consists of the ground, 1st, and 2nd floors; the area on the ground floor is 1294.3 m² and on the upper floors 603.4 m². The total gross floor area of the building is 2501.1 m², while the useful heated area of the building is approximately 2130 m². The building has an irregular T-shaped layout and consists of three volumes connected into one whole (Figure 3). In the northwest–southeast direction (hereafter X-dir), there are two volumes that have only the ground floor. The volume marked as V1 is 3.84 m high, while the volume V2 in the southeastern part of the building is 5.52 m high and consists of a one large hall. The central volume V3 of the building is arranged in a northeast–southwest direction (hereafter Y-dir) and has three stories with a total height of 11.52 m.

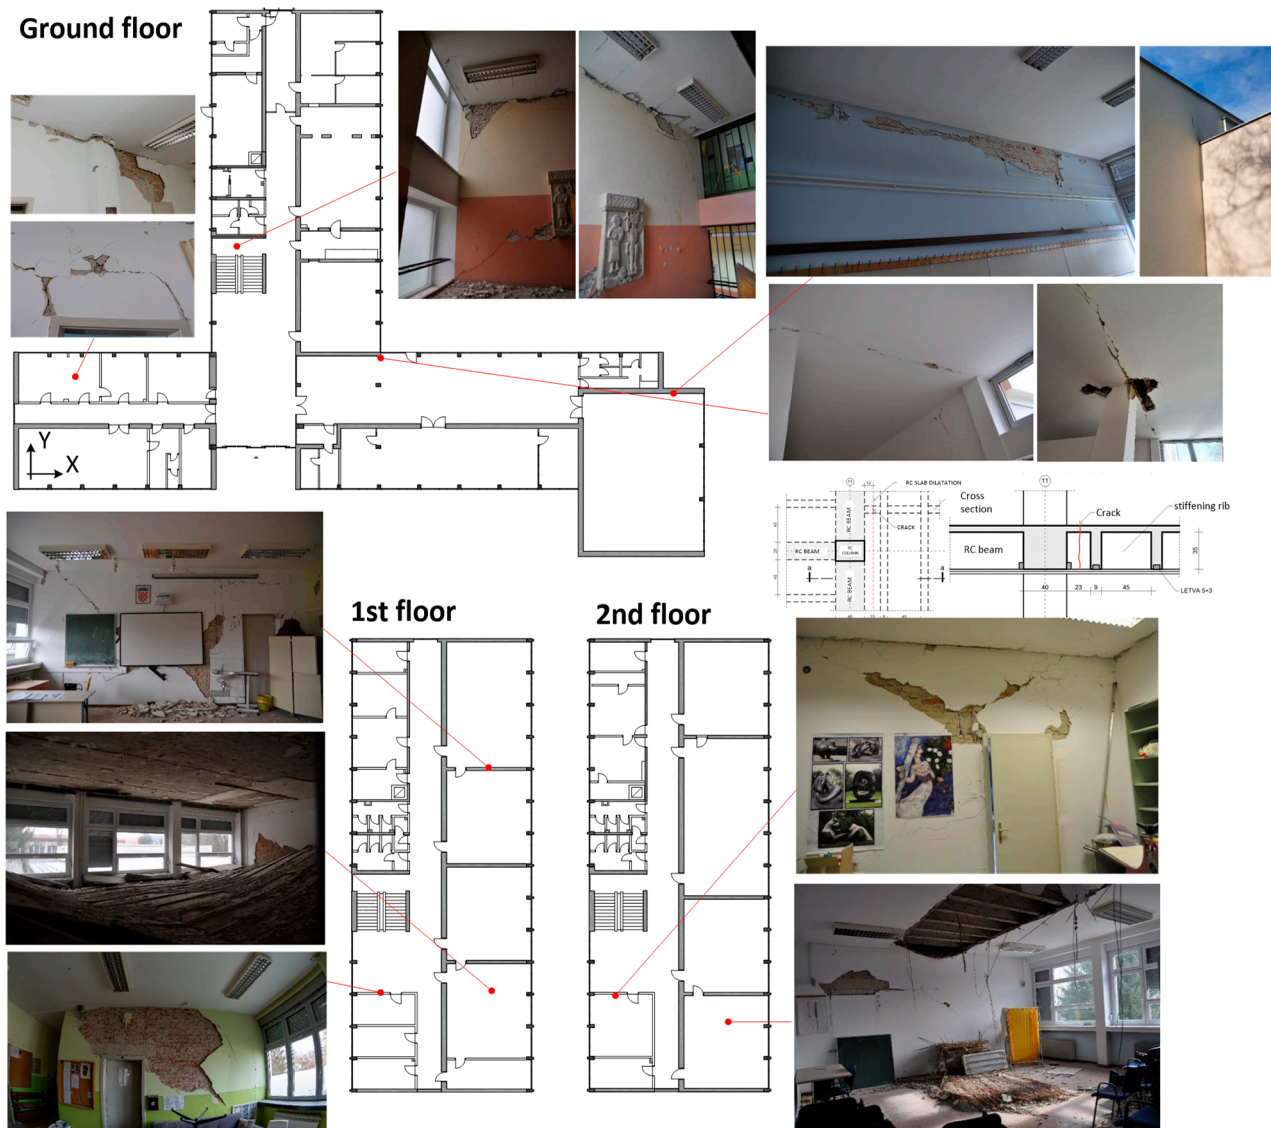
The building was damaged during the 29 December 2020 Petrinja earthquake. After a preliminary inspection, it was labelled as temporarily unusable with the need for emergency intervention measures due to the suffered damage. There was a risk of plaster and installations falling from the callings and the out-of-plane failure of severely damaged partition walls, so access was restricted in some parts of the building. The inspection revealed slight damage to the floor structures, moderate damage to the vertical elements and severe damage to the staircase and partition walls. The overall damage to the structure was classified as Level 3, according to the EMS scale. Characteristic damage can be seen in the Figure 6 with indicated location information.

Figure 6. Photographs of damage to the building (photos: courtesy of Joško Krolo and Karlo Jandrić, 2021; and CCEE, 2021).

Further detailed inspection in particular revealed that the damage to the brick wall to which the staircase landing is connected is significant and possess a considerable risk for usage. It is the only staircase in the building. Due to the structural irregularities, special attention was given to the locations where different volumes connect. Although there is no dilatation, the detailed inspection showed that the slabs are partially separated and that the stiffening ribs connect the different units of the building. In this location, between the lower and upper parts of the building, damage to the floor structure was observed. To determine the extent of the damage found, the lower layers of the ceiling were removed, and cracks were also found on the stiffening ribs of the slab in this area. Furthermore, in the section connecting volumes V1 and V3, cracks were recorded on the part of the wall located above the ground floor. Other observed damage included minor damage to the load-bearing masonry walls, extensive cracking of partition walls and major damage to the lower layers of ceiling structures, with cracking and the falling of plaster on almost all walls.
