Seismic Retrofitting of Dual Structural Systems-A Case Study of an Educational Building in Croatia

Seismic Retrofitting of Dual Structural Systems—A Case Study of an Educational Building in Croatia

Abstract: On 29 December 2020, a devastating Mw6.4 earthquake struck near the town of Petrinja, Croatia. The main earthquake was preceded by a Mw4.9 foreshock the day before. The earthquakes caused extensive damage to buildings, especially historic buildings made of unreinforced masonry but also to buildings of other typologies and to critical infrastructure. Today, recovery efforts in Croatia focus primarily on reconstruction and seismic retrofitting. Family homes and public, cultural, educational, and other facilities are top priorities. In this paper, a comprehensive study of existing building in the educational sector is presented as a case study. The seismic performance of the building is evaluated using numerical methods, first for the as-built condition and then for the retrofitted building. For each condition, the collapse mechanisms of the building were determined and critical structural elements were identified. The presented retrofit strategy of the dual structural system co

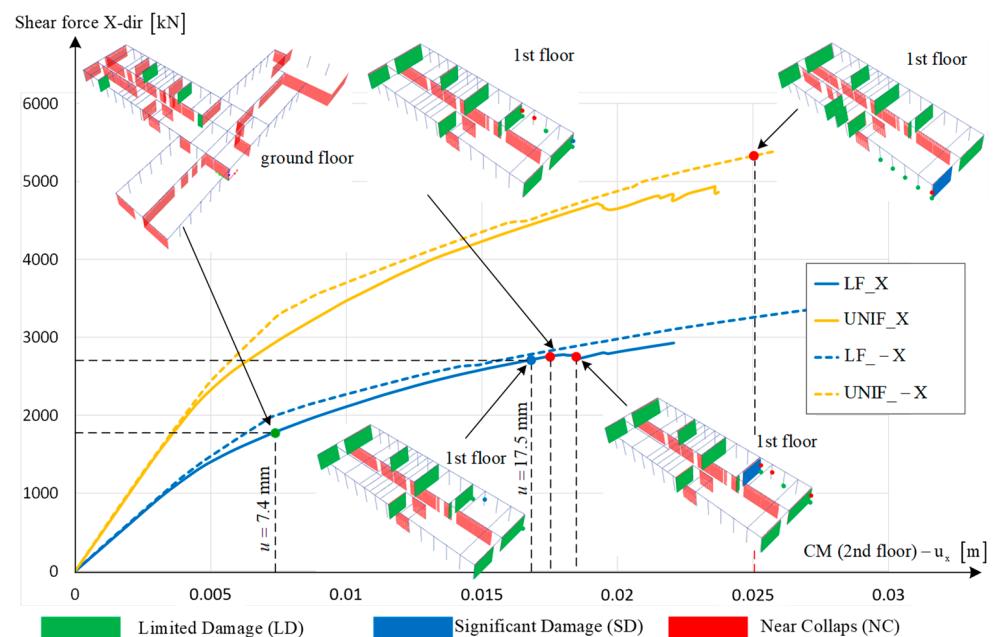
The most significant pushover curves for the action of the lateral force in the X-dir are shown in Figure 15. It can be seen that some elements of the structure come to a state of limited damage, which is reflected on the curve as a decrease in stiffness, i.e., the slope at a force of 1800 kN (base shear coefficient, B.S. = 5.6%) and a displacement of 7.4 mm. Then there is the initial opening of cracks and a reduction in the stiffness of individual elements. The diagram shows elements on the ground floor where cracks appear, even though they are present on all floors. The beginning of the failure of the structural elements occurs at a force of 2900 kN (B.S. = 9.1%) and at a displacement of 17.5 mm. The columns on the 1st floor reach the SD limit state due to exceeding the shear capacity. Since such damage of the columns is non-ductile, exceeding their ultimate capacity means that they soon reach the NC limit state.

Figure 15. Pushover curves in X-dir for as-built structure.

The next important point is the failure of these columns at a lateral force of 2900 kN and for a displacement of 18 mm. The masonry wall on the 1st floor next to the critical columns is also in a SD limit state, but it still has not utilized total load-bearing capacity. At this point, it can be said that the bearing capacity of part of the building is reached and that a local failure of the building is possible. As a result, the local failure of the floors may occur. It can already be said that the building is in a NC limit state, and it can be classified as having the highest degree of damage. However, even in the case of local failure, it is unlikely that the rest of the structure will collapse at this level of loading. The walls and

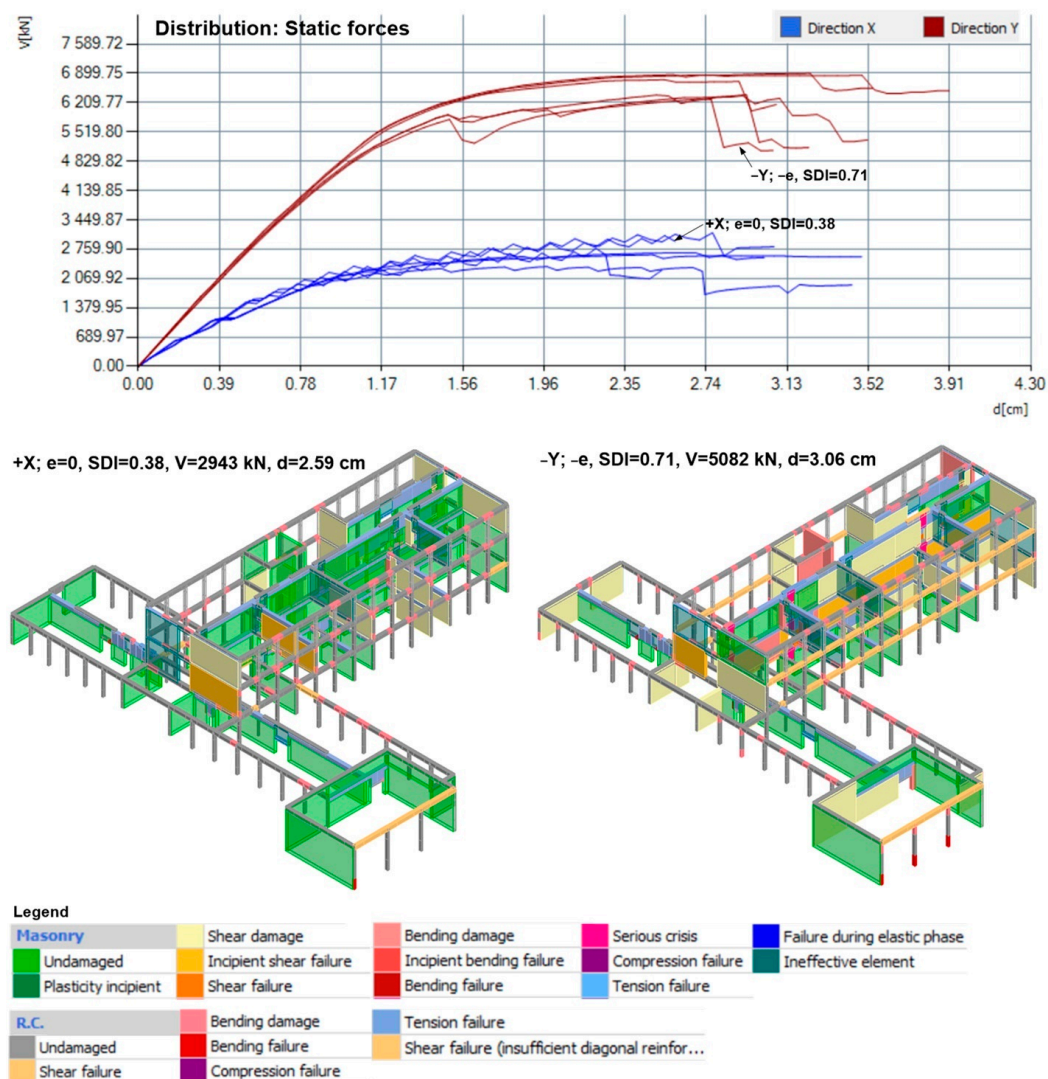
The analysis performed for the load distribution pattern according to the lateral force method (Static forces, Figure 21) proves to be less favorable for the structure than the previous case. Although the relevant structural failure mechanisms remain almost unchanged for the X-dir, the peak lateral force is around 2900 kN and the corresponding SDI is 0.38. In the Y-dir, significant damage is observed on a large number of walls on all floors, and in addition to the shear failure mechanism, there is also damage due to bending. However, the critical elements are the walls on the P9 axis, whose damage is noticeable on all floors. The main analysis performed for this direction has an SDI of 0.71.

Figure 21. EFM results: pushover curves and corresponding damage mechanism of the building obtained using the static forces load patterns.
