The December 2020 magnitude (Mw) 6.4 Petrinja earthquake, Croatia: seismological aspects, emergency response and impacts

Source / Izvornik: **Bulletin of earthquake engineering, 2023, 21, 5767 - 5808**

Josip Atalić¹ · Marija Demšić¹ · Maja Baniček² · Mario Uroš¹ · Iva Dasović³ · Snježan Prevolnik³ · Alen Kadić² · Marta Šavor Novak¹ · Miroslav Nastev⁴

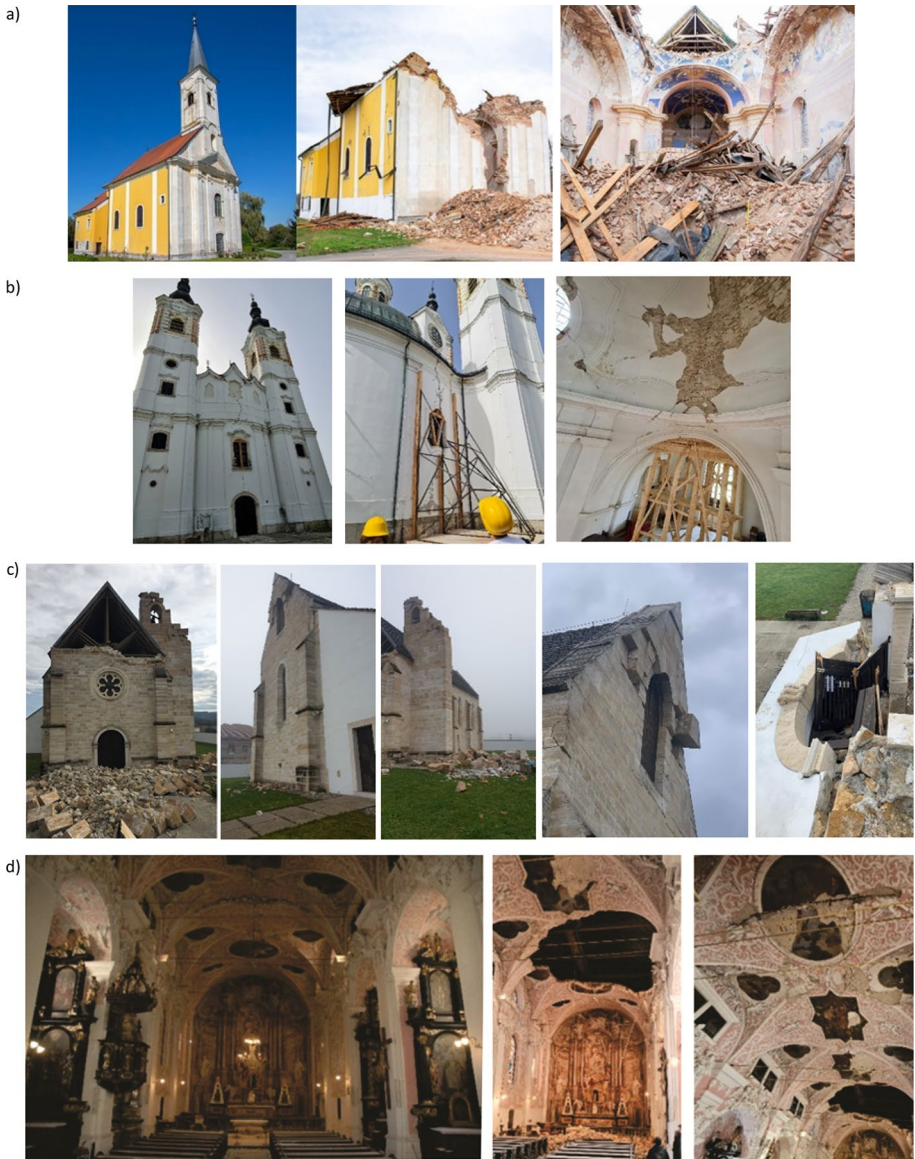
Figure 14a shows the church of St. Nicholas and St. Vid in Žažina, which suffered considerable structural damage caused by collapse of the bell tower. Part of the roof of the main nave also collapsed as did the vaults supporting the roof structure. Unfortunately, the organist of the parish lost his life under the rubble in this church. One of the most valuable and beautiful Baroque churches in continental Croatia is certainly the parish church of St. Mary Magdalene in Sela near Sisak (Fig. 14b). Both towers of the church, the entrance portal, the lintels and walls, and the dome were severely damaged. Urgent protective measures were therefore implemented including the erection of supporting scaffolding to alleviate any threat of collapse of arches and external walls, and stabilization of both towers. The third example shown here is the parish church of the Assumption of the Virgin Mary in Gora. This church was destroyed and rebuilt several times over the centuries. The last facsimile reconstruction of this early Gothic Templar church of carved stone blocks was completed in 2015 without any modern materials and techniques. The authentic reconstruction work was based on extensive archaeological and conservation-restoration research (Miletić and Valjato Fabris 2014). However, the project obviously lacked awareness of the seismic risks, and the new church sustained extensive damage, the tower collapsed together with several arches and part of the roof structure (Fig. 14c).

Due to the significant number of damaged buildings following the March 2020 Zagreb earthquake and insufficient time and resources, a large portion of those buildings remained without proper preventive measures and reconstruction. When the December 2020 Petrinja earthquake hit the region, it caused additional damage to structures already damaged by the previous earthquake. An example of such progressive damage is the church of St. Catherine in the Upper Town Zagreb, whose vaults extensively damaged during the previous earthquake collapsed together with parts of the ceiling (Fig. 14d).

Fig. 14 Damage to sacral buildings: **a** Church of St. Nicholas and St. Vid in Žažina, **b** Church of St. Mary Magdalene in Sela, **c** Church of the Assumption of the Virgin Mary in Gora, and **d** Church of St. Catherine in Zagreb after Zagreb earthquake (left) and after Petrinja earthquake (center and right) (photos: courtesy of Sisak archdiocese 2021; CCEE 2022; and Martina Vujanović, 2022)
