Source / Izvornik: **Bulletin of earthquake engineering, 2023, 21, 5767 - 5808**

The December 2020 magnitude (M_w) 6.4 Petrinja earthquake, Croatia: seismological aspects, emergency response and impacts

Josip Atalić¹ · Marija Demšić¹ · Maja Baniček² · Mario Uroš¹ · Iva Dasović³ · Snježan Prevolnik³ · Alen Kadić² · Marta Šavor Novak¹ · Miroslav Nastev⁴

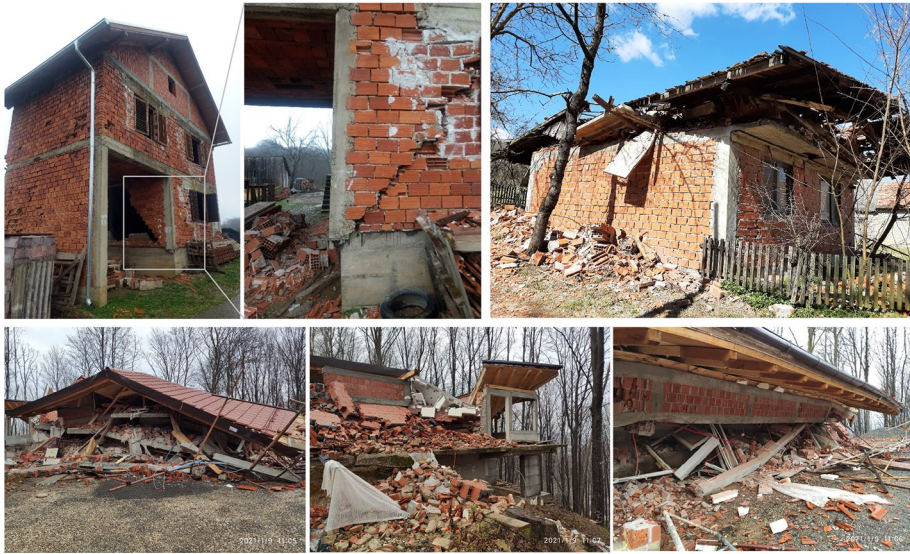
Fig. 20 Damage to (partially) confined masonry with significant structural deficiencies family houses (CCEE 2022)

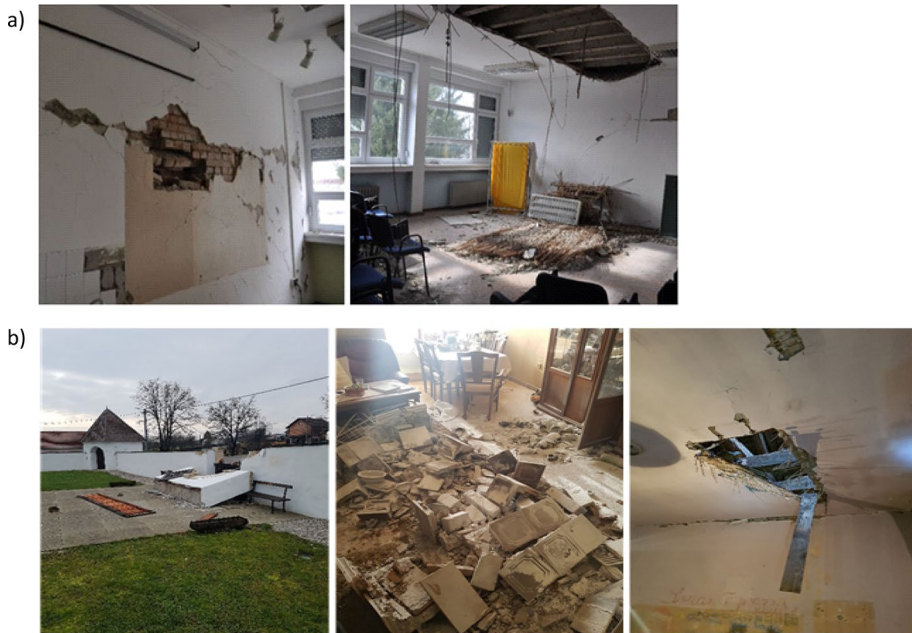
Damage to non-structural elements was by far the most frequent including damage to chimneys, to different parts of the roof, such as cracking and occasional falling of overhangs, cornices and roof tiles, and to various decorative elements. Almost all 'baroque' buildings in the epicenter suffered severe damage in their non-structural elements. These include cornices and significant cracking visible in decorative elements. As well, in many residential buildings, partition walls were damaged due to inadequate thickness and slenderness, or became completely detached from the load-bearing wall and had to be removed to avoid risk of complete collapse (Fig. 26a left).

Fig. 26 Damage to non-structural elements: **a** failure of partition walls and plaster detachment, **b** toppling of the outer wall, toppling of the heavy tile stove, and hole in the floor structure due to chimney collapse (CCEE 2022)

Cracks and detachment of plaster walls and ceilings (Fig. 26a right) from the inside as well as from the building facade were common in older buildings. More severe damage included the collapse of false ceilings. Damage was also observed to massive non-structural elements such as cantilevered concrete and masonry elements, as well as toppling of outer walls and rarely heavy tile stoves, which in some cases caused further damage (Fig. 26b).
