The December 2020 magnitude (Mw) 6.4 Petrinja earthquake, Croatia: seismological aspects, emergency response and impacts

Source / Izvornik: **Bulletin of earthquake engineering, 2023, 21, 5767 - 5808**

Josip Atalić¹ · Marija Demšić¹ · Maja Baniček² · Mario Uroš¹ · Iva Dasović³ · Snježan Prevolnik³ · Alen Kadić² · Marta Šavor Novak¹ · Miroslav Nastev⁴

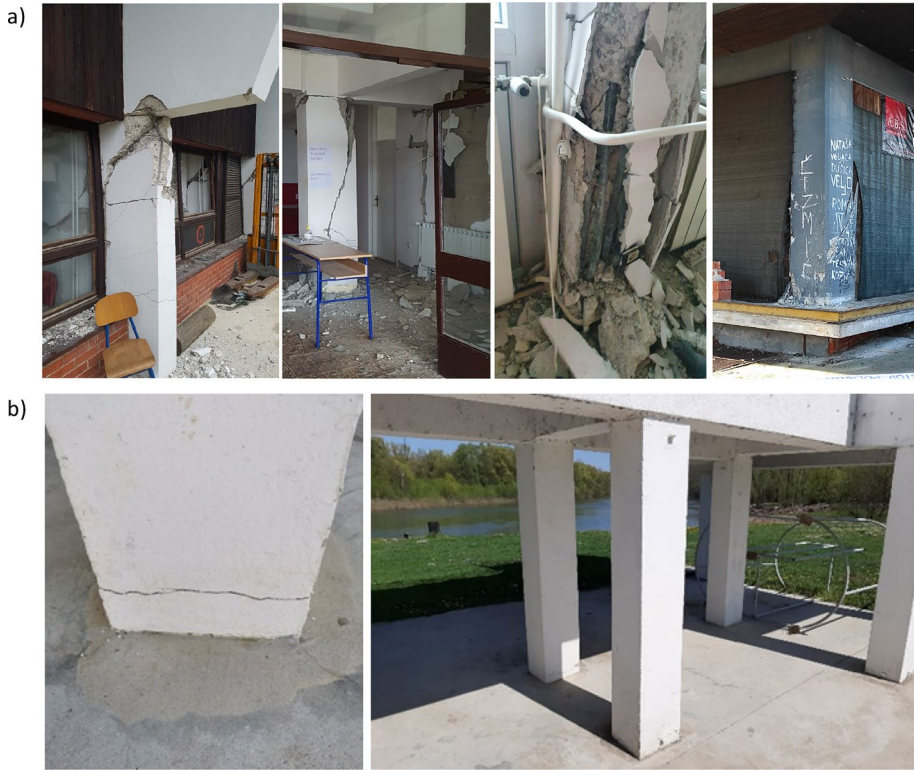
The absence of transverse reinforcement is characteristic of construction until 1964 and even later until 1981, when the first modern seismic codes were introduced that considered the ductility of joints and the prevention of brittle failure. Until then, the transverse reinforcement in the columns served mainly to connect the longitudinal reinforcement, and it was not considered in the load-carrying capacity because the horizontal seismic loads were not very high. Since the seismic forces were much lower according to the regulations of the time, it was not even necessary to provide the columns with

Fig. 24 Typical damage to RC building: **a** brittle fractures and **b** bending cracks in columns (CCEE 2022)
