The December 2020 magnitude (Mw) 6.4 Petrinja earthquake, Croatia: seismological aspects, emergency response and impacts

Atalić, Josip; Demšić, Marija; Baniček, Maja; Uroš, Mario; Dasović, Iva; Prevolnik, Snježan; Kadić, Alen; Šavor Novak, Marta; Nastev, Miroslav

Source / Izvornik: **Bulletin of earthquake engineering, 2023, 21, 5767 - 5808**

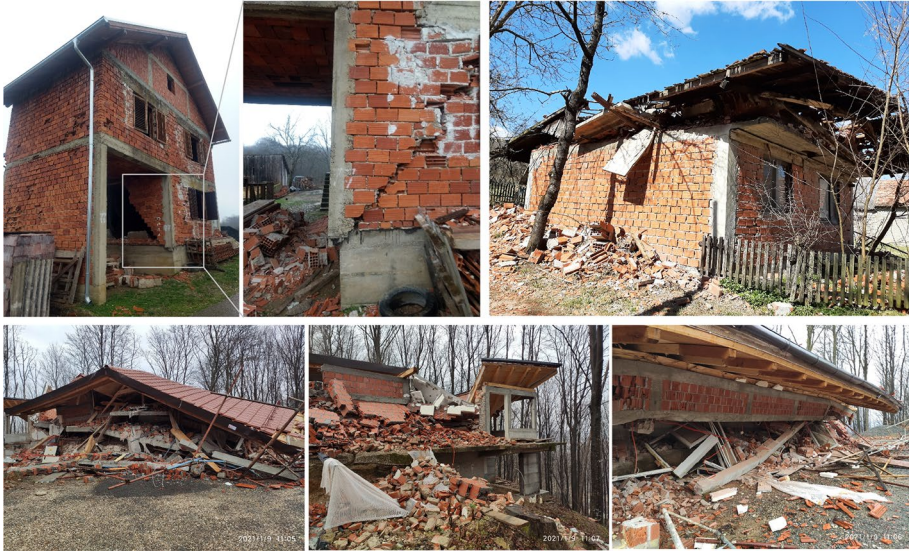
Fig. 20 Damage to (partially) confined masonry with significant structural deficiencies family houses (CCEE 2022)

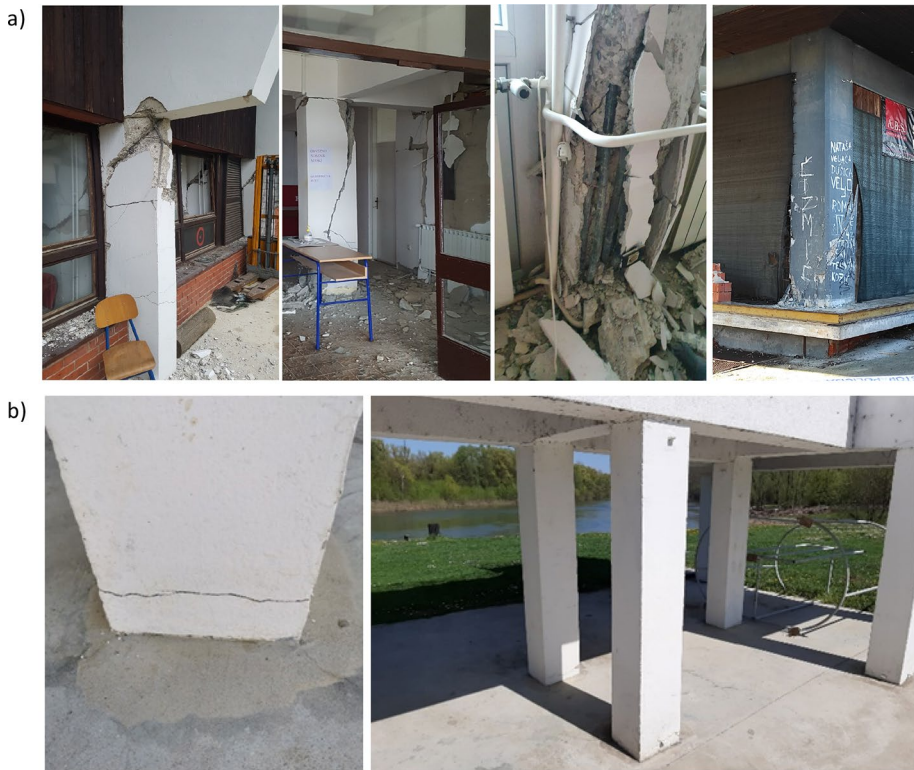
The absence of transverse reinforcement is characteristic of construction until 1964 and even later until 1981, when the first modern seismic codes were introduced that considered the ductility of joints and the prevention of brittle failure. Until then, the transverse reinforcement in the columns served mainly to connect the longitudinal reinforcement, and it was not considered in the load-carrying capacity because the horizontal seismic loads were not very high. Since the seismic forces were much lower according to the regulations of the time, it was not even necessary to provide the columns with

Fig. 24 Typical damage to RC building: **a** brittle fractures and **b** bending cracks in columns (CCEE 2022)

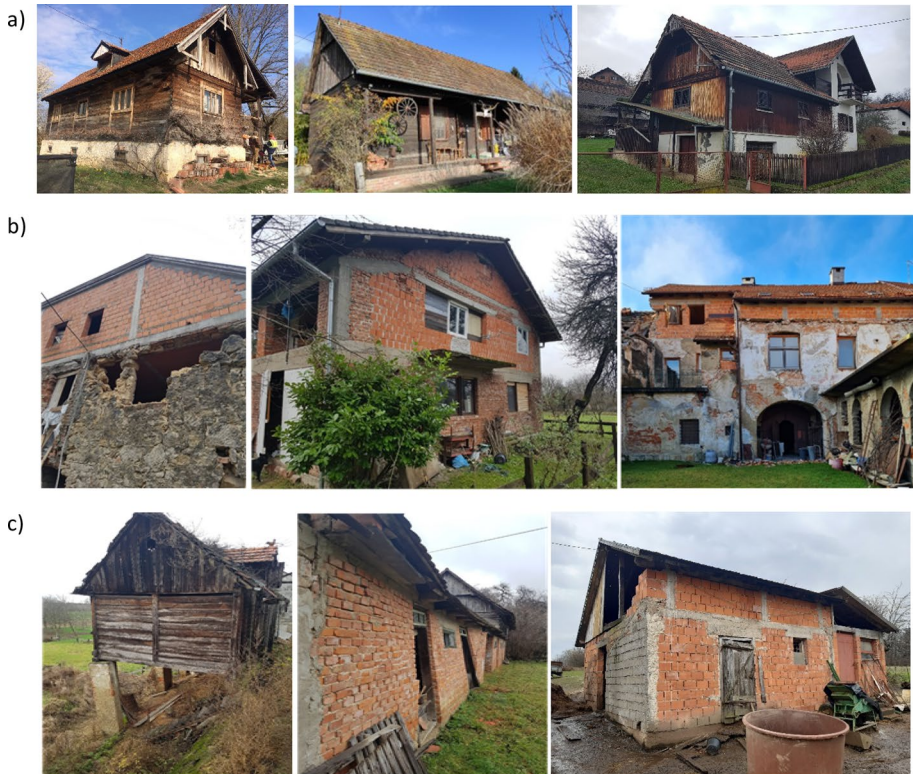
Traditional rural buildings are widespread across the Sisak-Moslavina County. Most of the observed damage was minor confirming their fair to good seismic performance exceeding that of the common URM buildings. The major advantage of these structures is in the light-weight wooden structural elements with joints with capacity to dissipate energy (Fig. 25a). Structural damage was almost inexistent and, when such damage did occur, it was localized mainly to joints between the wooden elements. Nonstructural damage, such

Fig. 25 Rural buildings: **a** Traditional wooden houses; **b** Buildings of different materials, and **c** agricultural buildings (CCEE 2022)

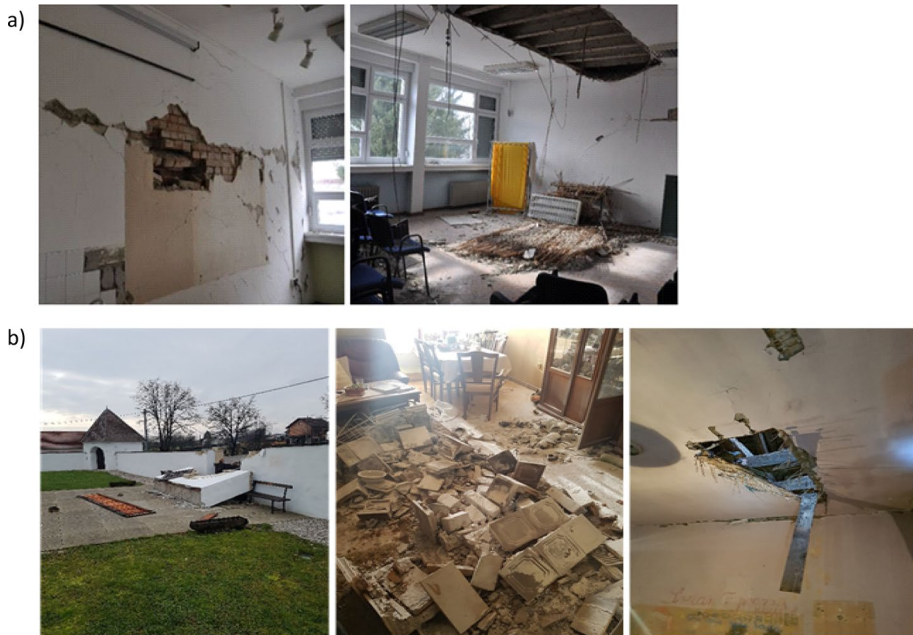
Damage to non-structural elements was by far the most frequent including damage to chimneys, to different parts of the roof, such as cracking and occasional falling of overhangs, cornices and roof tiles, and to various decorative elements. Almost all 'baroque' buildings in the epicenter suffered severe damage in their non-structural elements. These include cornices and significant cracking visible in decorative elements. As well, in many residential buildings, partition walls were damaged due to inadequate thickness and slenderness, or became completely detached from the load-bearing wall and had to be removed to avoid risk of complete collapse (Fig. 26a left).

Fig. 26 Damage to non-structural elements: **a** failure of partition walls and plaster detachment, **b** toppling of the outer wall, toppling of the heavy tile stove, and hole in the floor structure due to chimney collapse (CCEE 2022)

Cracks and detachment of plaster walls and ceilings (Fig. 26a right) from the inside as well as from the building facade were common in older buildings. More severe damage included the collapse of false ceilings. Damage was also observed to massive non-structural elements such as cantilevered concrete and masonry elements, as well as toppling of outer walls and rarely heavy tile stoves, which in some cases caused further damage (Fig. 26b).
