The December 2020 magnitude (Mw) 6.4 Petrinja earthquake, Croatia: seismological aspects, emergency response and impacts

Source / Izvornik: **Bulletin of earthquake engineering, 2023, 21, 5767 - 5808**

Keywords Physical damage · Masonry buildings · Emergency response · Post-earthquake survey · Social impacts

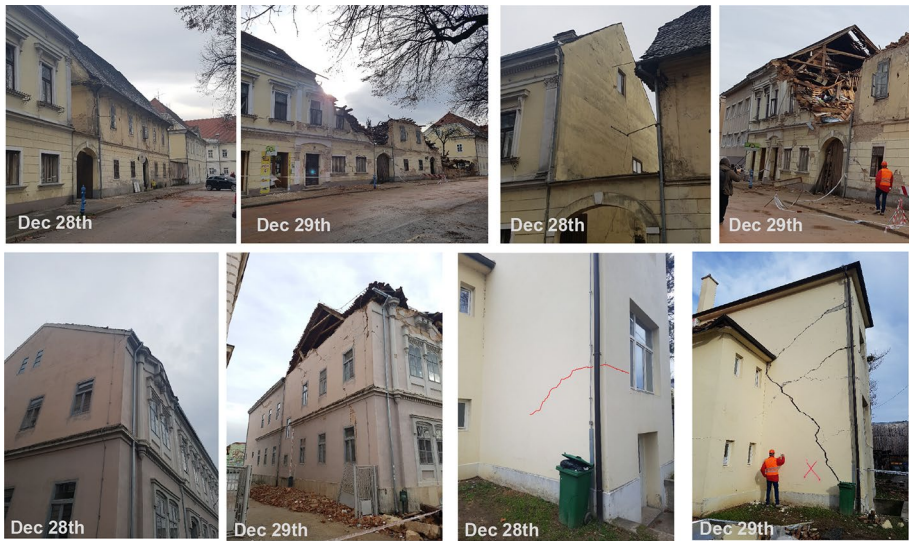
Fig. 27 Comparison of damage to buildings in Petrinja following the foreshock (indicated with Dec 28th) and the main shock (indicated with Dec 29th)
