Post-Earthquake Dynamic Performance of Intact Masonry Building Based on Finite Element Model Updating

As a case study, a building of a high school in Sisak (Figure 1) built in 1935 was taken. The building has four floors: basement, ground floor, and two upper floors. In the central part of the building there is a three-legged staircase with a landing. The foundations are constructed as a reinforced concrete slab. The load-bearing part of structure consists of walls made of solid bricks of 29(39) cm × 15 cm × 6.5 cm, floor slabs and reinforced concrete ribbed floor slabs. The thickness of the load-bearing walls in the basement is 60 cm and 75 cm, and 50 cm and 60 cm on the ground floor and upper floors. The partition walls are 15 cm, 18 cm, 25 cm or 30 cm thick and are made of hollow blocks. The floor slab is 25 cm thick and the reinforced concrete ribbed floor slab has a total height of 33 cm. The clear distance between the ribs is 60 cm, the width of the ribs is 13 cm, and the height is 23 cm. At the entrance of the building on the first and second floors, there is a load-bearing part of the structure that rests on columns with the square section of 75 cm × 75 cm and a height of

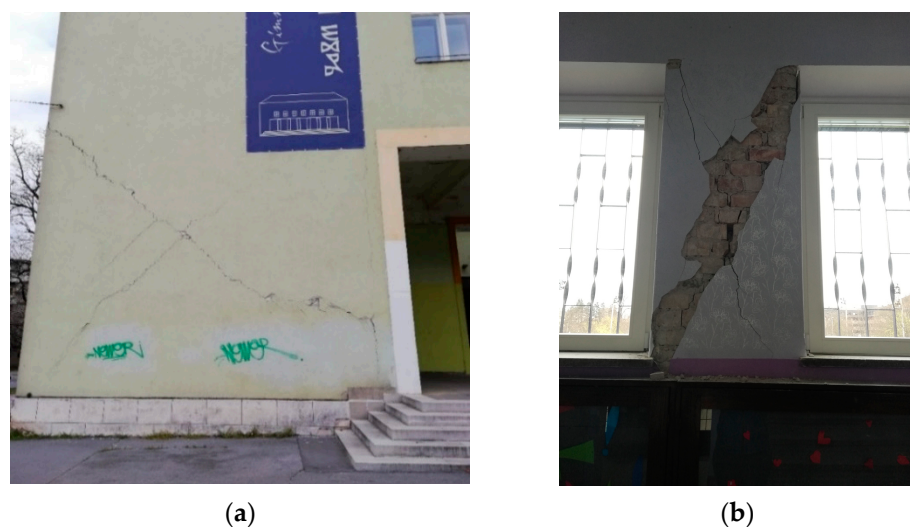
Figure 3. Observed characteristic damages on (a) the load bearing walls (b) the walls between the openings.

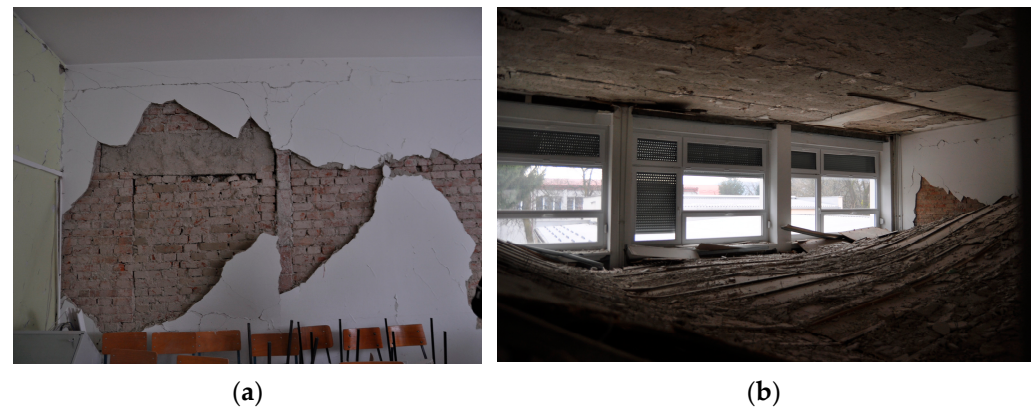
A detailed visual inspection was performed to visually evaluate the structure. During the inspection, some guidelines of the RVS (Rapid Visual Screening) method were applied [36]. The building was inspected by a team of four engineers. The inspection lasted approximately six hours. During the inspection, damage on load bearing and partition walls was observed on the ground floor and first floor. Special attention was paid to crack widths on structural and non-structural elements, separation between structural elements, and displacement of structural components. The cracks were generally diagonal and occurred both in the mortar joints and in the masonry units themselves. Some characteristic and specific damage can be seen in Figure 3. There was frequent evidence of crushing and spalling on many non-structural elements, seen in Figure 4a. Extensive detachment of the surface layer was evident on some parts of the ceiling, seen in Figure 4b. Considering the observation during the visual inspection, the finite element model of the structure in the updating phase is adapted to the found state.

Figure 4. Observed damage on (a) the partition wall and (b) the ceiling.

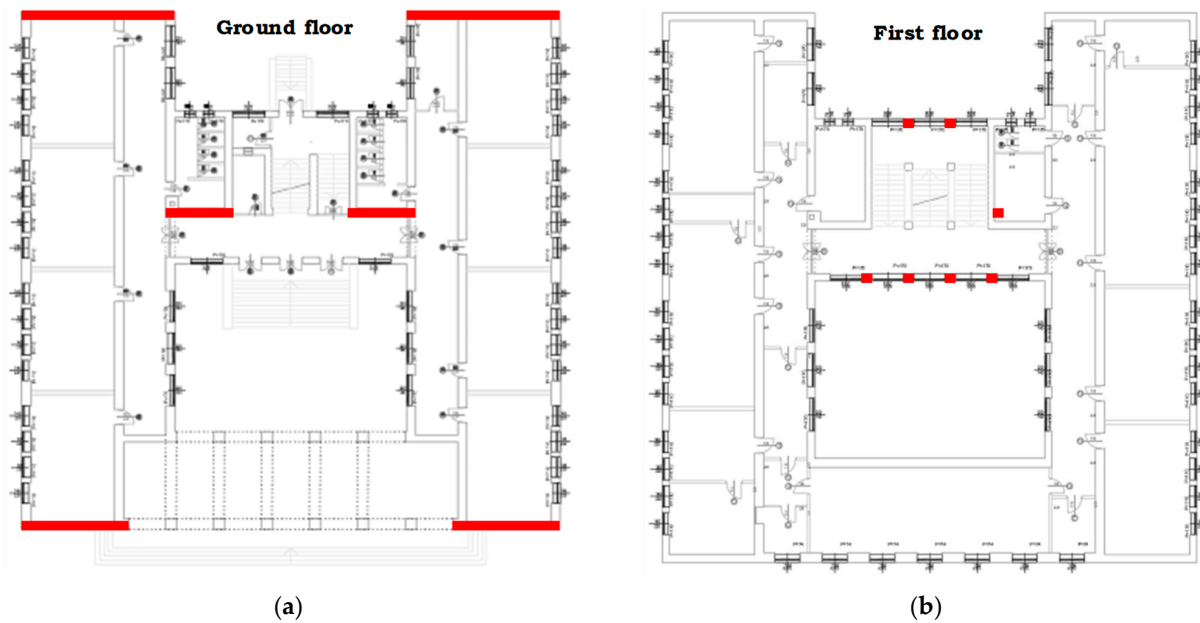
To be able to numerically predict the real structural behavior, the damaged structural elements in this step of analysis are modelled with reduced elasticity modulus. These elements were selected based on a visual inspection and their positions are marked in Figure 11.

Figure 11. The elements of the model with a reduced modulus of elasticity (red bars) at the (a) ground and (b) first floor.
