# Seismic upgrading of cultural heritage – A case study using an educational building in Croatia from the historicism style

Article *in* Case Studies in Construction Materials · May 2022 DOI: 10.1016/j.cscm.2022.e01183

## Seismic upgrading of cultural heritage – A case study using an educational building in Croatia from the historicism style

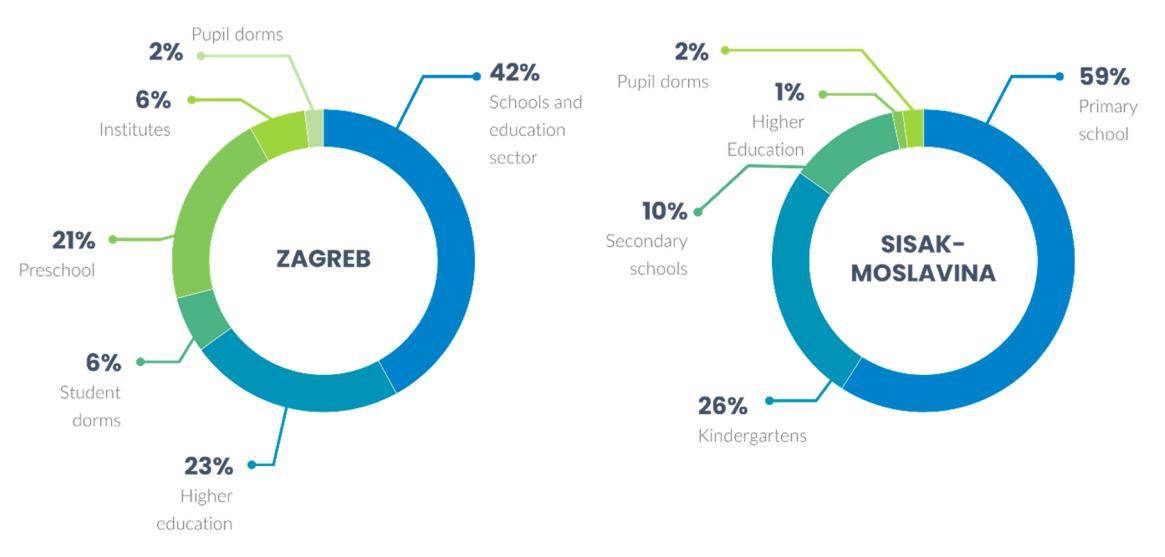
Fig. 2. Damaged buildings of the education sector in the 2020 Croatia earthquakes and two different regions [3,4].

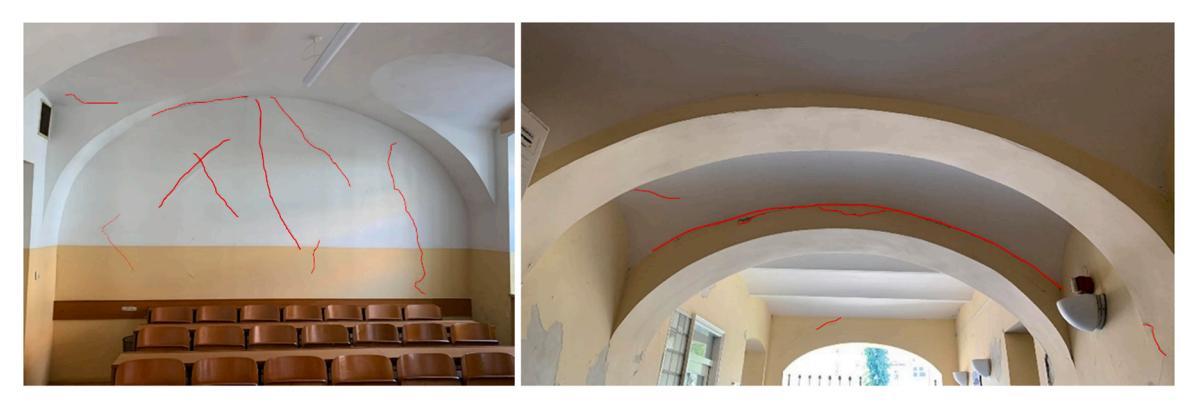
Fig. 6. Characteristic cracks, marked with a red line (photo credit: Mislav Stepinac).

A few months later, a detailed examination was performed [14,15]. The flowchart of the performed activities is shown in Fig. 7. It was found that the cracks on the walls of the central staircase core coincide from the outside and inside, which indicates that the cracks are not superficial. The walls of the central core extend through the entire height of the building without any lateral restraints, and are weakened by openings, so they are considered to be the most critical part of the building. Cracks in the transverse walls of central core indicate possible out-of-plane failure of the mechanism. Shear strength testing of masonry were performed [14,15]using a hydraulic jack (Fig. 8). Visual inspection followed by in-situ examinations is explained in detail in [11]. It revealed that the masonry was in a good condition. Archival documentation was insufficient for geometry assessment. Photogrammetry was used to assess the true geometry of the building (Fig. 9)[16–18]. DJI Mavic 2 pro drone was used to take photos. Altogether, 87 photos were taken and the basic model was made in Agisoft Metashape software [19]. The full assessment of the presented case study was elaborated more in the detail in [11].

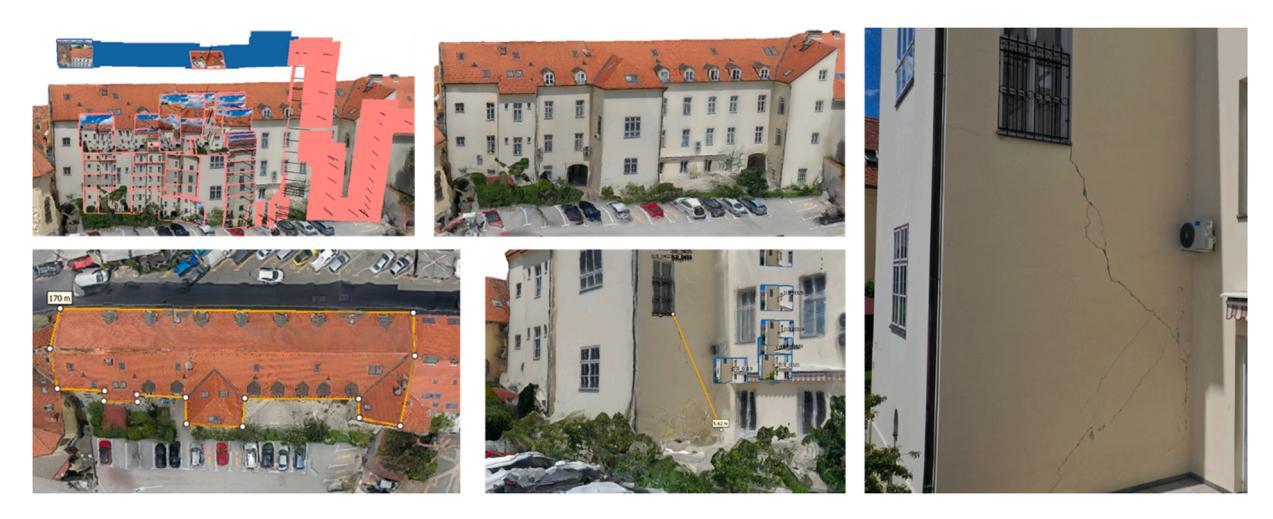
Fig. 9. Photogrammetric view of the building, respectively with positions of the camera, photogrammetric model, measuring of the roof geometry, measuring of a crack, photo of a crack.

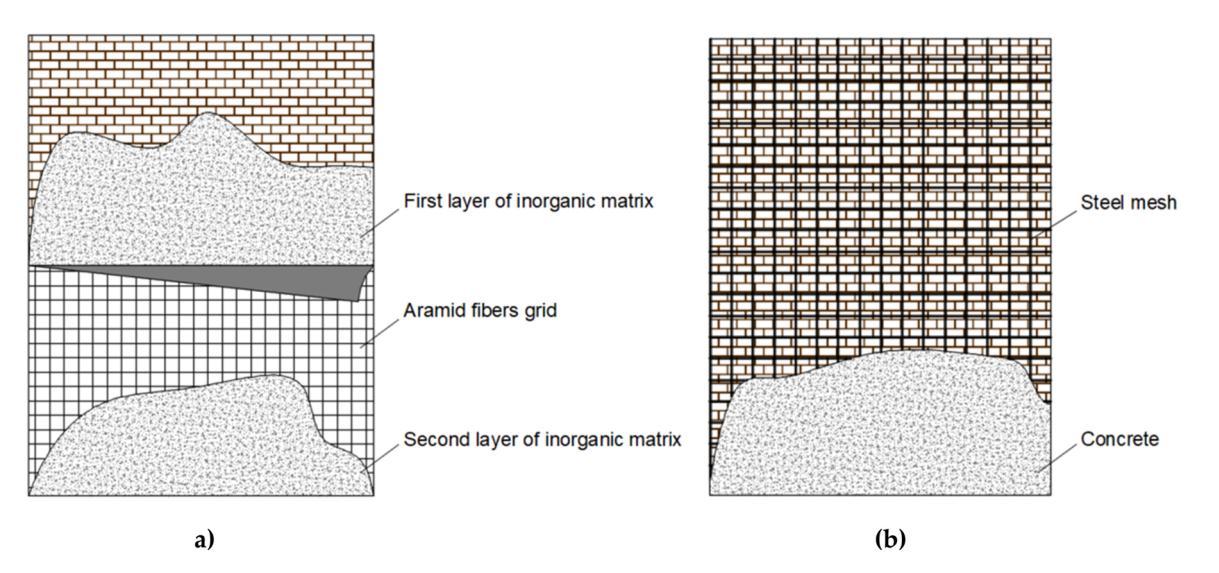
Fig. 10. (a) Application of FRCM (b) shotcreting.

Shotcrete is applied in the case of increased horizontal action. Reinforcement is placed on one or both sides of the wall, on which shotcrete is applied (Fig. 10b). Linings placed on opposite faces of the masonry are connected by transverse reinforcement. One lining is connected to the wall with anchors. The thickness of the lining is usually 5–6 cm, and it can be up to 8 cm for more massive walls. This way, a larger cross-section is realized, which then has increased compressive, tensile and shear strength and ductility [36]. Due to this and ease of application, this method is very common in practice during reconstruction, but its invasiveness should also be considered.

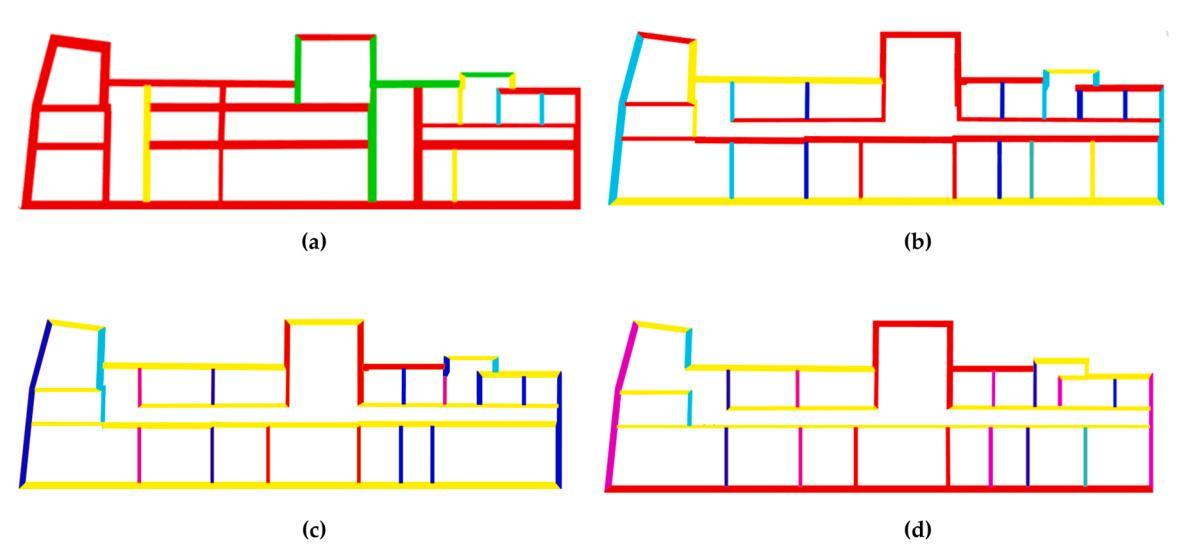
Fig. 11. FRCM system (a) ground floor plan (b) first floor plan (c) second floor plan (d) attic floor plan.

is not necessary to strengthen each element equally, nor is it economical. Masonry characteristics are shown in Table 3. For the first variant, the FRCM composite with aramid fibers was placed on both faces of the walls, 3 layers were used (Table 4, Fig. 11). FRCM with aramid fabric was used because it is common to use it in Croatia due to availability by the producers. FRCM-matrix was taken as it defined in the Italian code. The procedure was performed iteratively, the initial strengthening concept was corrected according to the

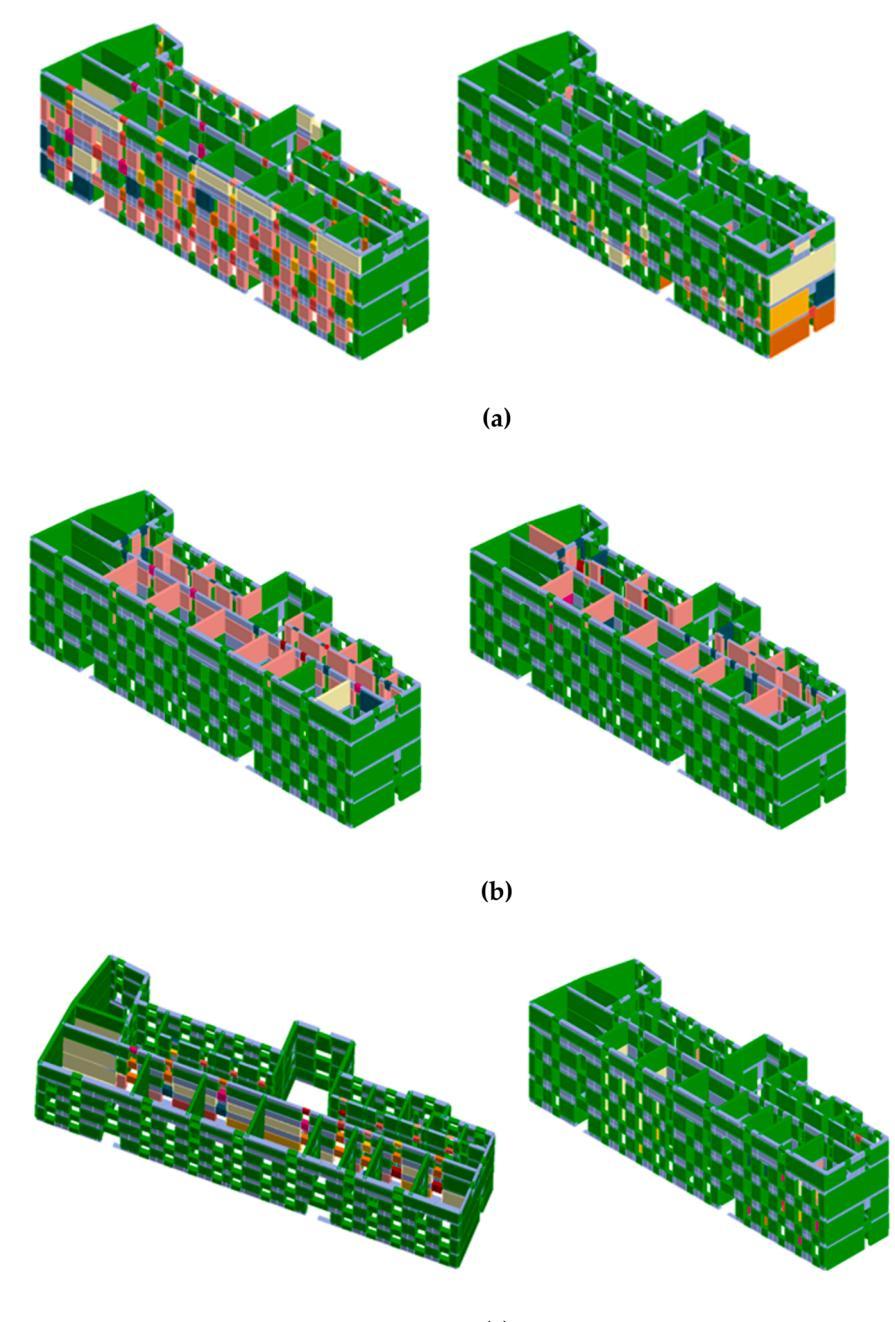
Fig. 16. Damage visualization for the most critical analysis in x (left) and y direction (right) (a) model strengthened by the FRCM system (b) model strengthened by shotcrete (c) model strengthened by FRCM systems and shotcrete.
