# Seismic Assessment and Retrofitting of Existing Road Bridges: State of the Art Review

*Source / Izvornik:* **Materials, 2022, 15, 1 - 23**

**Keywords:** seismic assessment; retrofitting; existing road bridges; bridge assessment; Croatia earthquake; urgent strengthening

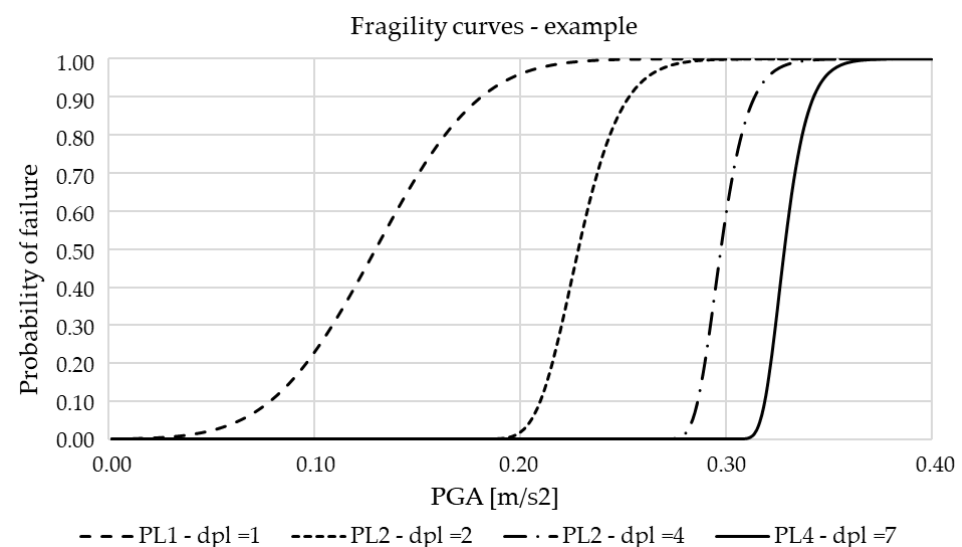
**Figure 1.** Example of fragility curves for bridge piers without adequate seismic capacity.

Fragility curves can be developed empirically based on historical data on past earthquakes or analytically using one of the methods listed in Table 1. The latter approach is more common, because there is insufficient data to empirically produce reliable curves [37]. Fragility curves are, in general, developed for one of the bridge components, mainly for the substructure parts, e.g., piers, abutments, and bearings. For each element, demand and capacity parameters are defined as a part of the analytical process in terms of displacements, lateral forces, rotation, etc., along with defined thresholds. A number of authors have dealt with this issue in the last two decades, as presented in detail in [37]. For example, Choi et al. [39] consider four limit states for bridge piers in terms of the damage index ( $d_{pl}$ ), which is defined as a ratio between the current horizontal displacement (e.g., of the top of the pier) and a displacement at the same point in a significant cross-section (e.g., the bottom of the pier). Theoretical fragility curves based on [39] are presented in Figure 1, each for one of the defined damage states.

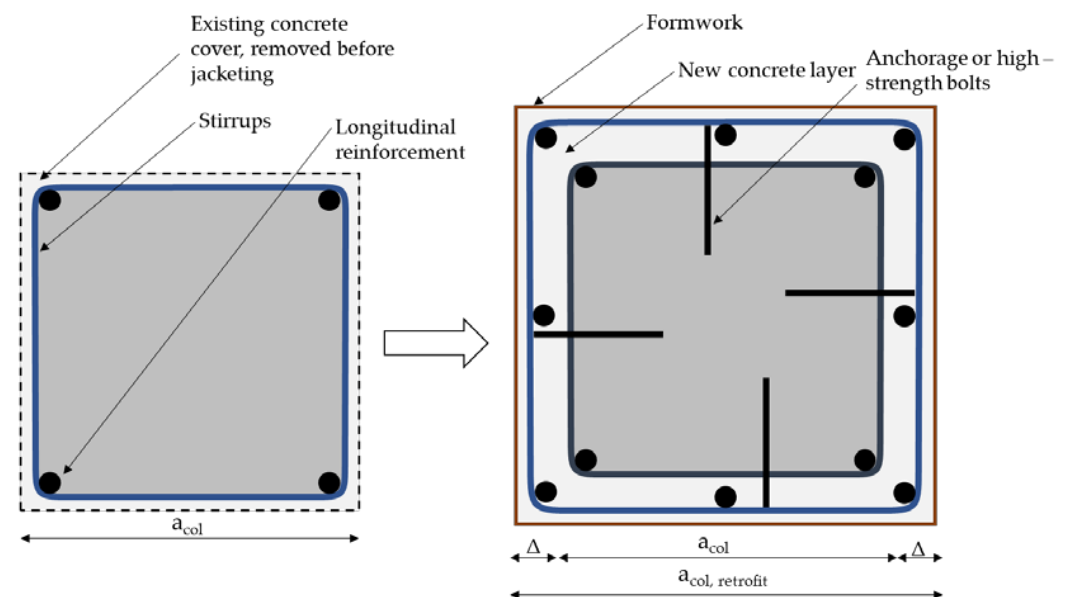
Figure 2. An example of reinforced concrete jacketing of existing columns.

The principle of this technique is quite simple; the objective is to increase the ductility and shear capacity of the existing column either by adding new reinforcement and a new layer of concrete or by using prefabricated jackets connected to the existing column by grouting. However, it is important to consider the increase in mass and stiffness of the retrofitted section, as their increase leads to shorter periods and increased base shear, thus increasing the seismic demands on the selected column and structural system. Traditionally, concrete jacketing is the oldest and most common method. A new layer of reinforcement is placed around the existing section over part or all of the length of the RC column and the concrete is poured using traditional formwork. The connection between the old and new sections is achieved by anchoring the new reinforcement in the existing concrete or by using high-strength bolts. An example of concrete encasement can be found in Figure 2.

The obvious disadvantages of RC jacketing are its cost and time inefficiency due to formwork installation, especially for taller piers. Moreover, the increase in ductility depends only on the additional longitudinal and transverse reinforcement (stirrups), as concrete is a brittle material. Another disadvantage of this technique is the relatively large increase in cross-section compared to other methods, which can be crucial in existing bridges where the passage under the bridge for crossing roads, railways, etc. is restricted. Taking into

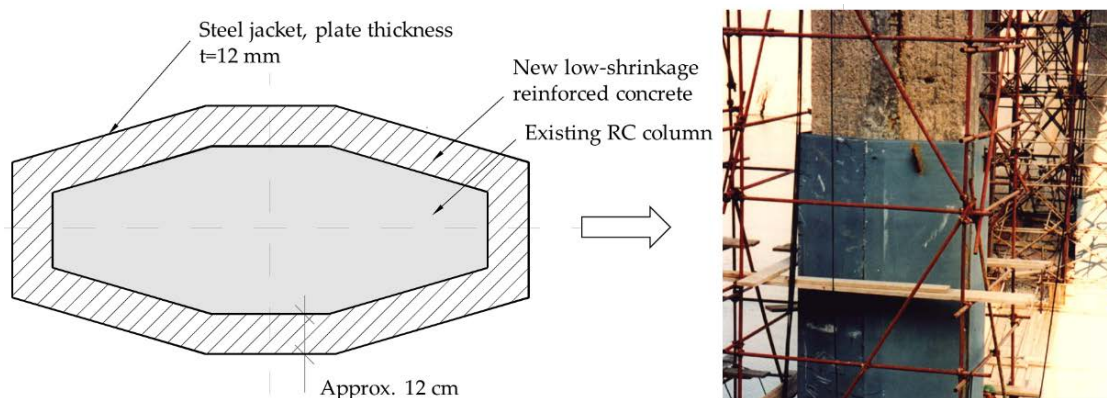
**Figure 3.** Seismic retrofitting of RC columns on Pag Bridge in Croatia showing the combination of RC and steel jacketing.

account the typical cross-sections of bridge piers and the diameter of the reinforcement used, the thickness of the cross-section with the RC sheathing increases by about 0.5 m. On the other hand, steel or high-performance material sheathing can increase the ductility and resilience of the cross-section by only a few centimeters [54]. Steel jacketing is most effective on circular columns where the sheathing is prefabricated in two halves that are positioned and welded around the column. The gap between the steel plate and the existing concrete is filled with grout to ensure the bond. In this way, a new composite cross-section is created that features increased shear strength, ductility, and buckling resistance [65]. The disadvantage of steel jacketing is its lack of cost-effectiveness due to more complex procedures and corrosion protection. Moreover, similar to RC jacketing, it increases the stiffness of the cross-section, which changes the seismic demands on the pier/column [52]. There are some examples of the combined use of RC and steel jacketing, where the steel plates are used as formwork. This method was applied to the columns of the Pag Bridge in Croatia, as shown in Figure 3. The Pag Bridge, built in the late 1960s, is a concrete arch bridge with very slender columns in a very aggressive maritime environment. During major reconstruction in the late 1990s, these columns were strengthened by adding a new layer of reinforcement and concrete encased in a steel plate with a thickness of 12 mm [88].

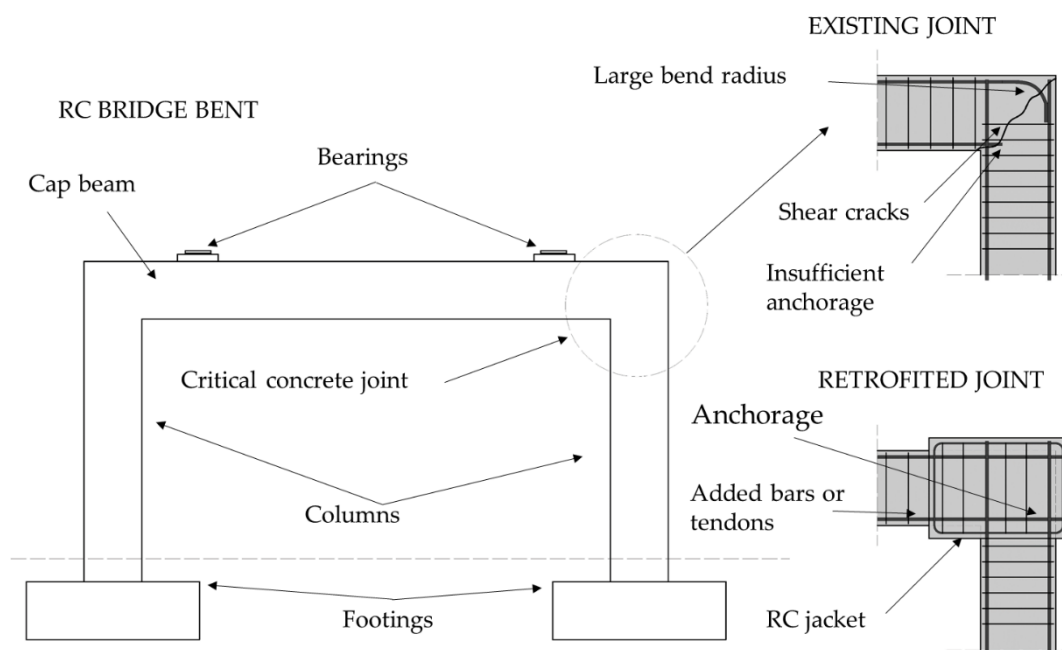
**Figure 4.** Seismic retrofitting of cap beams and concrete joints in RC bridge bents.

Many road bridges are supported on RC bents consisting of two or more columns connected with a transverse cap beam, as shown in Figure 4. The concrete joint between the top of the column and cap beam is subjected to both shear and flexural stresses during cyclic seismic loading. In older bridges, this joint is often designed without sufficient anchorage length in the longitudinal direction and sufficient reinforcement in the transverse direction, and can therefore be designated as a critical point because of the possibility of brittle failure. As described in Chapter 2, the approach to bridge design is that the superstructure should remain in the elastic region to force plastic hinges in the columns. This is achieved by increasing the stiffness and strength of the cap beam and the concrete joint between the beam and the column [65]. The retrofitting technique is similar to RC jacketing of columns, as the new concrete layer is poured around the joint along with sufficient reinforcement to be anchored in both the beam and a column; an example is shown in Figure 4.

RC bents for new bridges are not generally designed as shown in Figure 4 because the cap beam is usually extended beyond the columns, which provides more space for the reinforcement of the critical joint section. Therefore, while on some older bridges the cap beams are retrofitted similar to Figure 4, the new beam section is extended beyond the columns, creating a cantilever. This method is called a seat extender [53].

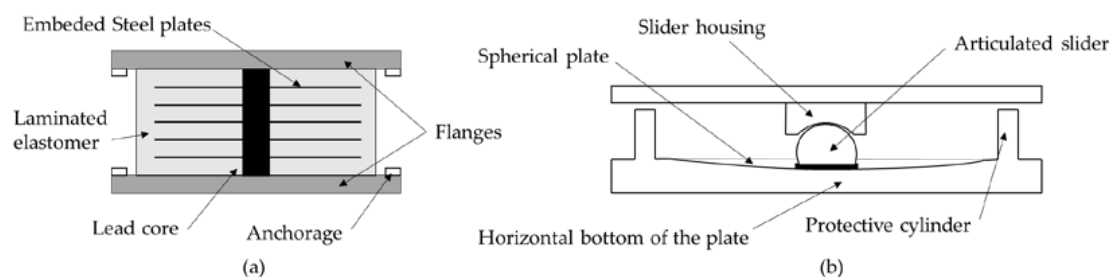
**Figure 5.** Isolation bearing schematics (a) elastomer (rubber)-based; (b) friction (sliding)-based.

SIB can be divided into two main groups, those based on elastomers (rubber-based) and those based on friction (sliding-based), depending on the principle of energy dissipation. The elastomer-based bearings are more commonly used for simply supported bridges, while plain bearings (also known as pot bearings) are used for longer continuous bridges spanning multiple spans. A schematic of each type is shown in Figure 5.

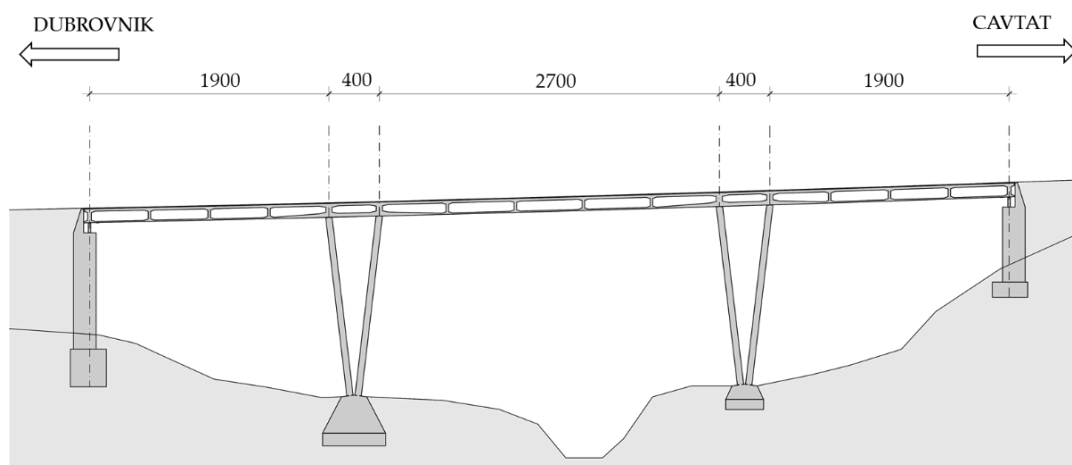
**Figure 6.** Longitudinal section of the first Case Study bridge (units in cm).

The first Case Study [13] bridge is a reinforced concrete bridge constructed monolithically in the 1960s. The bridge is comprised of five spans with dimensions of 19.0 + 4.0 + 27.0 + 4.0 + 19.0 m, and follows a complex road axis that features horizontal and vertical curves. The superstructure is comprised of a voided RC slab supported on V-shaped piers, visible in Figure 6; a cross-section of the slab is presented in Figure 7.

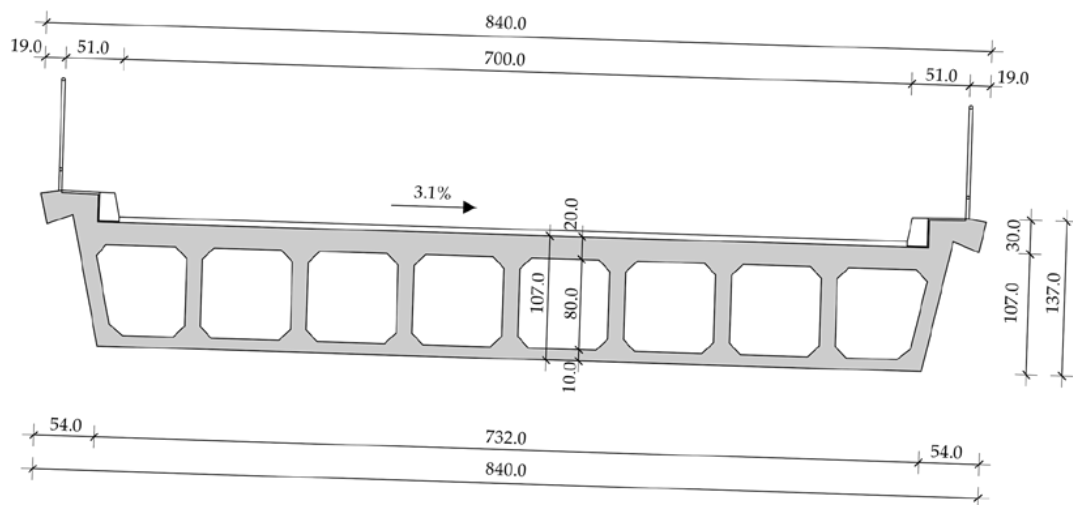
**Figure 7.** Cross-section (in the middle of the span) of the first Case Study bridge (units in cm).

The connection between the superstructure and the abutments is considered hinged, as the slab is supported on “Pendl” bearings. However, the connection of the slab and V-shaped piers (four in total) is hinged only in the longitudinal direction; in the transversal direction it is rigid and the two piers and deck form a rigid frame. The resulting statical system of the bridge is called a hinged strut frame.

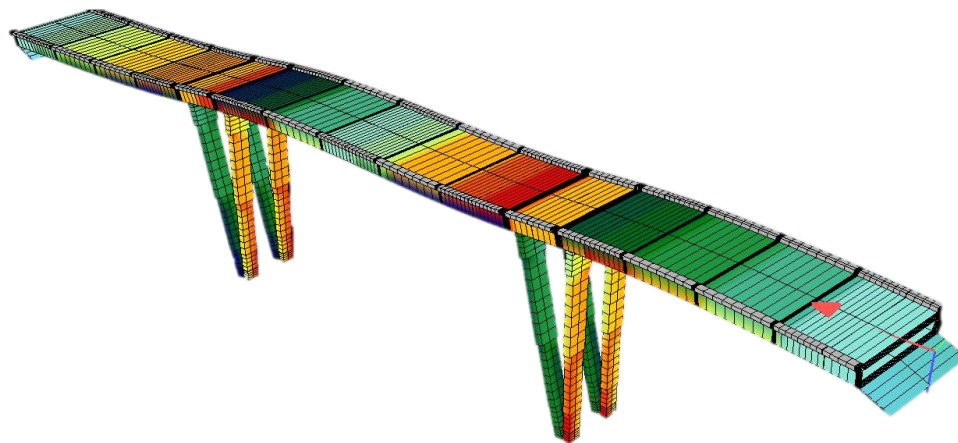
Figure 8. Numerical model of the Case Study bridge, first modal shape (longitudinal).

modal shapes were calculated; the results show that the first dominant mode is shaped as a translation in the longitudinal direction, while the second (with a smaller period) is a translation in the transverse direction. The first modal shape is presented in Figure 8, while the resulting modal parameters (periods, target displacements, and response spectrum values for obtained periods) for the first two modal shapes are provided in Table 4.

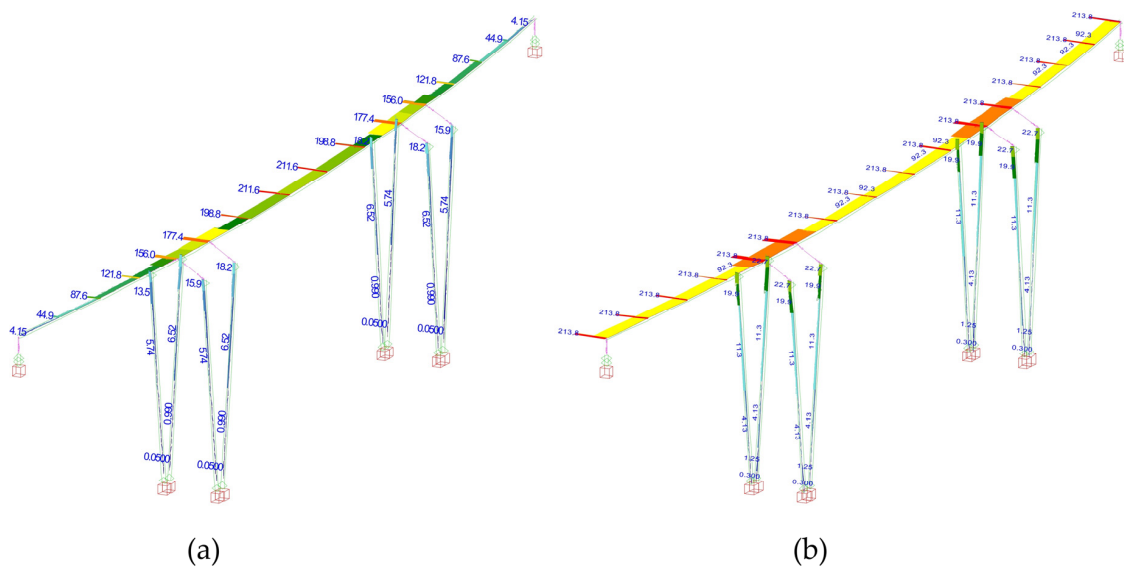
Figure 9. (a) horizontal load distribution along the superstructure; (b) horizontal load in proportion with dominant modal shape.

The target displacement for the first modal shape (Table 1) is 76 mm; while the existing expansion joint was designed to allow a maximum longitudinal displacement of 70 mm, when exceeded this would cause a collision between the superstructure and abutment wall. Therefore, the Case Study bridge was reassessed using the static nonlinear pushover analysis. A total of four cases were calculated with two types of load distributions for each direction, as presented in Figure 9 for first modal shape.

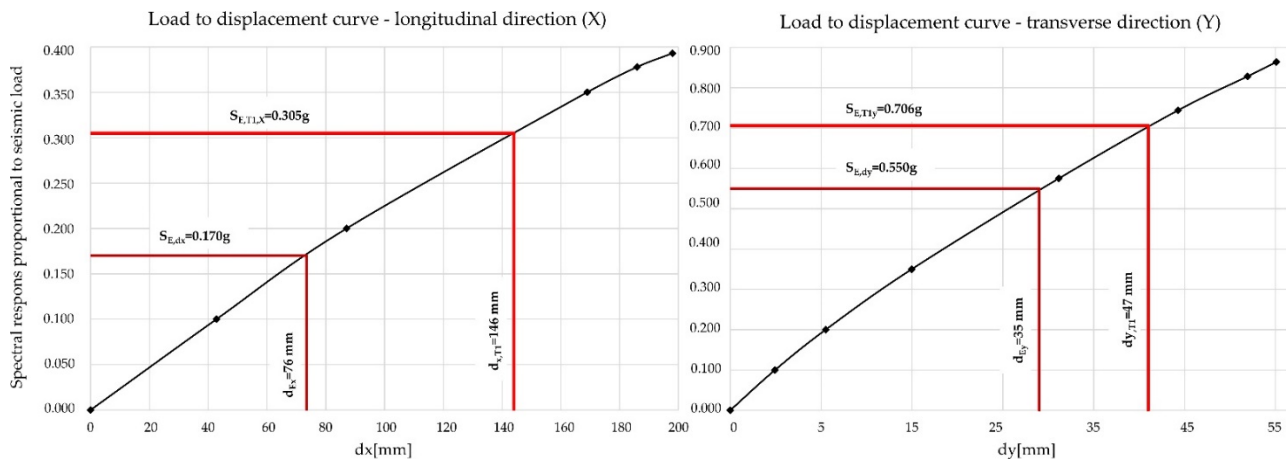
**Figure 10.** Load–displacement curves for the First Case Study bridge, longitudinal (left) and transverse (right) direction.

Pushover analysis results are presented in the form of load–displacement curves for each direction in Figure 10; the less favorable of two load distribution cases are presented. Two spectral responses are provided for each modal shape; the first ( $S_{E,dx}$  and  $S_{E,dy}$ ) shows the seismic load in which the target displacements ( $d_{Ex}$  and  $d_{Ey}$ ) are reached, while the second ( $S_{E,T1,x}$  and  $S_{E,T1,y}$ ) shows the maximum seismic load based on linear analysis along with the corresponding maximum displacements ( $d_{x,T1}$  and  $d_{y,T1}$ ).

The curves in Figure 10 show that the Case Study bridge does not have sufficient seismic resilience, as displacements corresponding to the two dominant modal shapes ( $T_x$  and  $T_y$ ) exceed the target displacements ( $d_{x,T1} > d_{Ex}$  and  $d_{y,T1} > d_{Ey}$ ).

In accordance with the assessment results (Figure 10), a proposal for seismic retrofitting is presented [13], focusing on the limitation of the displacements and the shear failure of the piers.

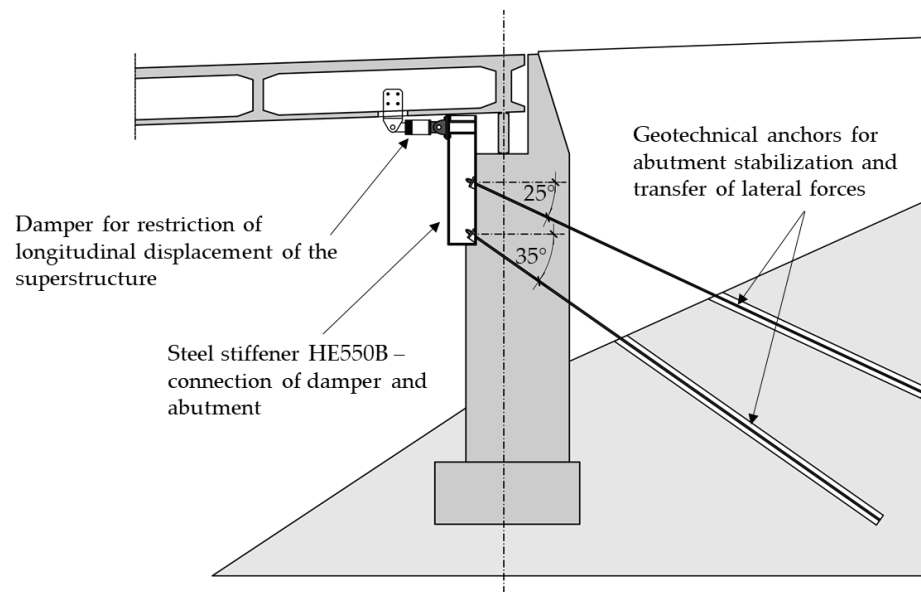
**Figure 11.** The proposed damper installation for the restriction of longitudinal displacement with geotechnical anchors, first Case Study bridge.

In order to restrict the longitudinal displacement of the superstructure, a total of three dampers with a maximum  $+/-50$  mm should be placed on the abutment which transfers the longitudinal reaction, as shown in Figure 10. Each of the dampers has a capacity for transfer of longitudinal force of 1250 kN; however, analysis of the existing abutments showed that such loads exceed its load-bearing capacity. Therefore, the abutment should be strengthened; this can be conducted using RC jacketing with additional reinforcement or with the addition of geotechnical anchors which would transfer the load directly to the embankment. Due to the limited space beneath the bridge, the solution with geotechnical anchors was chosen, as can be seen in Figure 11.

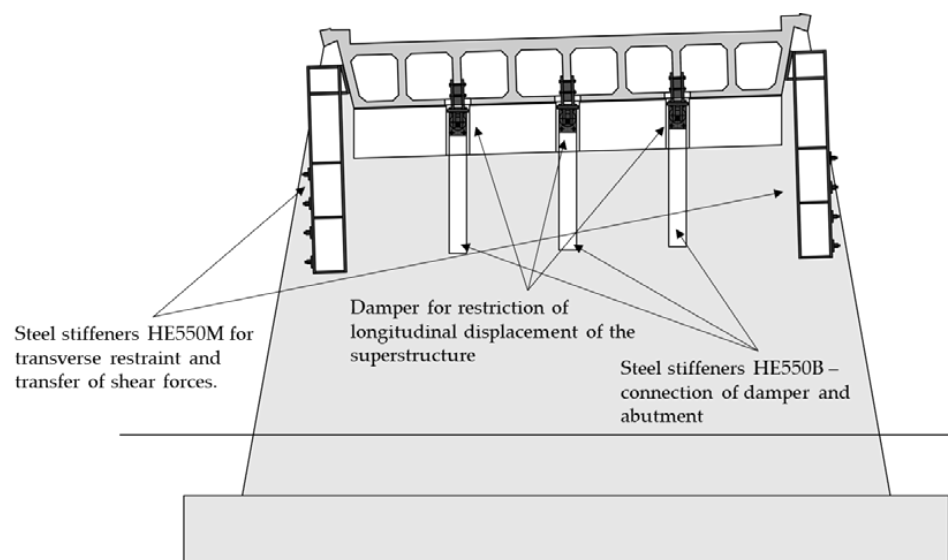
**Figure 12.** Transverse view of the abutment with both longitudinal and transverse stiffeners and displacement restraints, proposal for seismic retrofitting of the first Case Study bridge.

As the supports on the abutment are not able to withstand the transverse seismic forces, a transversal displacement restraint to be placed on both abutments is proposed. These are present in Figure 12 as additional steel profiles (HE550M) which have sufficient shear resistance to withstand imposed seismic forces. The shear strengthening of the piers should be conducted using FRP jacketing, as RC (due to limited space) and steel (due to variable cross-section) are not optimal solutions and would not be cost-effective.

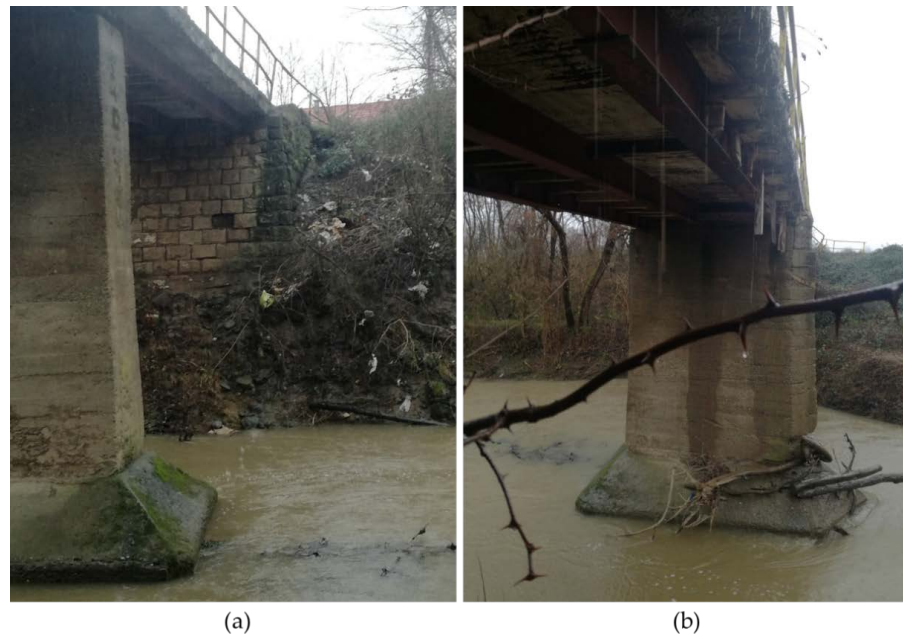
**Figure 13.** (a) Masonry abutment and (b) composite superstructure of the bridge to Majske Poljane.

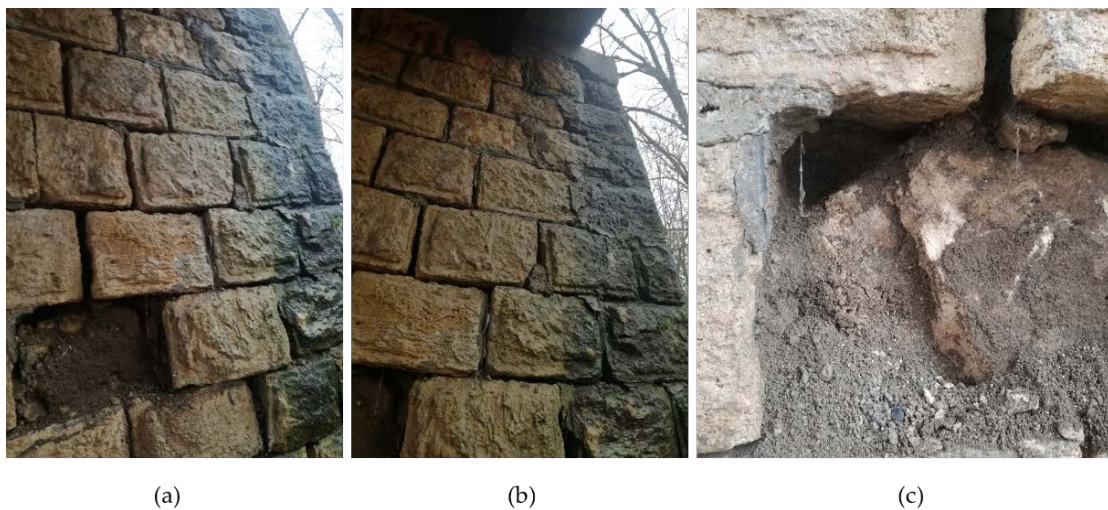
**Figure 14.** (a,b) Damage to the masonry walls of the abutment; (c) escarpment of infill material from the abutment.

During the visual inspection of the bridge to Majske Poljane, it was found that the masonry abutment had structural damage affecting its stability, with immediate action needed in order to allow heavy traffic over the bridge. The damage to the abutment is shown in Figure 14. The stone blocks from both the abutment wall and the wing walls were damaged and started to fall off. As the abutment was constructed as shallow with land infill that to transfer the vertical loads to the foundations, there was a danger that the collapse of the wing walls would result in the collapse of the bridge.

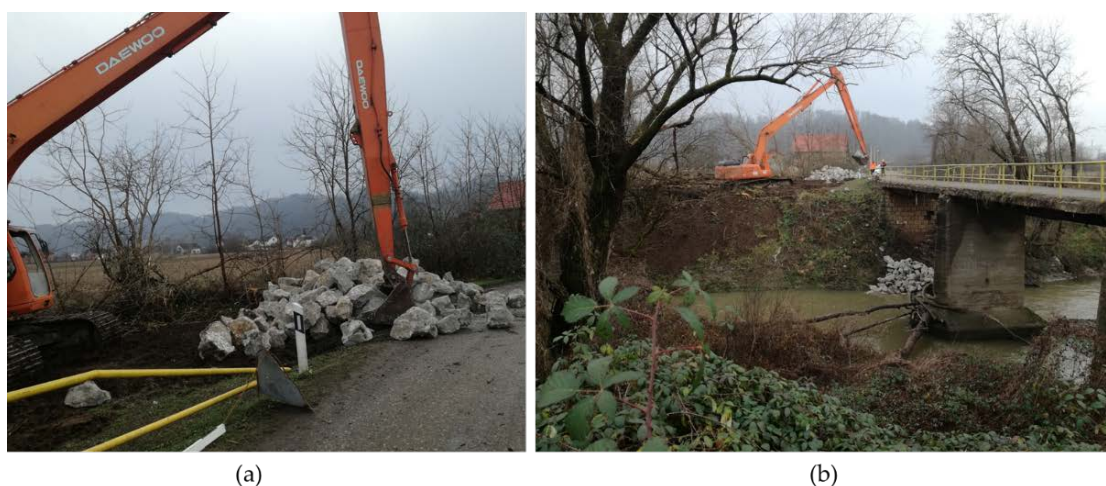
**Figure 15.** (a) Stone material for urgent stabilization; (b) placing of the additional weight on the abutment and embankment.

Both the wing and abutment walls required stabilization, and the only possible solution due to urgency and the available resources in the area at the time was to impose an additional dead load on the abutment and surrounding embankment. This was conducted by adding stone blocks that would act as stabilizing weights to allow traffic on the bridge, which was critical as the bridge is one of the only two entrances to the village. This urgent and temporary retrofitting is shown in Figure 15.

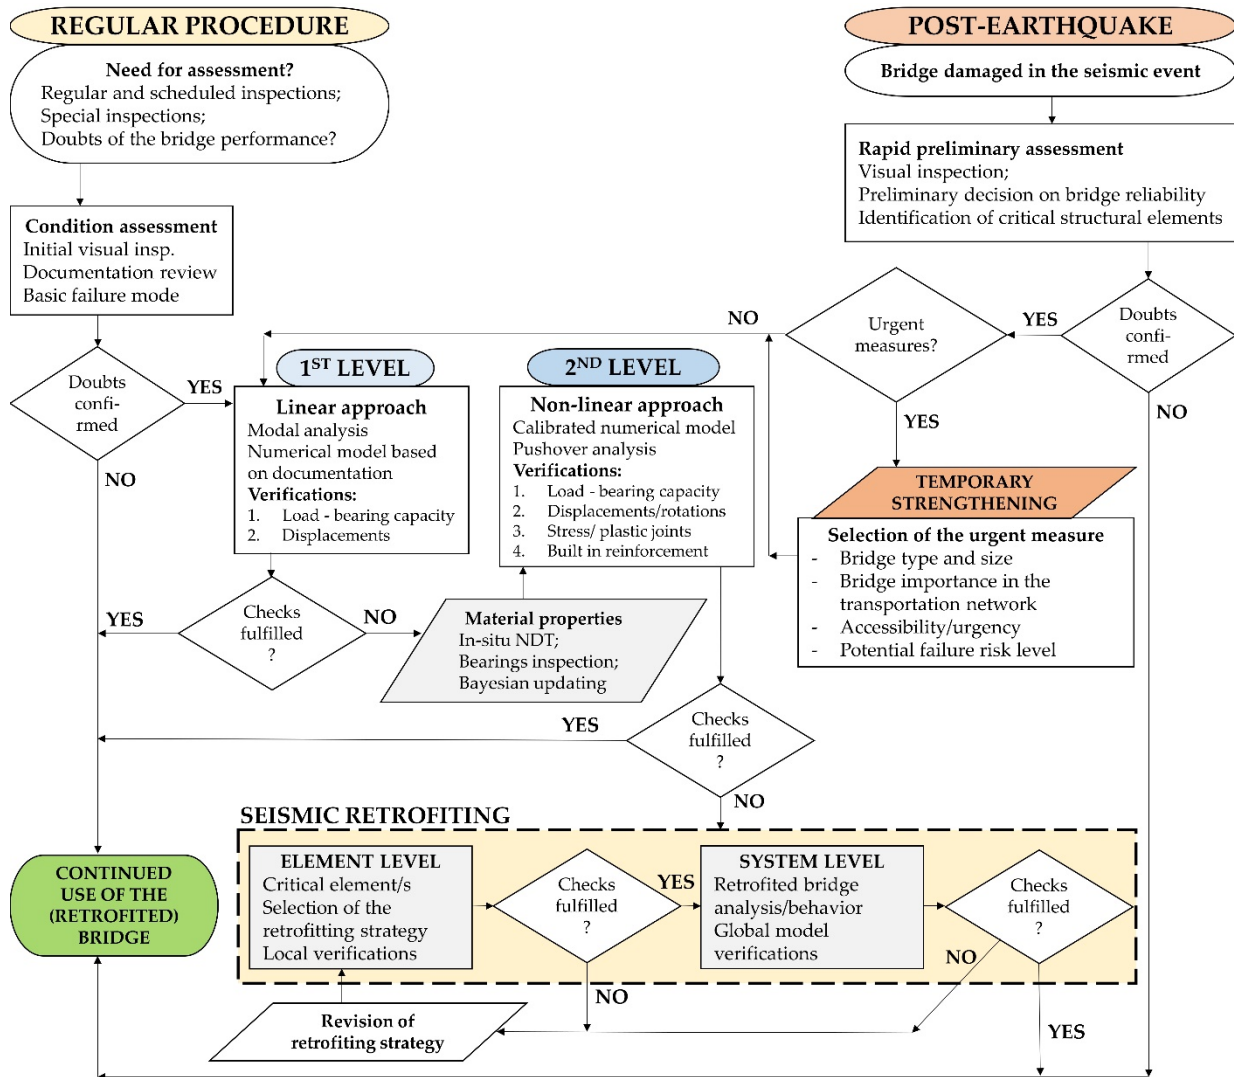
Figure 16. Proposed multi-level assessment method for typical existing road bridges.

If a bridge meets the required ULS checks (codified-EN 1998-2 [5]), it is considered reliable and can be used without restrictions. However, if it does not meet the ULS checks, it is re-evaluated at the second level, where the numerical model is calibrated using material properties obtained with in situ NDT tools and Bayesian updating. The analysis at this level is based on a nonlinear pushover analysis, and additional checks are performed. Similar to the first level, the bridge is considered safe for use if it meets the verifications. If not, the

seismic retrofit strategy is selected and applied based on the identification of the critical structural elements. First, the local checks (at the element level) are performed, and if they are satisfied, evaluation at the system level (global model) is performed. If at any of the steps the selected measure is not considered effective, the procedure is repeated with a revised retrofit strategy.
