Case study on application of ground-penetrating radar for non-destructive assessment of historical building

Source / Izvornik: **1st Croatian Conference on Earthquake Engineering 1CroCEE, 2021, 763 - 772**

In this paper, the main principles of the GPR technique are presented. This is followed by the application of GPR for the localization of reinforcement and determination of slab geometry in the case of Faculty of Teacher Education in Petrinja.

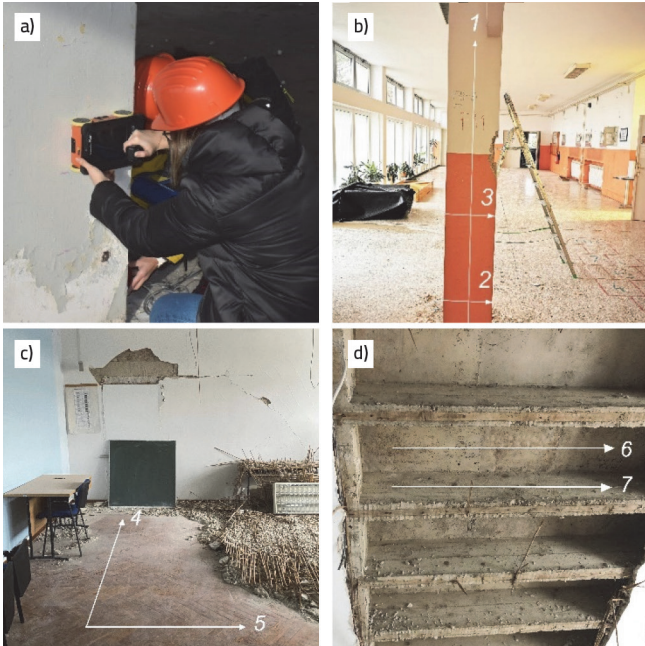
The GPR survey was performed using the ground-coupled handheld GSSI Structure Mini XT system with a centre frequency of 2.7 GHz, Fig 3a. Profiles were performed along the longitudinal axis of the columns to locate the stirrups (profile 1), while perpendicular profiles were used to locate the longitudinal bars (profiles 2 and 3), Fig 3b. Data collection was performed for 10 columns.

The survey of the mezzanine structure between the ground and first floor was conducted without removing the parquet flooring. According to the project documentation, the mezzanine structure consists of the following layers: parquet, cement screed, bitumen and ribbed concrete slab. The profiles (profiles 4 and 5) were taken in two perpendicular directions, Fig. 3c. In addition, the mezzanine structure was examined from the underside with two profiles, Fig. 3d. Profile 6 was taken from the underside of the concrete slab, while profile 7 was taken from the side along the rib of the ribbed slab. Although profiles 4, 5, 6, and 7 were not from the same part of the slab, it was assumed that the geometry of all slabs in the building was the same. The GPR profiles were further analysed in Radan 7 software. The dielectric constant of 5.5 was determined from a known depth verified at the site. This value was assumed to be constant for each scan considered.

Figure 3. a) GPR handheld system; b) Column profiles; c) Profiles from the top of the mezzanine structure; d) Profiles from the underside of the ribbed concrete slab

The profiles obtained on the top of the slab are shown in Fig 6 (profile 4) and Fig 7 (profile 5), while the reinforcement plan from the project documentation can be seen in Fig 8. The geometry corresponds to the ribbed slab. The possible representation of the geometry from the GPR results is shown below. The first 8 centimetres correspond to the layers of the floor. The top of the concrete slab was shown as a line on the radargram. The thickness of the slab was estimated to be approximately 6 cm. Detected hyperbolas in the slab on the radargrams were assumed to be the rebars. At the end of the rib there were two reflections nearly 8 cm wide that could correspond to the top and bottom edges of the wooden plank. The presence and geometry of the planks were confirmed in the rib, Fig 3d.

Positive hyperbolic signs from reinforcement in the ribs were noted above the wood plank. Although the project documentation (Fig 8) states that these should be two hyperbolic marks from two reinforcing bars in the rib, it could be possible that they are close together so that the GPR could not detect them as separate objects. Also, in Fig. 6, the authors found negative signs circled in yellow above the rebars in the rib. These are the locations where the nails connect the wood plank to the rib, and it is possible that the concrete was improperly poured at this location. It could be possible that there is significant segregation so the mark could be from the air void space. Evidence of improper casting of the ribs was confirmed on site, Fig 3d.

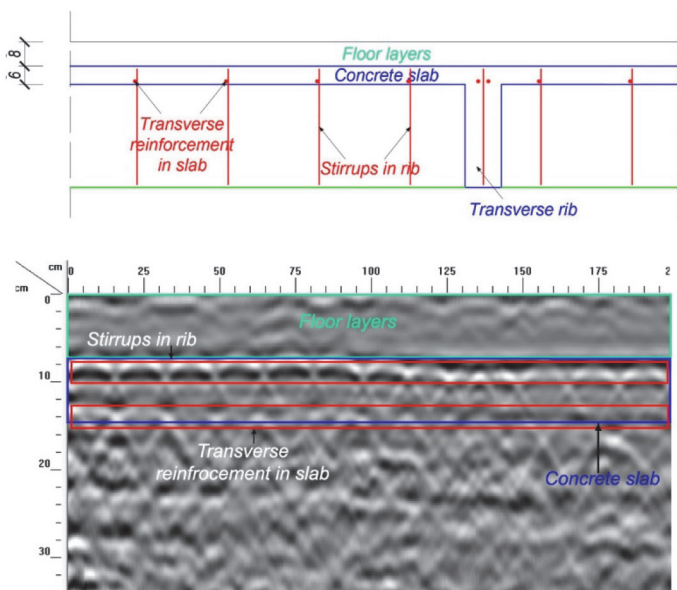
Figure 7. Possible representation of geometry slab from the profile 5

The possible representation of the geometry of the slab from profile 5 is shown in Fig. 7. It was noted that the profile was most likely obtained between two adjacent ribs, but closer to one of them, so that the profile lies just above and perpendicular to the legs of the stirrups in a rib. Two arrays of hyperbolas were found in the radargram. The first is most likely from the legs of the stirrups in the rib, while the second is from the transverse reinforcement in the slab. The interpretation problems arose from the fact that the rebars are close to the top and bottom concrete surfaces, so they overlap with these reflections. The determined spacing between these hyperbolas is 15 cm, which is not consistent with the project documentation. Therefore, the spacing of the stirrups and the transverse reinforcement in the slab was checked by the profiles 6 and 7, Fig. 9.
