# Seismic upgrading of cultural heritage-A case study using an educational building in Croatia from the historicism style

*Source / Izvornik:* **Case studies in construction materials, 2022, 17, 1 - 17**

More than two years have passed since the devastating earthquakes struck Croatia in 2020, in which many educational buildings were damaged. In addition, several damaged educational buildings are under heritage protection, representing a special challenge for civil engineers during structural renovation. Strengthening methods that achieve adequate level of seismic capacity are limited in order to preserve the identity of these buildings. In the manuscript, a short overview of the damage to the educational sector is given with a special focus on a renovation of one case study. The case study is an educational building with a masonry structure located in the Lower Town of Zagreb and from the 19th century. An assessment of the structural condition was performed and a model was developed in the 3Muri software. Three variants of strengthening methods were applied to the model – FRCC, shotcrete and a combination of FRCC and shotcrete. Finally, each variant model was analyzed using the p

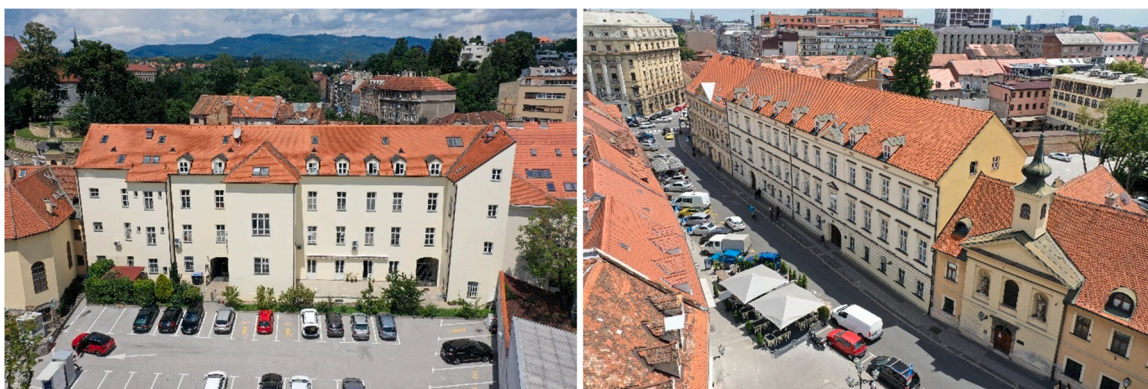
**Fig. 3.** South and north façade of the case study building.

The focus of this paper is an educational building with the status of cultural heritage located in the Lower Town of Zagreb (Figs. 3, 4). The building was constructed in the 19th century and served as a boys' seminary. Originally it was a single-story building but it was upgraded later. The last reconstruction was in 1997. Nowadays, the building is used as a higher education institution. Prior to the earthquake, the building was regularly maintained.

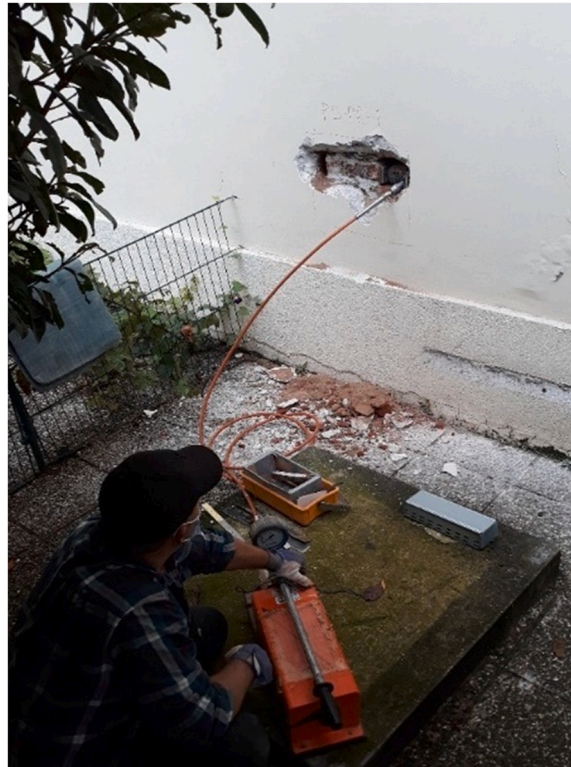
Fig. 8. Shear strength test of masonry [12].

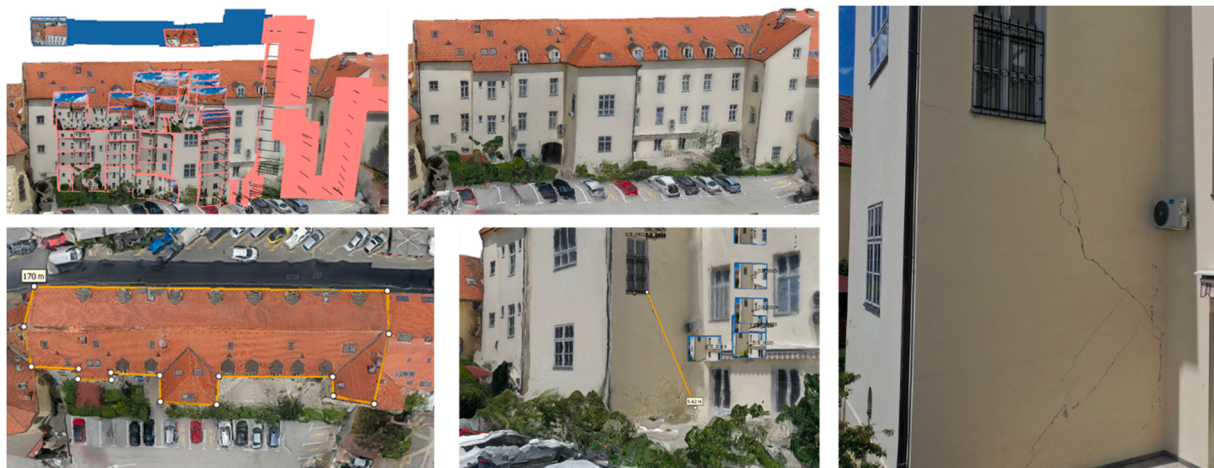
**Fig. 9.** Photogrammetric view of the building, respectively with positions of the camera, photogrammetric model, measuring of the roof geometry, measuring of a crack, photo of a crack.
