Assessment of Performance Indicators of a Large-Span Reinforced Concrete Arch Bridge in a Multi-Hazard Environment

Marić, Marija Kušter; Ivanković, Ana Mandić; Srbić, Mladen; Skokandić, Dominik

Source / Izvornik: **Buildings**, 2022, 12(7)

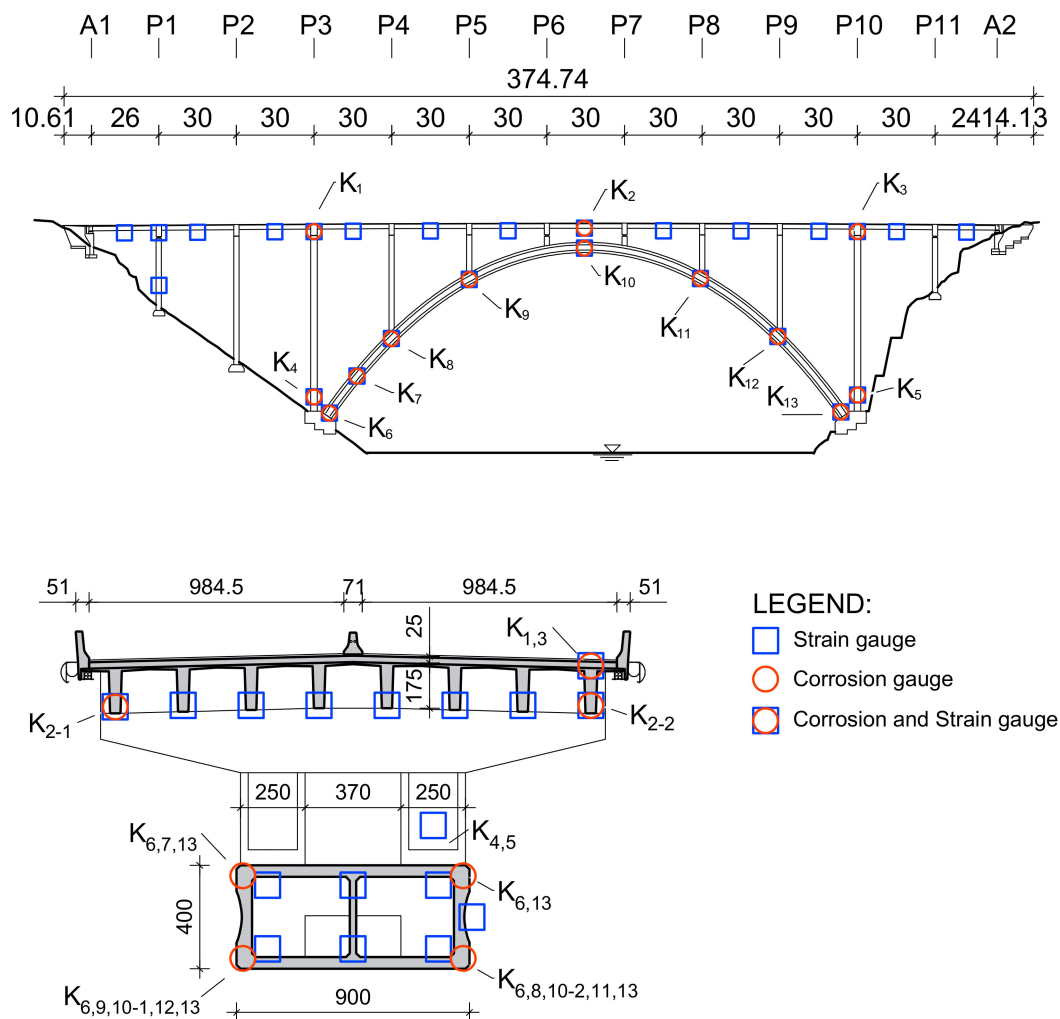
The installed monitoring system included (Figure 2):

- Ninety-two strain gauges (18 on the concrete and 74 on the reinforcement);
- Forty temperature sensors;
- Twenty-one corrosion sensors (anode-ladder);

Figure 2. Location of strain and corrosion gauges installed on the Maslenica Bridge.

These were placed at carefully selected locations on the arch and girders of the superstructure (Figure 2).

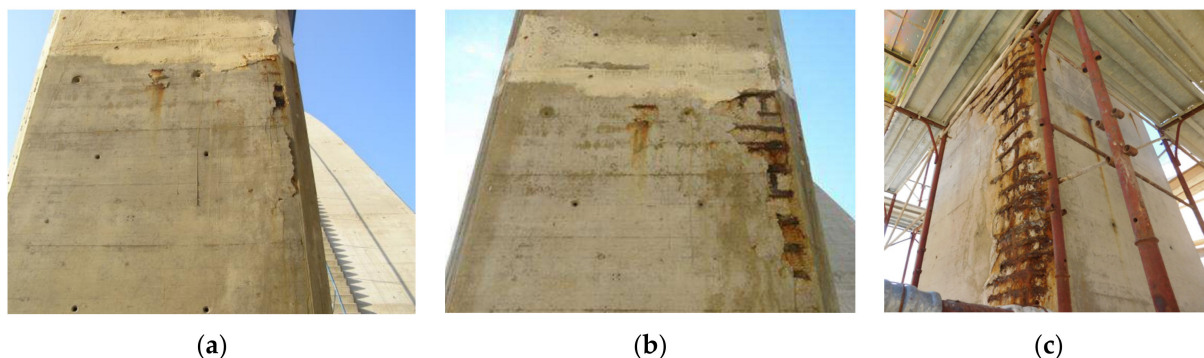
A visual inspection in 2006 revealed corrosion-related damage to piers, piers foundations, the arch, and abutments (Figure 4a). In addition to the maritime environment, the causes include inadequate concrete cover, poor construction quality, and lack of maintenance [22]. Besides cracks generated during or immediately after construction, structural cracks and concrete layering were observed on the pier P2. The worst damage was found on pier P3, especially on the surface exposed to the NE bora wind. There was no significant visible damage to the abutments and the lower part of the superstructure, but there was water leakage through the expansion joint [22].

Figure 4. Propagation of corrosion of the reinforcement on the pier P3 in different periods: (a) 2006, (b) 2010; (c) 2017—shortly before repair.

A detailed visual inspection in 2010 and additional testing in 2012 confirmed further deterioration of the bridge (Figure 4b). Defects during construction and water leakage through the expansion joint were noticed on the abutments. Piers, particularly those above the arch abutments (P3 and P10) were in the worst condition and need repair. There were defects during construction, cracks, and delamination of concrete cover. Similar damage, but at a lower level, was noted on the exterior surface of the arch. Rainwater was seeping through the built-in openings in the arch boxes, while the stairs for inspection were completely damaged. Insufficient concrete cover and corrosion-induced damage was also noticed on the arch abutments [23]. On the main girders, a protective coating was damaged, while other defects were localized. The asphalt pavement was damaged and deteriorated, as it was not renewed after the opening of the bridge. There was also minor damage to the

Unfortunately, it was a poor decision by the designer not to include these pier foundations in the repair. As can be seen in Figure 4, the structural element corrodes rapidly once active corrosion of the reinforcement begins. Only 11 years have passed since the first visible signs of corrosion (brown spots, Figure 4a) to the spalling of the concrete cover and the reduction in the reinforcement cross-section (Figure 4c).

Depending on the results of the corrosion risk assessment, two types of repair solutions are applied. The most damaged elements in the propagation stage of corrosion, such as the portal piers P3 and P10 up to a height of 20 m and the arch foundation, are completely rehabilitated. Rehabilitation includes hydrodynamic removal of the existing concrete layer up to 2 cm deeper than the reinforcement. If the existing reinforcement is less affected by corrosion (reduction in the cross-section of less than 20%), the rebars are cleaned. If the existing reinforcing bars are severely corroded and the reduction in the cross-sectional area is 20% or more, they are removed and replaced with new reinforcing bars anchored in sound concrete. A new layer with steel microfibers is then applied and the concrete cover depth is increased to 7 cm [3,21].

Structural elements where corrosion is considered to still be in its initial phase (arch, outer main girders, all columns except those at the arch springing up to 35 m above sea level) are treated locally. The damaged concrete is removed using a hydrodynamic method and repaired with repair mortar under high pressure [3,21].

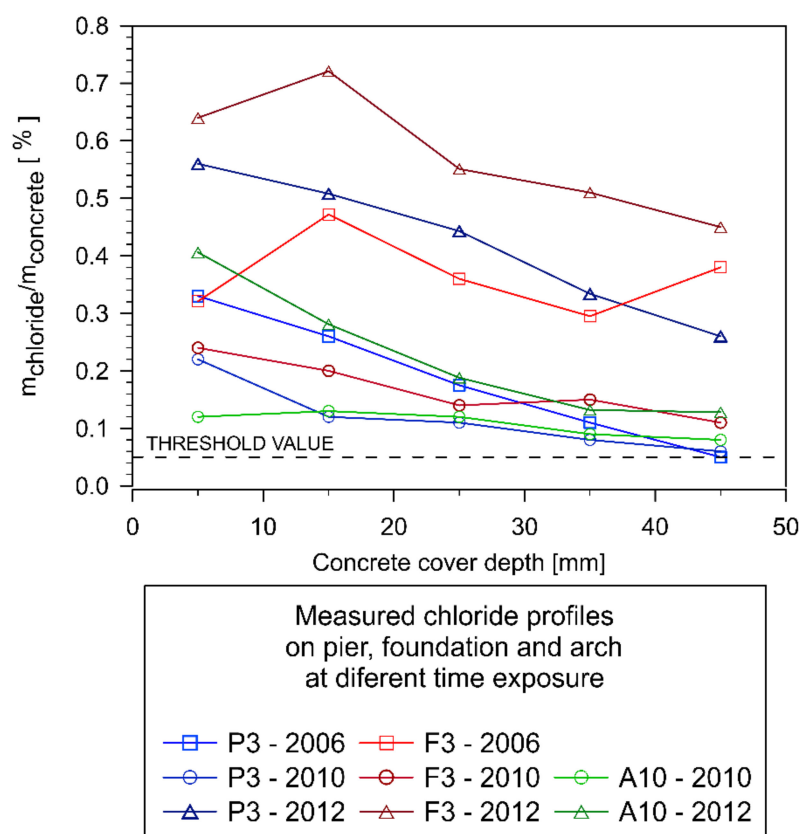
Testing in 2006 showed that the threshold chloride content of 0.4% of the mass of cement or 0.05% of the mass of concrete had been reached at the reinforcement level on 10 of the total of 14 measuring locations on piers and exposed parts of the pier foundations. More extensive results were obtained four years later, showing that the measured locations on girders, piers, the arch, and pier and arch foundations, exposed to the dominant bora wind from the north, reached the threshold chloride value at the reinforcement level; however, on the opposite sides of the same structural elements, sheltered from the wind, chloride content at the reinforcement level was low, on average 0.01% of the concrete mass. Measurements in 2012 were focused on the most vulnerable surfaces on piers, the arch, and pier and arch foundations. On all 16 samples, chloride content at the depth of 5 cm not only reached the threshold value but surpassed it by almost 10 times (Figure 5).

Figure 5. Measured chloride profile on pier P3 (15 m above sea level, surface exposed to NNE), joint pier P3 and arch foundation F3 (10 m above sea level, surface exposed to ENE), and arch segment close to the arch foundation at pier P10 (10 m above sea level, surface exposed to ENE) in different time periods: 2006, 2010 and 2012.

In Figure 5, measured chloride profiles are presented on three groups of elements: pier P3 (15 m above sea level, surface exposed to NNE), joint pier P3 and arch foundation F3 (10 m above sea level, surface exposed to ENE), and the arch segment close to the arch foundation at pier P10 (15 m above sea level, surface exposed to ENE) in different time periods: 2006, 2010 and 2012. According to the measured values, it can be concluded that reinforcement depassivation had already started in 2006, after 9 years of exposure to the maritime environment. Active corrosion of steel reinforcement caused cracks and damage

Values of chloride in concrete taken from pier P3 and foundation F3 measured in 2006 are higher than the chloride content measured on the same elements in 2010. This may be due to the local influence of concrete damage and environmental exposure, since it is not possible to always take samples from the same position and due to variations in seasonal and multi-year cycles, as found in [46]. However, in each time period, the chloride content is higher than the threshold value, which should be the trigger point to decide on further maintenance and repair. As can be seen in the chloride profiles measured in 2012, damages caused by active reinforcement corrosion cause damage to the concrete, accelerating chloride penetration. Consequently, deeper layers of concrete are contaminated with chlorides and must be removed during repair.

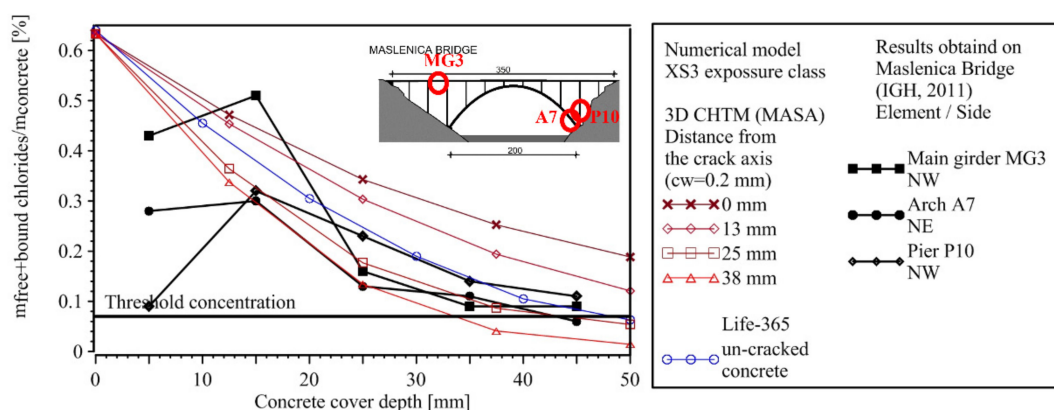
Chloride penetration in concrete is analyzed again after 13 years of exposure using two models for service life prediction, Life-365 and 3D chemo-hygro-thermo-mechanical (3D CHTM) model [41,42]. In addition, two environmental exposure conditions XS1 (airborne chloride) and XS3 (splash zone), were considered according to the European Standard EN 206:2013. The assumed surface chloride concentration for both models is 0.25% and 0.64% of the concrete mass for exposure classes XS1 and XS3, respectively. The initial chloride diffusivity is relatively low and the same for both models: $7.94 \times 10^{-12} \text{ m}^2/\text{s}^2$ for the Life-365 and $5.50 \times 10^{-12} \text{ m}^2/\text{s}^2$ for the 3D CHTM model. The comparison with measured data (Figure 6) led to the conclusion that both models are able to realistically predict the chloride concentration in concrete after a long period of time (more than 10 years). However, the 3D CHTM numerical model, which considers cracks in the concrete, predicts the depassivation time much more accurately [18,39,40]. Life prediction analysis combined with other testing methods leads to the conclusion that a service life of 100 years can be achieved with the designed concrete quality and concrete cover depth. However, cracks and damage in the concrete that occur during construction and exploration shorten the depassivation time to less than 10 years [18,39,40].

Figure 6. The total chloride content in concrete after 13 years of sea exposure: comparison of the numerical results and measured values on the Maslenica Bridge (reproduced with permission from [40], IOP Proceedings, 2019).

It should be noted that both models assume constant boundary conditions: surface chloride concentration, water saturation, relative humidity, and temperature, while chlorides penetrate into concrete by diffusion. Therefore, the effects of climate change, seasonal and long-term weather variations, as well as wetting–drying cycles, effects of precipitation, and other types of chloride transport are not considered, although their influence can be significant [46,51–53]. However, the focus of the analysis is on demonstrating the impact of cracks on chloride concentration in cracked and the local uncracked concrete.
