# Optimised technology for repair of vertical surface of concrete bridge elements

**Abstract:** A large number of concrete bridges need to be repaired due to durability problems. This research focuses on evaluating the bond quality of the repair material, which has the highest influence on the durability of the repair. Onsite experimental research is performed on the vertical surfaces of the column of the Klara Jug bridge, which is located in the southern part of the Zagreb. Since the experimental research is carried out in parallel with the ongoing repair works on other bridge elements, the experimental conditions correspond to the real construction site conditions. Simulation of the actual site rehabilitation process was carried out on the test fields, which included removal of the damaged concrete by hydrodemolition at a depth of 1.5–2 cm, washing of the concrete by roto nozzle and wet spraying of the repair mortar. The results of the pull-off tensile bond strength show that there is an optimum period for spraying of repair mortar after washing the concrete surface. Optimal time for application of mortar is 90 min after completion of washing of the vertical concrete surface by

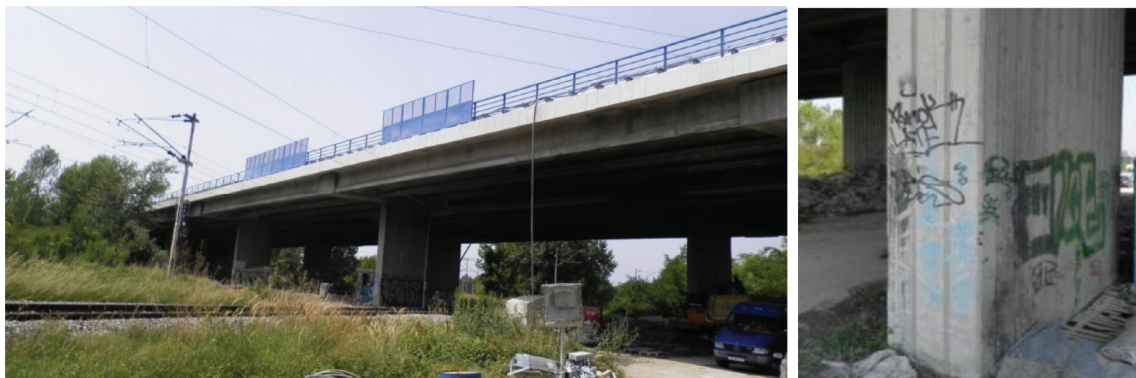
Fig. 1: View of Klara jug bridge (left); column used for experimental work (right).

The column surface was divided into 24 vertical segments, each with an area of 1 m<sup>2</sup>. The existing concrete was removed by hydrodemolition to an average depth of 1.5–2 cm. At this depth, large aggregates were broken, which is a visual indicator of strongly bonded constituents in the concrete substrate. Hydrodemolition was performed using a Hammelmann HDP 114 high-pressure pump at a pressure of 2,100 bar.

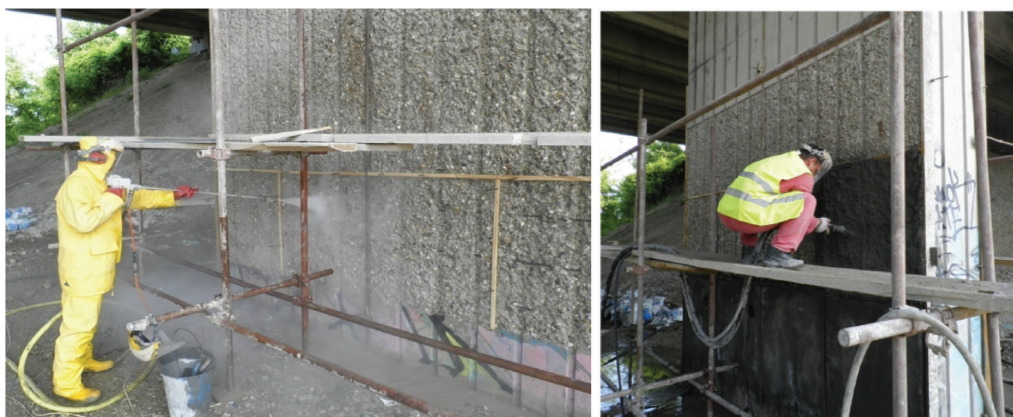
Fig. 2: Surface preparation by hydrodemolition under high pressure to a depth of 1.5 cm, (left) and spraying of repair mortar (right).

After hydrodemolition, the surface preparation was performed with the same type of machine but with a so-called rotary nozzle. The rotary nozzle was operated at a pressure of 1,720 bar, which gives an optimal surface roughness and removes fine particles and concrete residues left behind by hydrodemolition. Moving the nozzle closer to the surface removes loose concrete particles, while a greater distance is more efficient to remove smaller particles. Lower water pressure with higher flow would be more effective in washing off the fine particles, but would not be able to remove loose concrete particles after hydrodemolition. Each 1 m<sup>2</sup> test segment was treated with water

for 2 min (Figure 2). This amount of time was sufficient to create a well-prepared surface for mortar application. After water demolition and surface washing, the concrete surface was free of loose parts and cracks, and about 50% of the surface contained visible aggregate particles.

After surface preparation, the repair mortar was applied to the surface using the wet spray method. The repair mortar of class R4, according to the performance requirements of the standard EN 1504-3:2005, was sprayed with spray equipment from the manufacturer Putzmeister. The mortar was delivered in bags and mixed on site. Before delivery, the mortar was stored in a closed warehouse, while after delivery to the construction site, it was protected with a plastic sheet. The mortar was mixed at the construction site by adding water to the mixture. The mortar was mixed in a horizontal mixer positioned directly above the spray pump. When the required homogeneity of the mixture was achieved, the mortar was discharged into the pump and conveyed through a hose. A spray nozzle is attached to the end of the hose. In the nozzle, thorough mixing of compressed air and wet components takes place, forming the final jet.

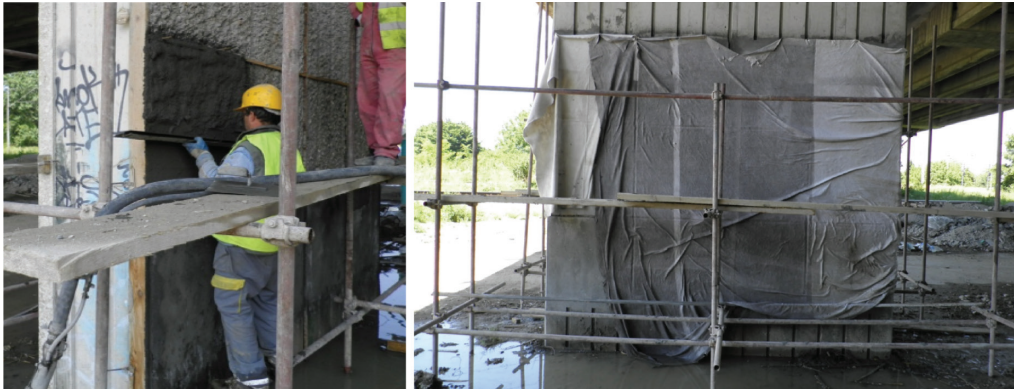
Fig. 3: Finishing of repair mortar surface (left) and curing of repair mortar (right).

and then additional finishing was applied (Figure 3). The repair mortar was cured by wrapping the surface with geotextile and spraying with water once a day (Figure 3).

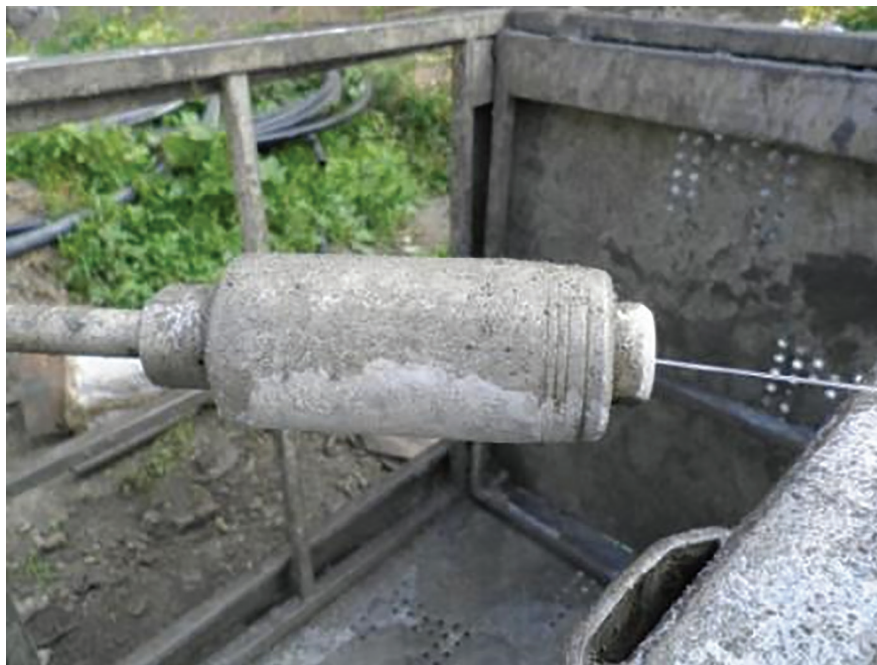
Fig. 5: Roto nozzle for washing of concrete surface.

Figure 5 shows the rotary nozzle used for surface preparation.

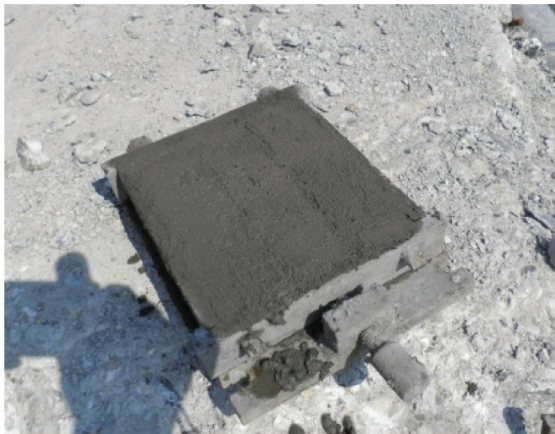
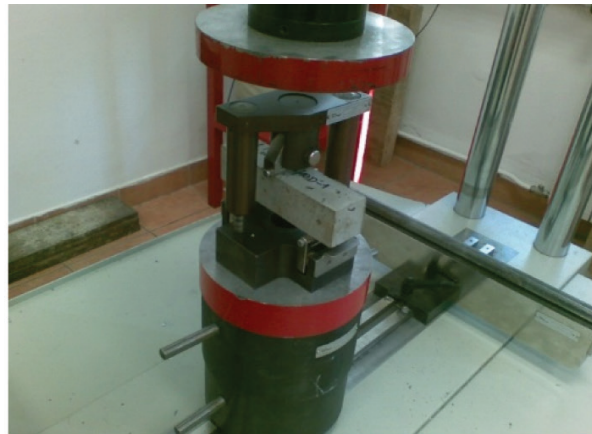
**Fig. 7:** Mortar samples for compressive and bending strength testing (left) and testing of bending strength (right).

moulds for prisms with dimensions 40 mm x 40 mm x 160 mm and in cylinders with diameter 100 mm and height 200 mm. The samples were cured in the laboratory under water at  $20 \pm 2^\circ\text{C}$  until testing. Figure 7 shows the mortar compacted in moulds for strength testing and the performance of the bending strength test.
