Seismic Assessment and Retrofitting of Existing Road Bridges: State of the Art Review

Keywords: seismic assessment; retrofitting; existing road bridges; bridge assessment; Croatia earthquake; urgent strengthening

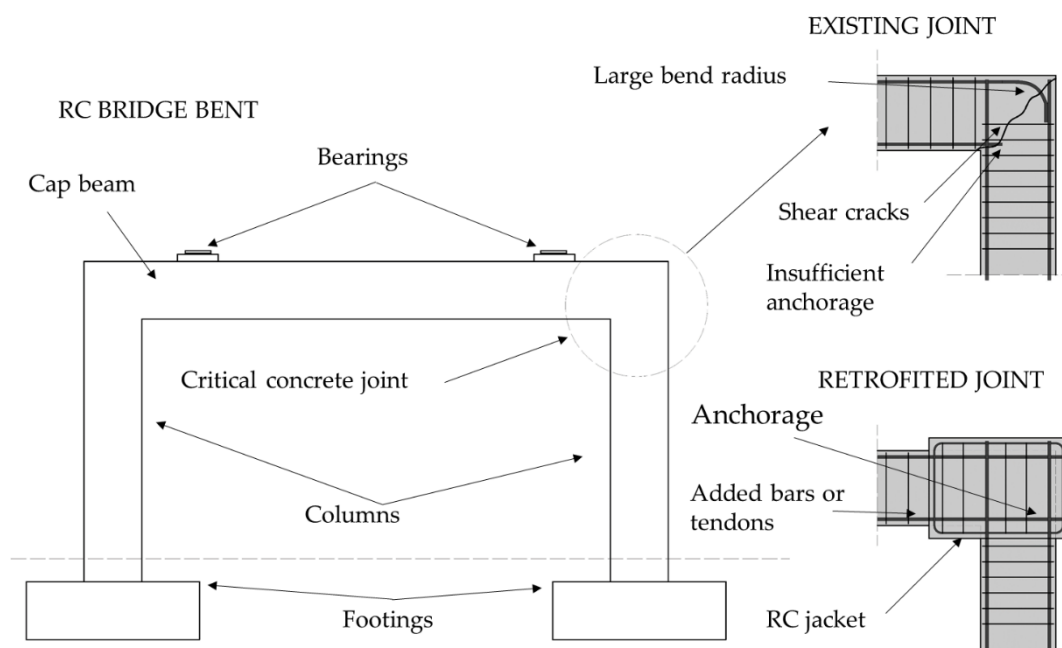
**Figure 4.** Seismic retrofitting of cap beams and concrete joints in RC bridge bents.

Many road bridges are supported on RC bents consisting of two or more columns connected with a transverse cap beam, as shown in Figure 4. The concrete joint between the top of the column and cap beam is subjected to both shear and flexural stresses during cyclic seismic loading. In older bridges, this joint is often designed without sufficient anchorage length in the longitudinal direction and sufficient reinforcement in the transverse direction, and can therefore be designated as a critical point because of the possibility of brittle failure. As described in Chapter 2, the approach to bridge design is that the superstructure should remain in the elastic region to force plastic hinges in the columns. This is achieved by increasing the stiffness and strength of the cap beam and the concrete joint between the beam and the column [65]. The retrofitting technique is similar to RC jacketing of columns, as the new concrete layer is poured around the joint along with sufficient reinforcement to be anchored in both the beam and a column; an example is shown in Figure 4.

RC bents for new bridges are not generally designed as shown in Figure 4 because the cap beam is usually extended beyond the columns, which provides more space for the reinforcement of the critical joint section. Therefore, while on some older bridges the cap beams are retrofitted similar to Figure 4, the new beam section is extended beyond the columns, creating a cantilever. This method is called a seat extender [53].

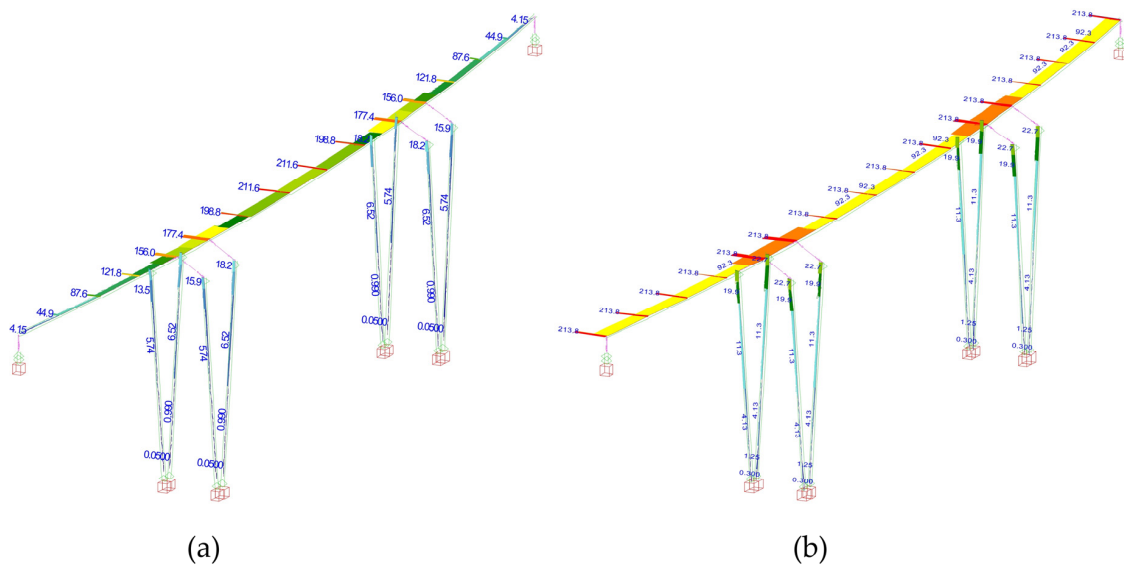
Figure 9. (a) horizontal load distribution along the superstructure; (b) horizontal load in proportion with dominant modal shape.

The target displacement for the first modal shape (Table 1) is 76 mm; while the existing expansion joint was designed to allow a maximum longitudinal displacement of 70 mm, when exceeded this would cause a collision between the superstructure and abutment wall. Therefore, the Case Study bridge was reassessed using the static nonlinear pushover analysis. A total of four cases were calculated with two types of load distributions for each direction, as presented in Figure 9 for first modal shape.
