# Influence of Stray Current on Fastening System Components in Urban Railway Tracks

Source / Izvornik: **Applied Sciences**, 2023, 13

**Journal article, Published version**

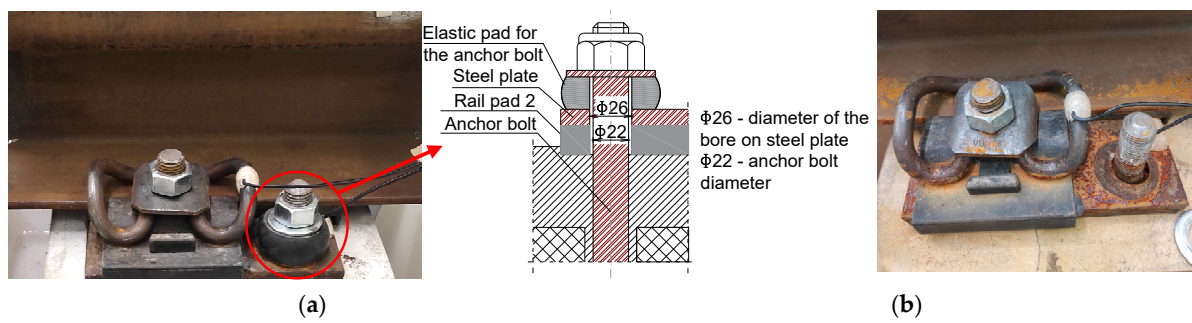
**Figure 8.** DEPP fastening system: (a) Case 1: elastic pad and nut at the anchor bolt. (b) Case 2: elastic pad and nut removed from the anchor bolts.

- Case 1: Elastic pads and nuts were placed on the anchor bolts (Figure 8a).
- Case 2: The elastic pads and nuts were removed from the anchor bolts (Figure 8b).
