Source / Izvornik: **Buildings, 2022, 12, 1 - 28**

Condition Assessment and Seismic Upgrading Strategy of RC Structures—A Case Study of a Public Institution in Croatia

Abstract: In 2020, Croatia was struck by two catastrophic earthquakes, resulting in more than 50,000 damaged structures. The majority of these are masonry buildings, but there are a number of reinforced concrete structures that suffered moderate to extensive damage. In this paper, the seismic condition assessment and upgrading of existing RC structures are presented with a case study building in Zagreb. The assessment procedure includes initial visual inspection, rapid preliminary evaluation, detailed in situ measurements, and non- and semi-destructive methods. New technologies were applied and followed by numerical modeling and verifications. Strengthening proposals are made that respect owner needs and the needs for the energy retrofitting of the existing RC building. As the integrated approach should be respected in the renovation of existing buildings, this case study can represent an example of good practice in the process of seismic and energy retrofitting.

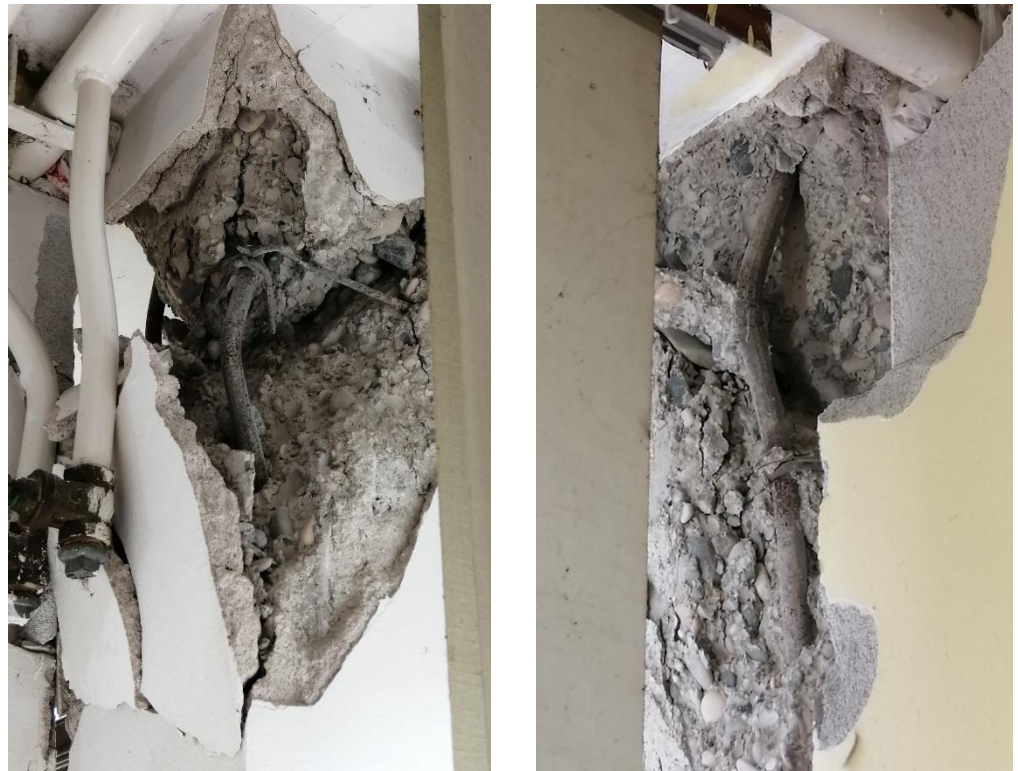
Figure 1. Buckling of plain bar reinforcement on top of the RC piers.

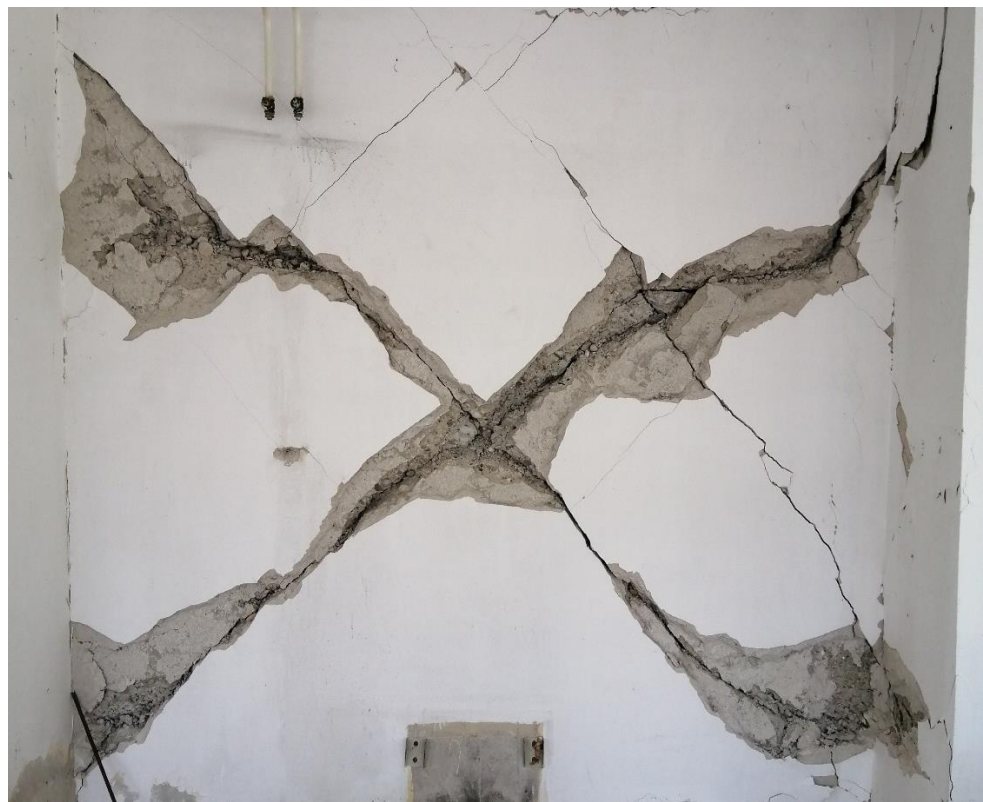
Figure 2. Diagonal cracks in the lightly reinforced RC shear wall.

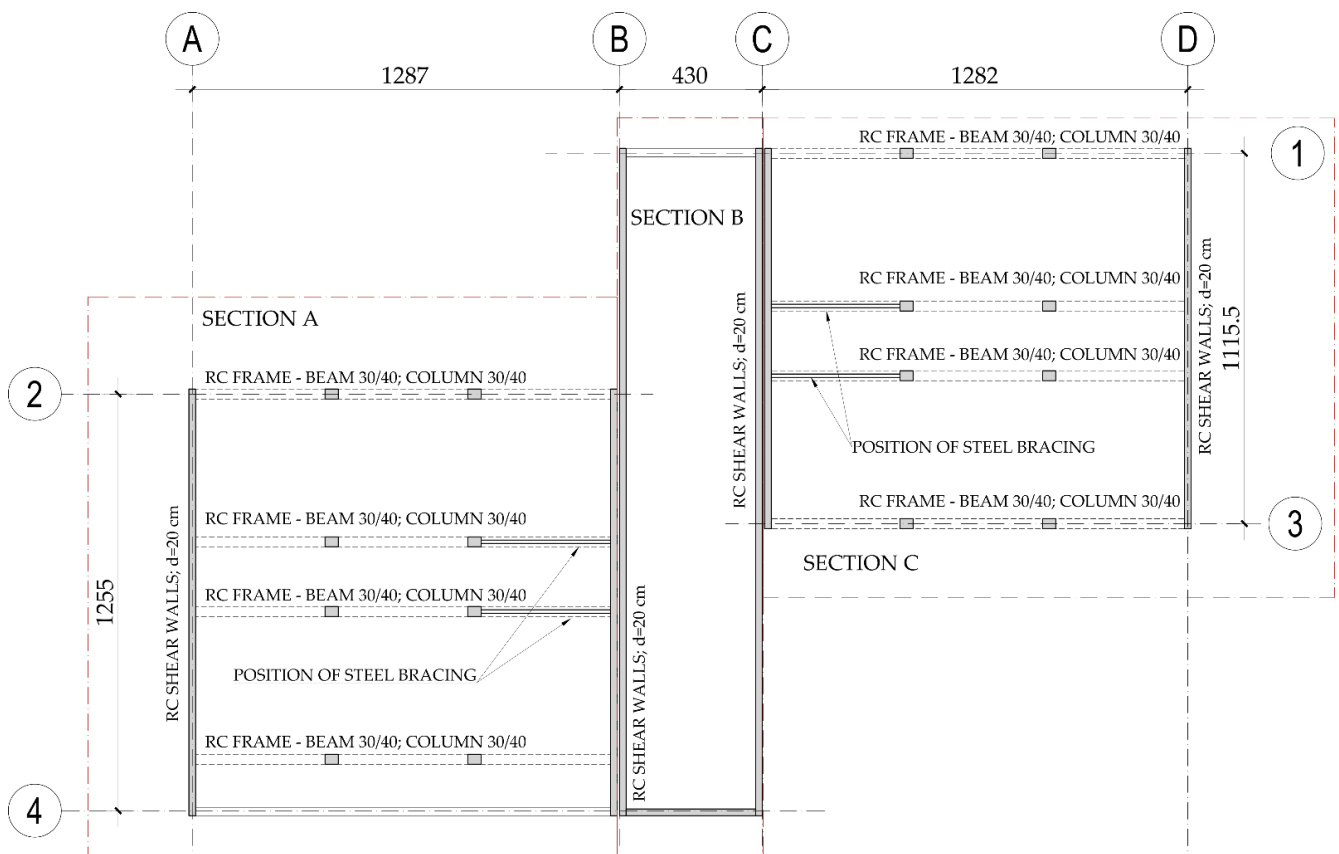
Figure 5. Characteristic floorplan of the case study building (all units in cm).

The case study building is divided into three structural sections, labeled as sections A to C. Each section is a structural system of its own, with a 7 cm joint between them, in accordance with the seismic joint condition, part 4.4.2.7. in EN 1998-1 [15]. The structural system of sections A and C is a combination of uncoupled shear walls and frames, while section B is comprised only of shear walls, as shown on the characteristic floorplan in Figure 5. Reinforced concrete walls are 20 cm thick (except in the basement where the walls are 30 cm thick), and the columns have a cross-section of 30 × 40 cm on which the beams with a height of 40 cm are supported. Floor structures are RC slabs, with a thickness of 14 cm. There are a total of six stories, including the basement and attic, with a total height of 18.53 m. The foundations are constructed as pad foundations for the columns and foundation beams for the shear walls.

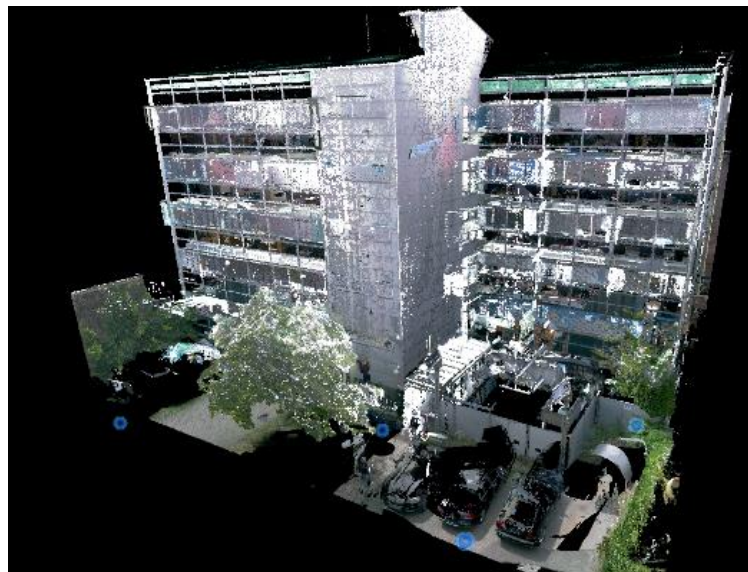
Figure 7. Laser scanning workflow.

As part of the inspection of the building and determining the dimensions, the object was scanned in detail with a laser scanner and a preliminary cloud of points was created. Laser scanning was conducted over several weeks to create a 3D cloud of points inside and outside of the building. The laser scanner used was a compact Leica BLK360 3D imaging laser scanner with an integrated spherical imaging system and thermography panorama sensor system. Three-dimensional point clouds are delivered with an accuracy of 4 mm at a distance of 10 m with the help of three spherical, panoramic HDR cameras with a thermal imaging camera. To create a precise point cloud, it was necessary to perform one or more scans in each room of the building, i.e., several positions in large spaces such as the roof structure. The laser scanner created a point cloud of the inner part of the building and then a point cloud of the outer part of the building. Eventually, the two point clouds were merged through the Cyclone Field 360 and Register 360 software. To create a precise digital twin using LiDAR technology, the scanner captures 360,000 dots per second from multiple

locations within each room with a certain percentage of overlap. With the help of laser scanning, the time spent on documenting and reviewing geometry, especially on large and complex buildings, is significantly shorter. The point cloud was further used to create an accurate 3D model, to create a precise 2D floor plan. To ensure the best results possible, it is favorable to avoid weather conditions for scanning such as rain, snow, fog, or even illumination by the sun. Moreover, highly reflective (polished metal, gloss paint), highly absorbent (black), and translucent (clear glass) surfaces are unfavorable for scanning and should be taped, powdered, or colored if necessary and possible. The whole procedure consists of several steps as seen in Figure 7. When creating point clouds in the field, the Cyclone Field 360 software stores the data, including a 360° image, laser scanning point cloud, and a thermal image. After two scans have been recorded in an adjacent or the same room, making sure that they overlap sufficiently, they should be automatically connected in the field software; if not, they are manually adjusted in the Cyclone Register software. When this step was repeated enough times in all the necessary positions, i.e., on all the floors (Figure 8) with a sufficient percentage of overlap, we obtained a point cloud for the whole building that we could use to create a BIM model. The final point cloud consisted of 225 scans and 2 billion and 300 million points. By obtaining point cloud data we were able to create a precise digital twin.

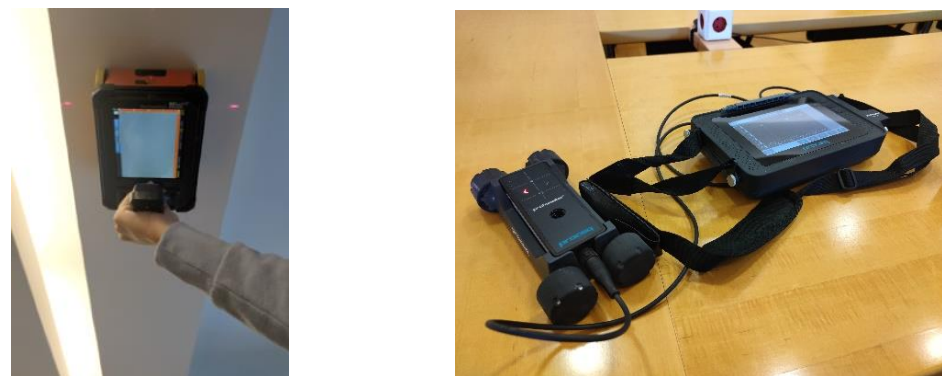
Figure 11. GPR and Profometer used for measurements.

To determine the type and amount of reinforcement installed in reinforced concrete, parts of the structures were inspected. Two different methods were used: GPR and removing the concrete cover. Determination of the amount and location of reinforcement was performed with a Profometer 650 AI reinforcement tracker, manufactured by Proceq in Switzerland, and a StructureScan Mini XT georadar, manufactured by GSSI (Figure 11). The operation of the georadar is based on the emission of electromagnetic waves into the material, with the aim of determining the position of objects below the surface. It consists of a transmitting antenna that emits electromagnetic waves, which are then reflected when they encounter an object. The reflected wave is registered by the receiving antenna. A

reinforcement finder is a device intended for localization of reinforcement in concrete. In the coil located in the probe of the device, an alternating current is induced which generates an alternating magnetic field. The presence of reinforcing steel in an alternating magnetic field results in the appearance of eddy currents, which also form a magnetic field. This leads to a change in the impedance of the coil, on the basis of which the thickness of the concrete cover and the diameter of the reinforcement are determined.

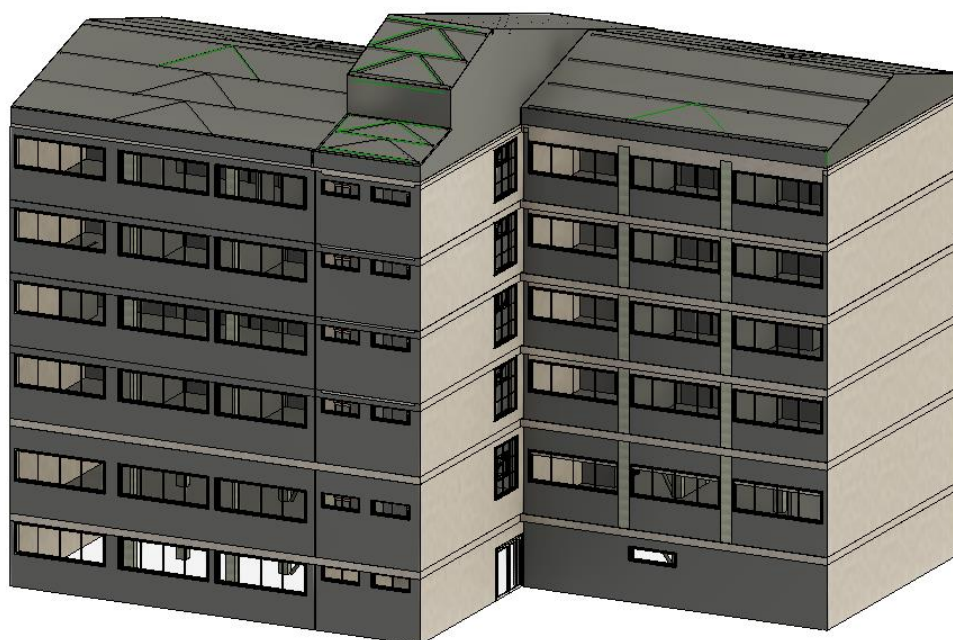
Figure 14. BIM model of the case study building.

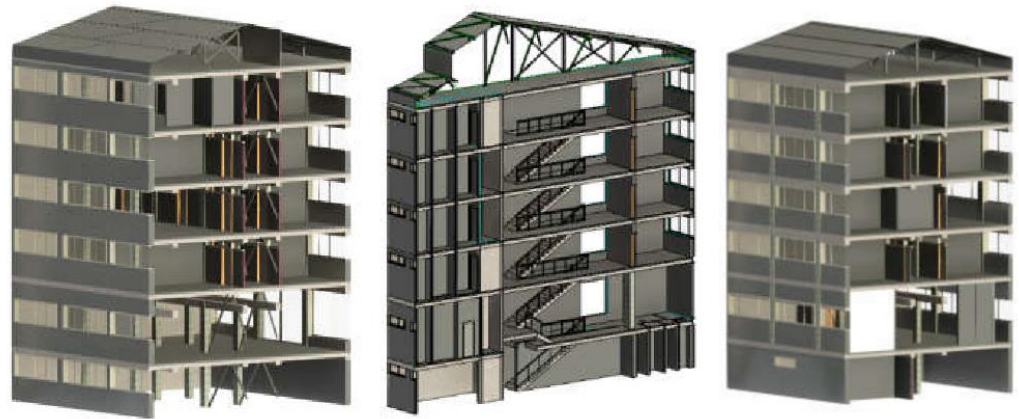
Figure 15. Three different sections of the case study building.

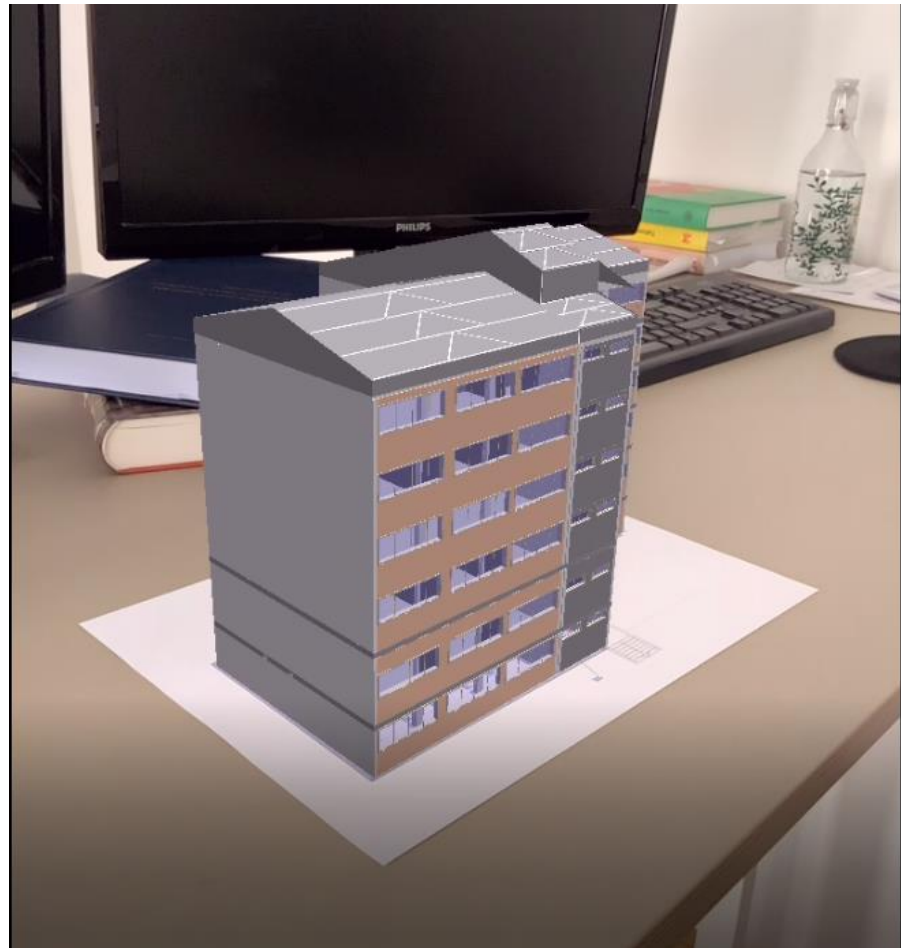
Figure 16. Scaled-down BIM model in augmented reality.

The model can be scaled from a smaller size (Figure 16) to a real-size object that can be inspected and compared to an existing building.

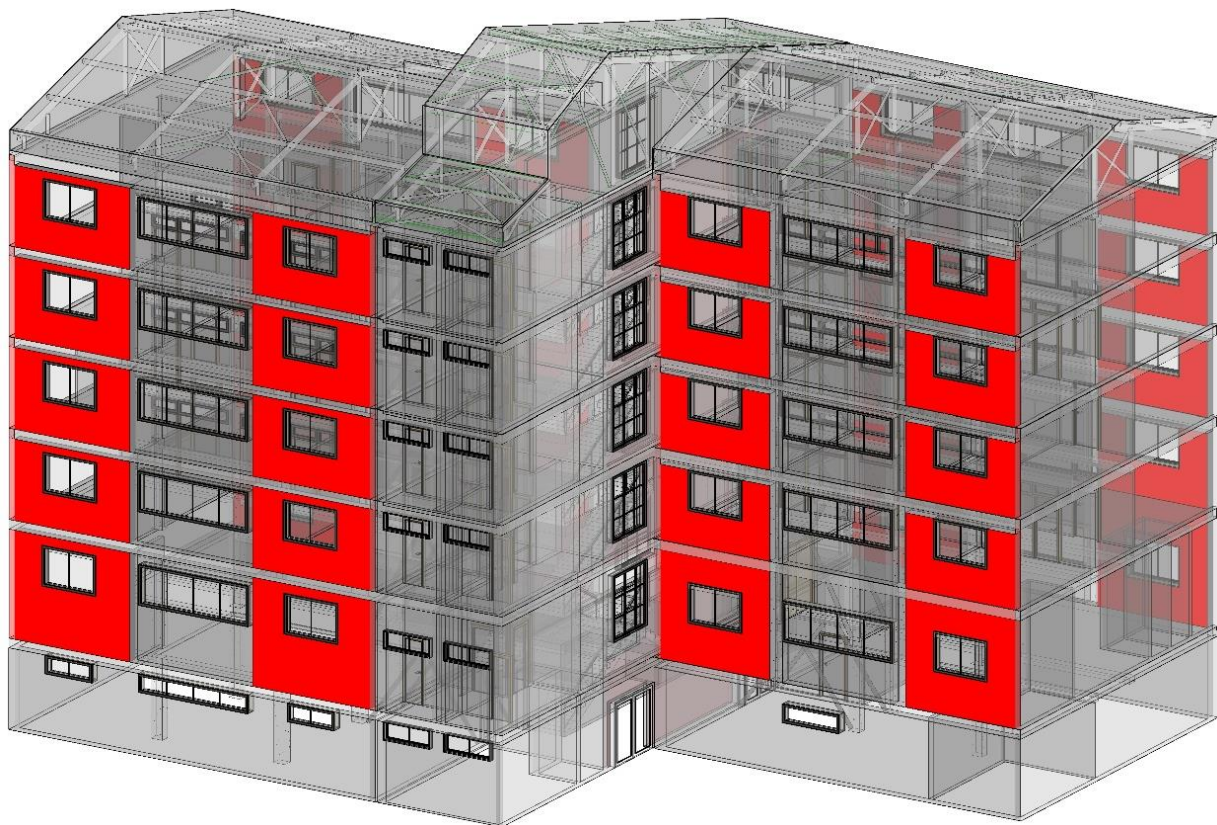
Figure 22. Additional RC perimeter walls.

The only proposed solution which does not interfere with the interior is the construction of the new perimeter RC walls in direction X on all sections. In this approach, the global behavior of the structure would change completely, as the first natural period would now be in direction Y, due to the increased stiffness of direction X. By doing so, the structure would have more evenly distributed stiffness and the eigenmodes would be more regular. Furthermore, the perimeter RC walls (shown in Figure 22) would transfer the majority of the seismic force, and the existing frames would fulfill ULS verifications without any measures. However, this solution is the most expensive, as it requires total reconstruction of the east and west facade.
