# Fatigue Behaviour of Aluminium Members with Different Notch Root Shapes

*Source / Izvornik:* **Buildings, 2022, 12(5)**

**Abstract:** In unitised curtain walls, the transfer of horizontal loads, mainly wind loads, from the upper into the lower unit is achieved through the head/notch interlocking connection. Optimisation of the machining process would require a sharp root of the notch, causing an increase in the stress concentration. In order to predict fatigue resistance during design life, the influence of the radius at the root of the notch has been tested in both static and cyclic regimes. The cyclic regime is based on the load history equivalent of 50 years of wind exposure. Numerical simulations on the test assembly have been conducted in order to verify their adequacy for future research on similar issues. The experimental results demonstrated that, for the given specimen shape and alloy, a sharp notch would not lead to premature failure, and such a detail is safe from the purview of damage-tolerant design.

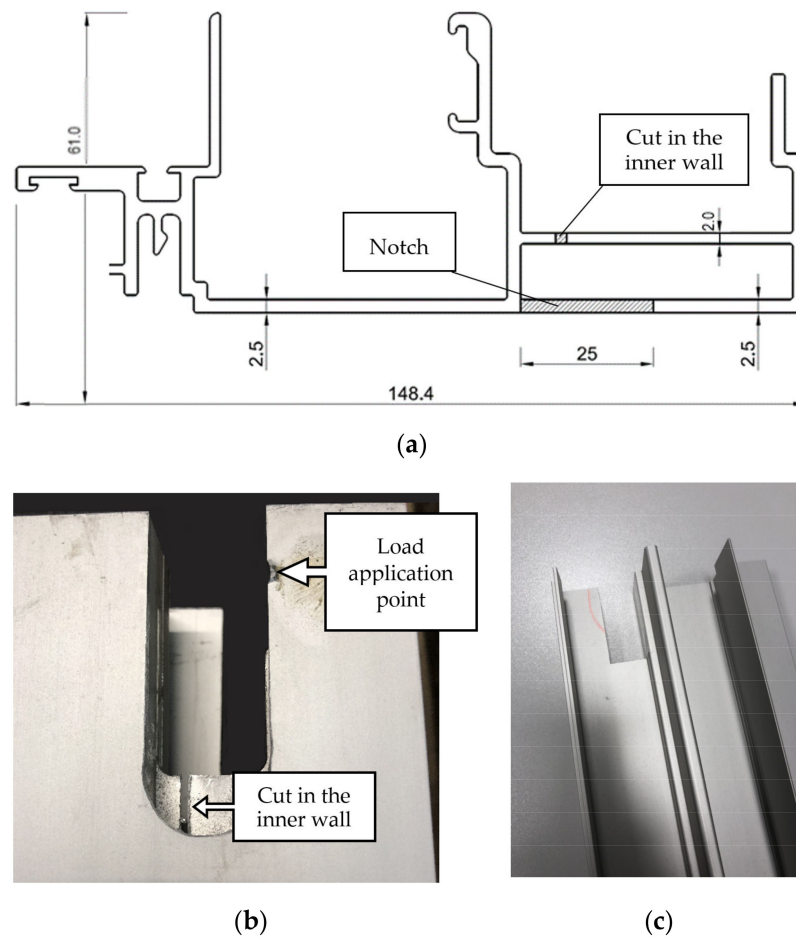
**Figure 5.** (a) Cross-section of the profile, (b) semi-circular notch in the profile, (c) view of the profile.

The profile used was the male half of the split mullion (Figure 5a), an aluminium extrusion with an asymmetric cross-section. The inner wall of the section parallel to the notched wall was continuously cut for the entire length of the specimen, as shown in Figure 5b, so that the inner wall did not contribute to the loadbearing capacity of the notch.

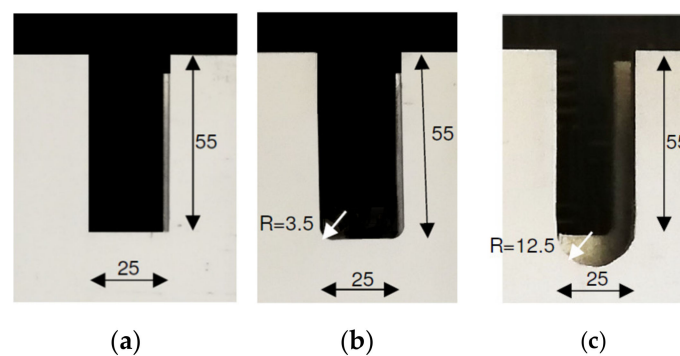
**Figure 6.** Geometry of the (a) sharp notch, N1, (b) rounded notch, N2, and (c) semi-circular notch (mm).

The geometry of the notches is shown in Figure 6. The width of the notch was 25 mm, which enabled a close fit of the chicken head. The depth of the notch was 55 mm. This enabled  $\pm 20$  mm of vertical movement in the stack joint.

It should be noted that the total depth of the semi-circular notch was 67.5 mm, which allowed for a straight length of 55 mm plus a radius of 12.5 mm for the semi-circle. In practice, the semi-circular notch was not used due to geometric constraints. The vertical section through the stack joint between two façade units is shown in Figure 7a. The enlarged detail in Figure 7b shows the vertical movement capacity of the stack joint when the gap between two units closes. The grey chicken head shows the nominal position as-designed. The blue chicken head shows the closed position if the rounded notch was used. The red chicken head shows the closed position if the semi-circular notch was used. It can be observed that the movement capacity of the semi-circular notch (sc) was smaller than that of the rounded notch (rnd), as the movement of the chicken head was limited by the contact

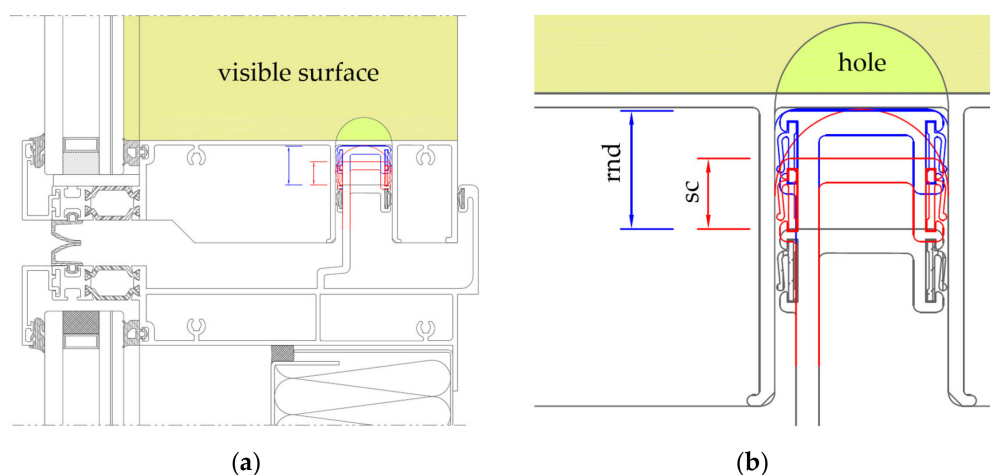
**Figure 7.** (a) Stack joint; (b) enlarged detail showing the vertical movement capacity.

with the semi-circular notch (red contour in Figure 7). The position of the semi-circular notch would need to be higher to enable the same movement capacity as the rounded notch, but this is not possible, as, in that case, the semi-circular part of the notch would protrude over the horizontal transom and enter the area visible to the user (green hole in Figure 7), leaving it open for the passage of air and water into the building. However, the semi-circular notch was investigated as well for comparison. For test, specimens with a semi-circular notch at a total depth of 67.5 mm were used. Numerical modelling was performed for both semi-circular geometries, at 55 mm and 67.5 mm of the notch depth.

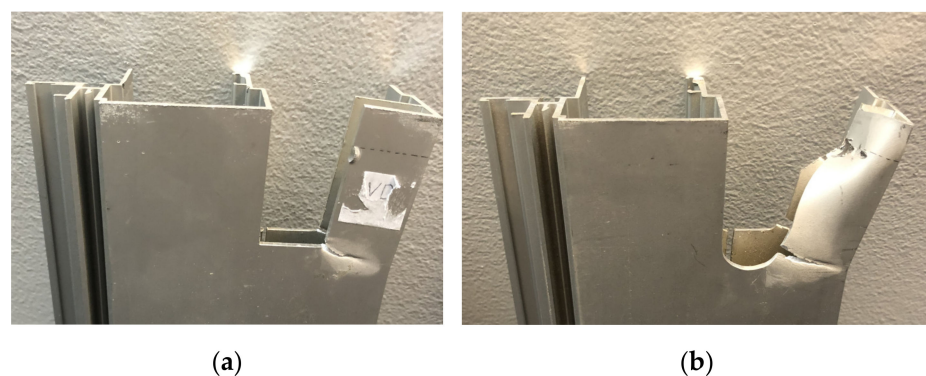
**Figure 10.** Fracture in monotonic tests: (a) Sharp notch specimen M\_N1\_1; (b) Semi-circular specimen M\_N3.

It should be noted that specimens with the sharp notch (Figure 10a), as expected, had lower breaking forces (6.78 kN and 6.99 kN), which was, on average, 82% of the breaking force for specimens with rounded or semi-circular notches (8.08 kN, 8.61 kN, and 8.45 kN). Since the opening of the notch was measured at the time of the fracture, there was a notable difference for various specimens. This value depended on the mode of the breakage and comprised localized plastic effects; for M\_N3, this value was highest as the wall buckled, which can be seen in Figure 10b.

Specimens with the sharp notch failed through the crack at the root of the notch due to the concentration of tensile stress (Figure 10a). Specimens with the rounded or semi-circular notch experienced local buckling of the aluminium wall at the load application point prior to the fracture, so the material at the root of the notch was exposed to the combined stress due to the rotation of the aluminium wall (Figure 10b). The rotation of the aluminium wall was a secondary effect caused by the buckling of the wall, which shifted the application point of the load out of the plane of the wall.

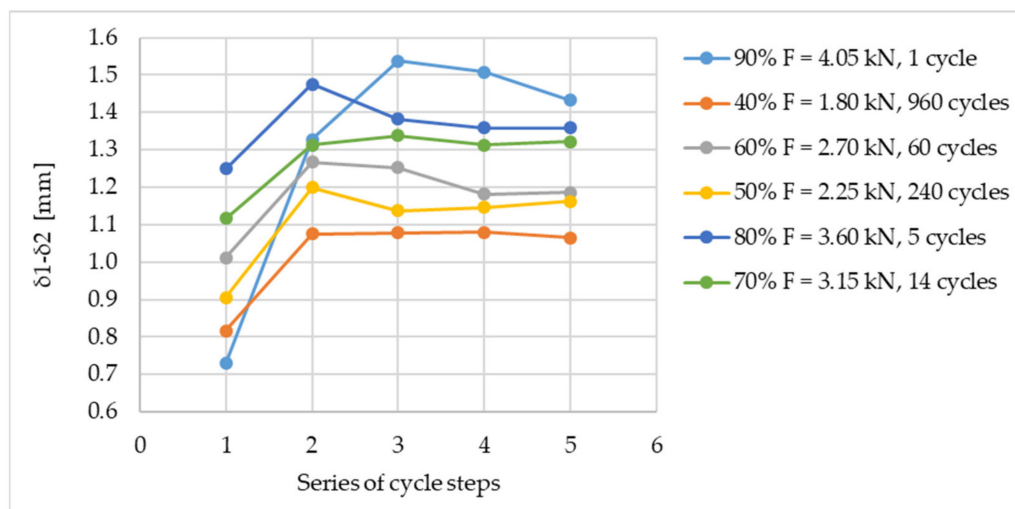
**Figure 11.** Opening of the notch, sharp notch specimen C\_N1\_1.

Figure 11 shows the diagram of the maximal opening of the notch, expressed as the difference between deflections  $\delta_1$  and  $\delta_2$  (readings of LVDT\_1 and LVDT\_2, respectively) for each set of cycles (single  $F_i$ ) in each series for the specimen with the sharp notch (C\_N1\_1). It can be noted that there was a slight increase in the opening of the notch ( $\delta_1 - \delta_2$ ) after the first series for  $F_i = 90\%$  F and  $F_i = 40\%$  F load cycles. This could be caused by the onset of the crack in the root of the notch, but this pattern was not observed on other specimens and there is no definite proof of that hypothesis. For subsequent series of cycle steps, it can be observed that a stable value of measured deflections and slight fluctuations were attributed to the tolerance of the applied force due to the precision limits of the hydraulic press.

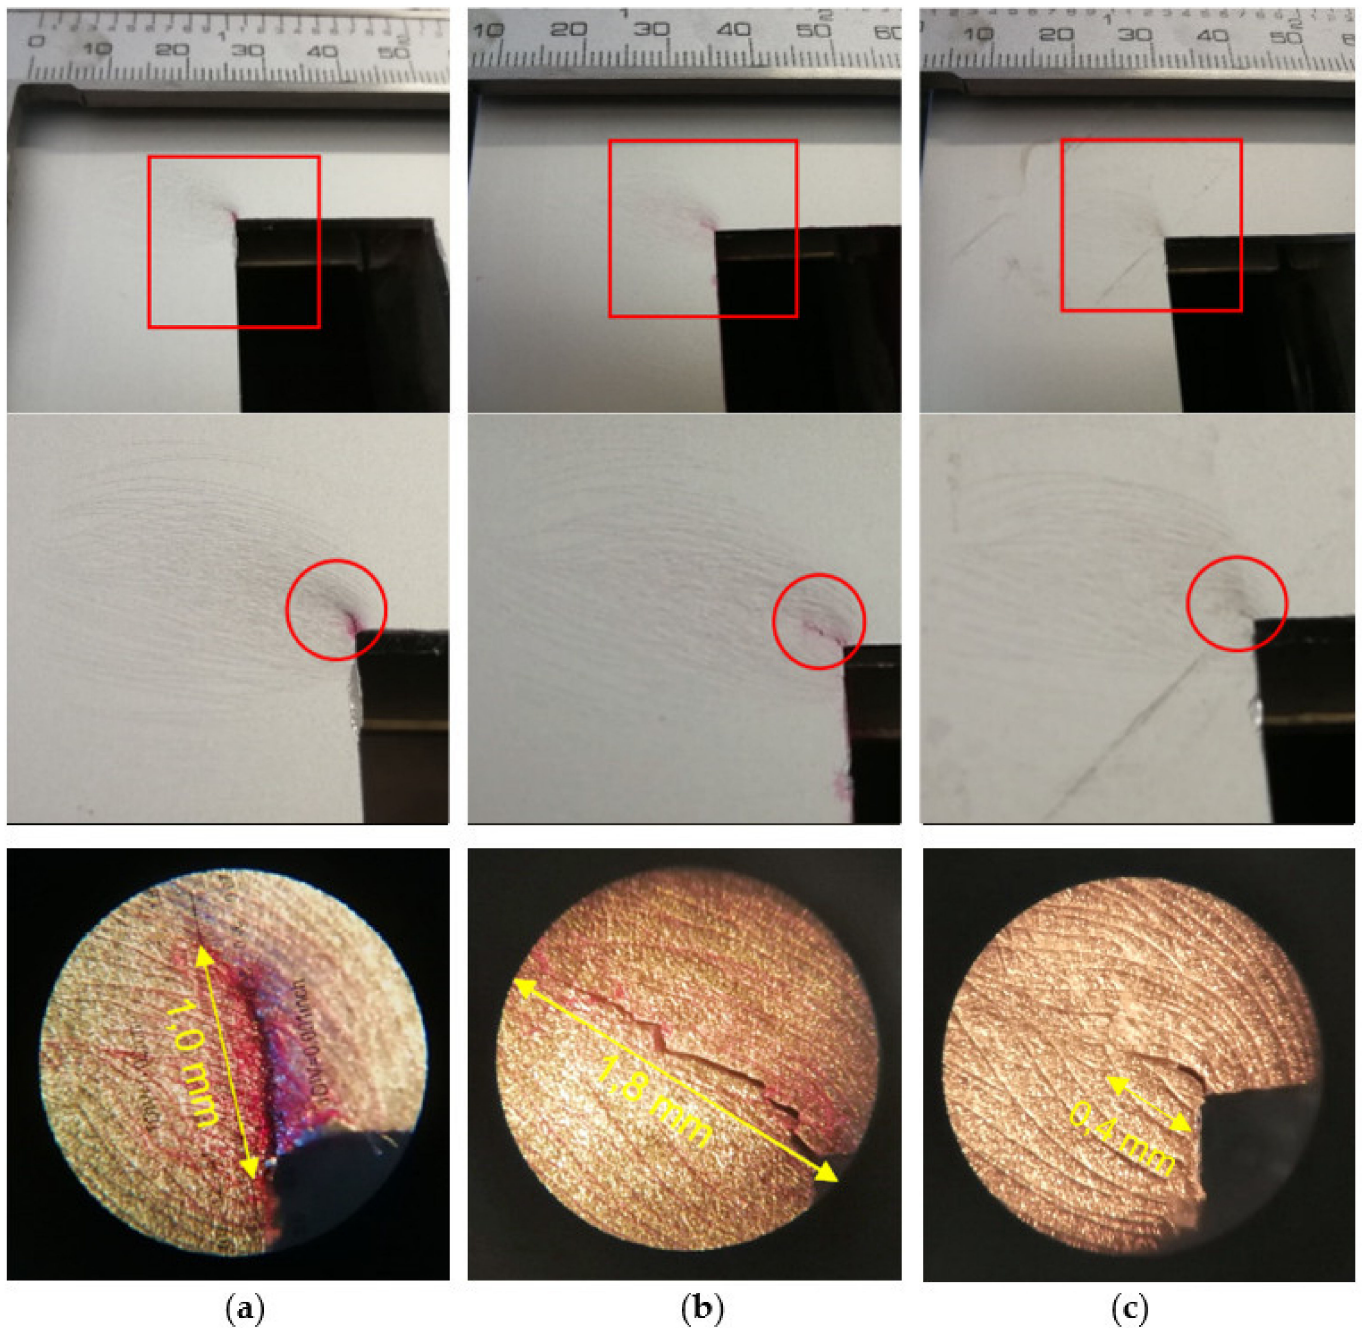
**Figure 12.** Cracks in specimens with the sharp root: (a) C\_N1\_1, (b) C\_N1\_2, (c) C\_N1\_3.

In all 3 specimens with the sharp root notch (C\_N1\_1, C\_N1\_2 and C\_N1\_3), a crack developed at the root of the notch (Figure 12). The stress concentration during the cyclic loading caused the crack propagating 1–2 mm in the direction bisecting the internal corner of the notch, which was in the range of  $35^\circ$  to  $55^\circ$ . The length of the fracture was measured using a microscope Elcometer 900 graduated  $\times 50$ . It was not possible to identify the cycle at which the crack appeared nor its propagation rate. The apparent slight differences in the colour of surfaces in Figure 12, enlarged details, are due to the light conditions and to residues from the red liquid penetrant used to emphasise surface irregularities; in fact, all samples had the same surface finish.

In tested specimens with a sharp notch, this behaviour was observed. The nucleation of the crack happened early during the test, but throughout the entire cycling, it remained stable. It is assumed that the crack remained within the plastic zone (Figure 3), and did not grow out of it. This was confirmed by numerical modelling, which showed that the plastic zone was much deeper (20–40 mm) than the length of the cracks, which were experimentally determined in the range of 1–2 mm; see Figure 12.

All specimens with the sharp root notch exhibited full-penetration cracks propagating at 45° for a length of 1–2 mm. The crack geometry was consistent in shape for all 3 specimens. It should be noted that the propagation of cracks was very limited to the vicinity of the sharp internal corner and the length of cracks was lower than the thickness of the aluminium wall (2.5 mm). This indicates that such a situation should remain stable for the duration of the building's design service life and that repeated loading would not result in progressive collapse of such a detail. Thus, specimens with a sharp notch fulfil the requirements for the damage-tolerant design according to [21]. Buildings with such a notch design can be deemed safe for use. This reasoning does not take into account other non-structural performance requirements, such as possible breach of the air barrier, possible water penetration, or aesthetic issues related to such a crack.

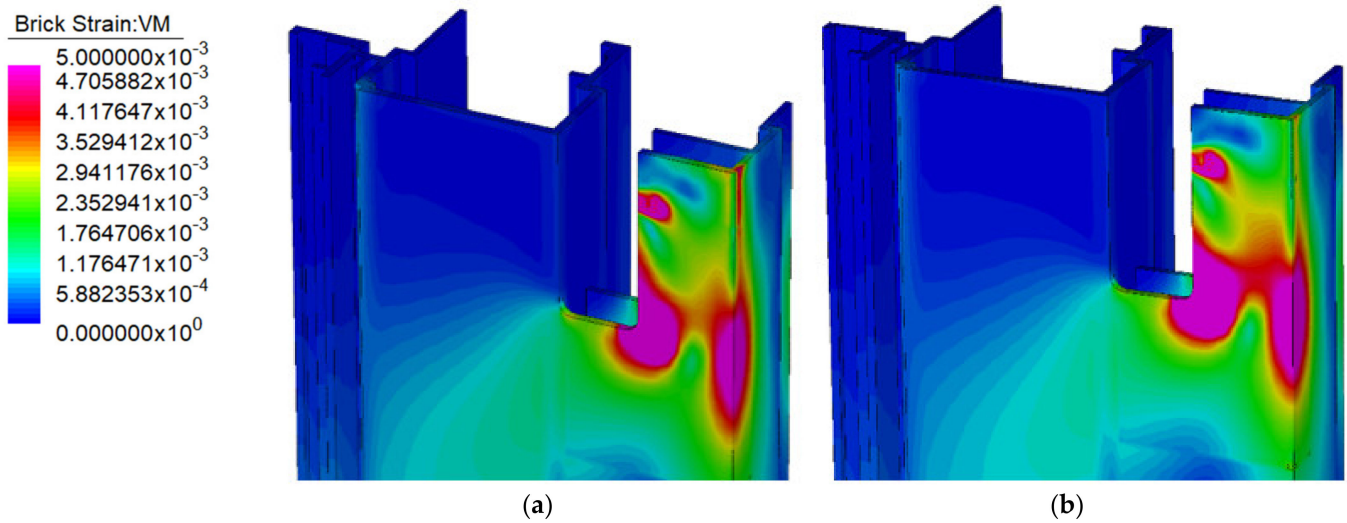
**Figure 18.** Strain in the model of the rounded notch: (a) True stress–strain curve (coupon A11), load 5.5 kN; (b) nominal stress–strain curve (alloy EN AW 6063 T6), load 5.0 kN.

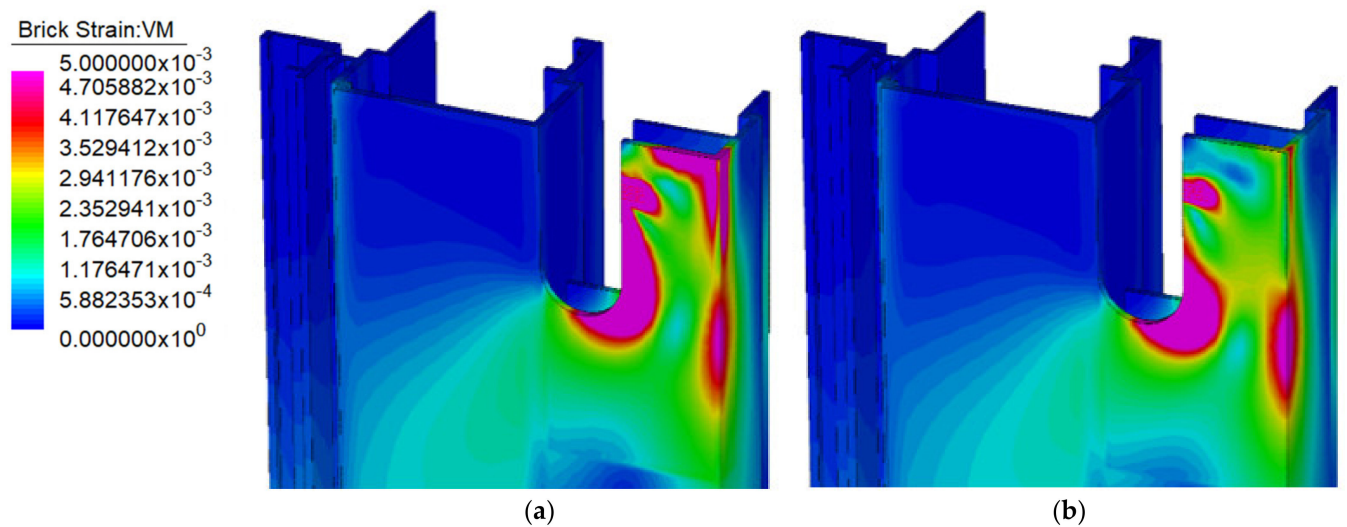
**Figure 19.** Strain in the model of the semi-circular notch 55 mm: (a) True stress–strain curve (coupon A11), load 5.5 kN; (b) nominal stress–strain curve (alloy EN AW 6063 T6), load 5.0 kN.

For the semi-circular notch, two different geometries were modelled, Figures 19 and 20. The difference between them was the total depth of the notch. Tested specimens had an initial depth of 55 mm, to which a semi-circular machining with a radius of 12.5 mm was performed, resulting in a total depth of 67.5 mm. In order to match the total depth of the other two geometries, an additional model with a semi-circular root was created, which had a total depth of 55 mm, including the semi-circular part, equal to the sharp and rounded notches. Hence, a 67.5 mm notch was representative of tested specimens, whereas a 55 mm notch had the same notch depth as other tested geometries.

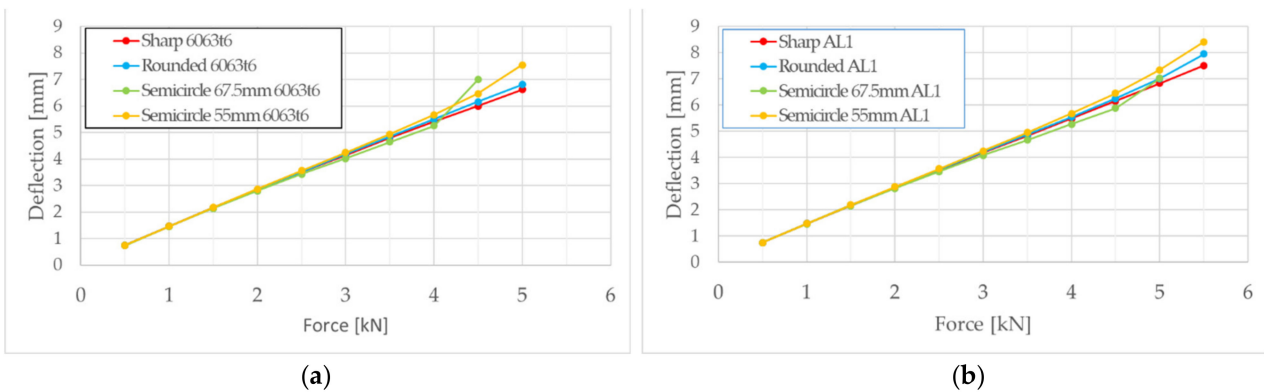
**Figure 22.** Deflection-force curves for the (a) nominal and (b) true stress–strain curves.

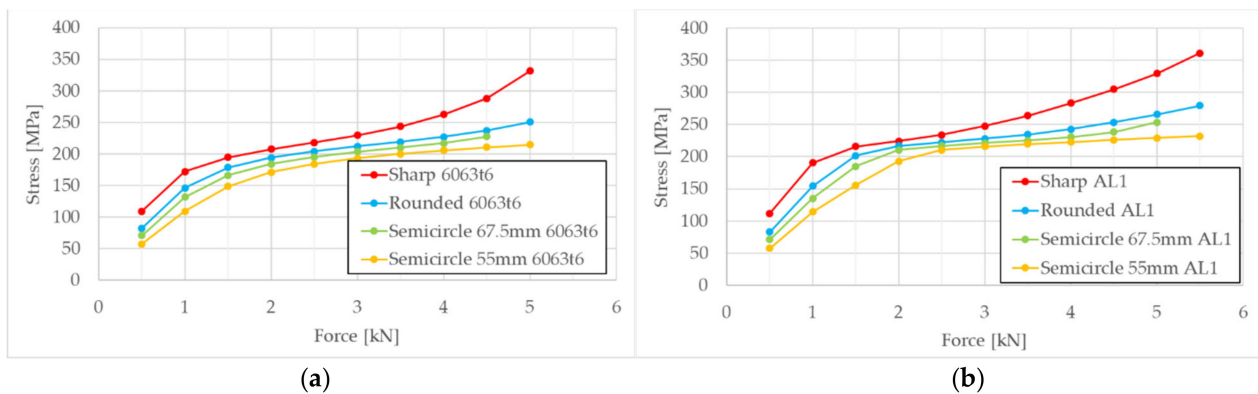
Figure 23. Von Mises stress–strain curves for the (a) nominal and (b) true stress–strain curves.
