Fatigue Behaviour of Aluminium Members with Different Notch Root Shapes

Source / Izvornik: **Buildings, 2022, 12(5)**

Keywords: notch; aluminium profile; fatigue; wind action; stress concentration; unitised curtain wall

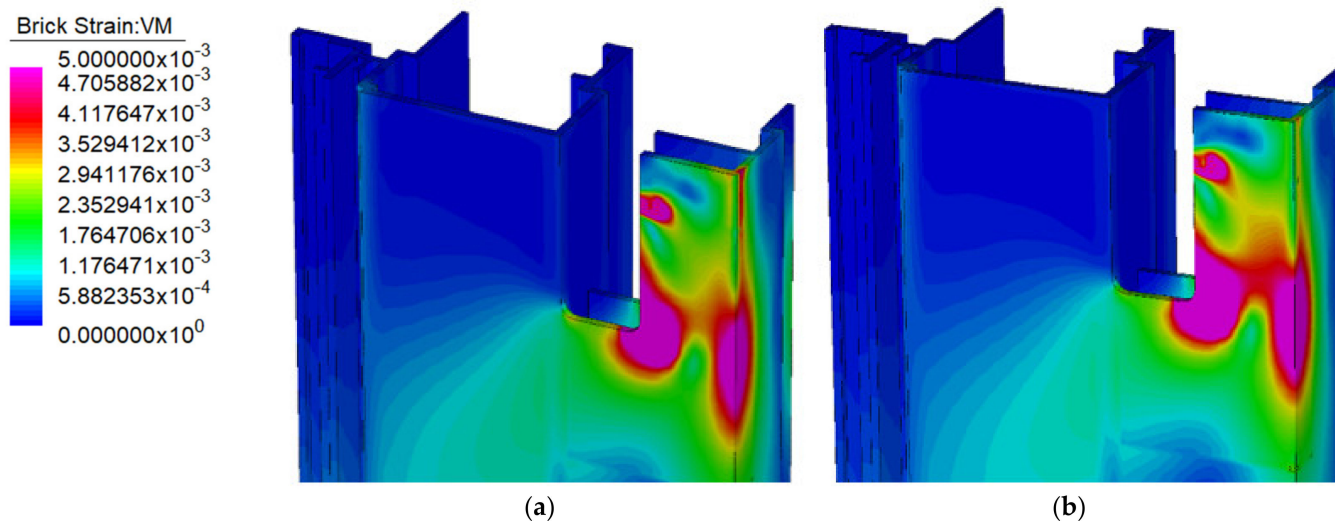
Figure 18. Strain in the model of the rounded notch: (a) True stress–strain curve (coupon A11), load 5.5 kN; (b) nominal stress–strain curve (alloy EN AW 6063 T6), load 5.0 kN.

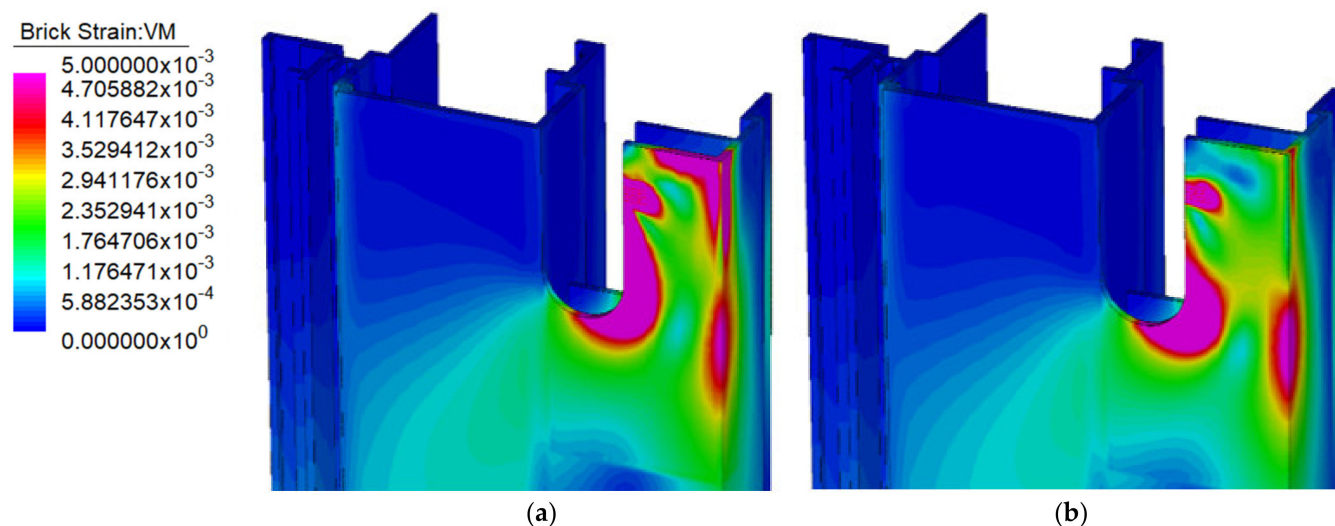
Figure 19. Strain in the model of the semi-circular notch 55 mm: (a) True stress–strain curve (coupon A11), load 5.5 kN; (b) nominal stress–strain curve (alloy EN AW 6063 T6), load 5.0 kN.

For the semi-circular notch, two different geometries were modelled, Figures 19 and 20. The difference between them was the total depth of the notch. Tested specimens had an initial depth of 55 mm, to which a semi-circular machining with a radius of 12.5 mm was performed, resulting in a total depth of 67.5 mm. In order to match the total depth of the other two geometries, an additional model with a semi-circular root was created, which had a total depth of 55 mm, including the semi-circular part, equal to the sharp and rounded notches. Hence, a 67.5 mm notch was representative of tested specimens, whereas a 55 mm notch had the same notch depth as other tested geometries.

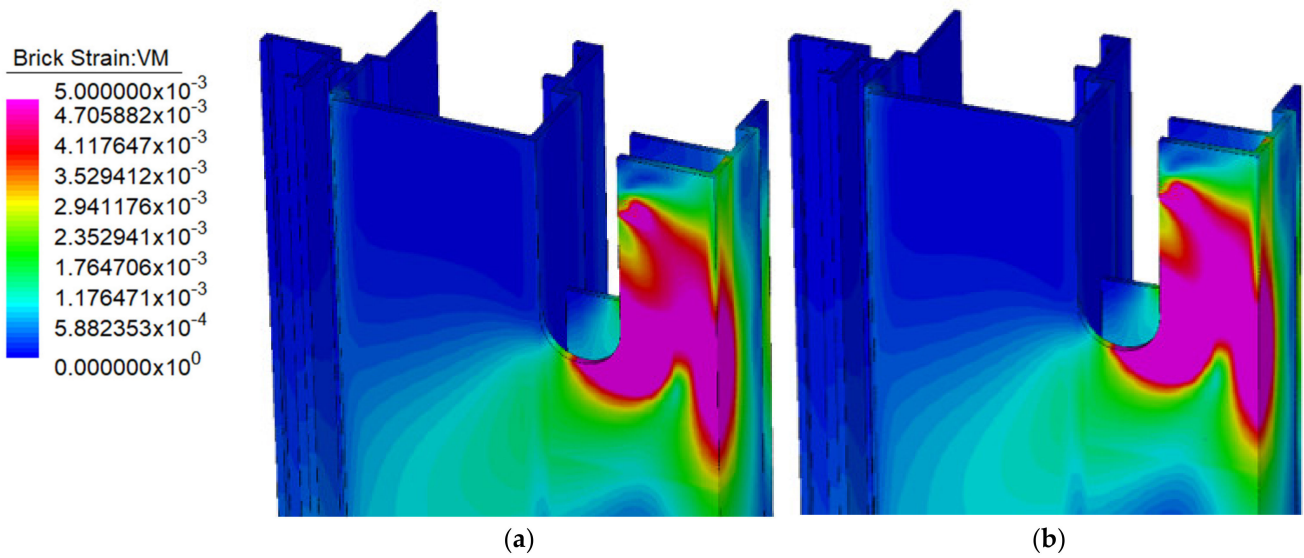
Figure 20. Strain in the model of the semi-circular notch 67.5 mm: (a) True stress–strain curve (coupon AL1), load 5.0 kN; (b) nominal stress–strain curve (alloy EN AW 6063 T6), load 4.5 kN.
