Seismic Assessment and Retrofitting of Existing Road Bridges: State of the Art Review

Journal article, Published version

Keywords: seismic assessment; retrofitting; existing road bridges; bridge assessment; Croatia earthquake; urgent strengthening

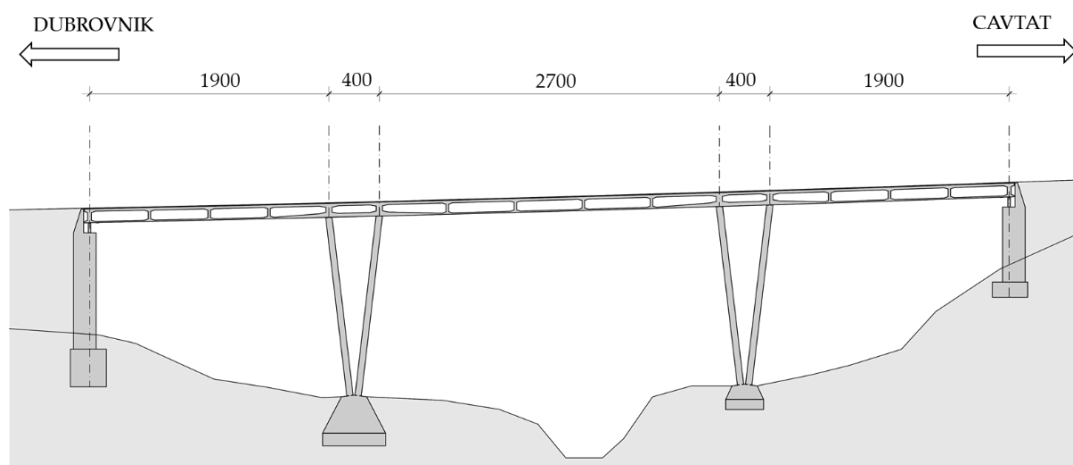
Figure 6. Longitudinal section of the first Case Study bridge (units in cm).

The first Case Study [13] bridge is a reinforced concrete bridge constructed monolithically in the 1960s. The bridge is comprised of five spans with dimensions of 19.0 + 4.0 + 27.0 + 4.0 + 19.0 m, and follows a complex road axis that features horizontal and vertical curves. The superstructure is comprised of a voided RC slab supported on V-shaped piers, visible in Figure 6; a cross-section of the slab is presented in Figure 7.

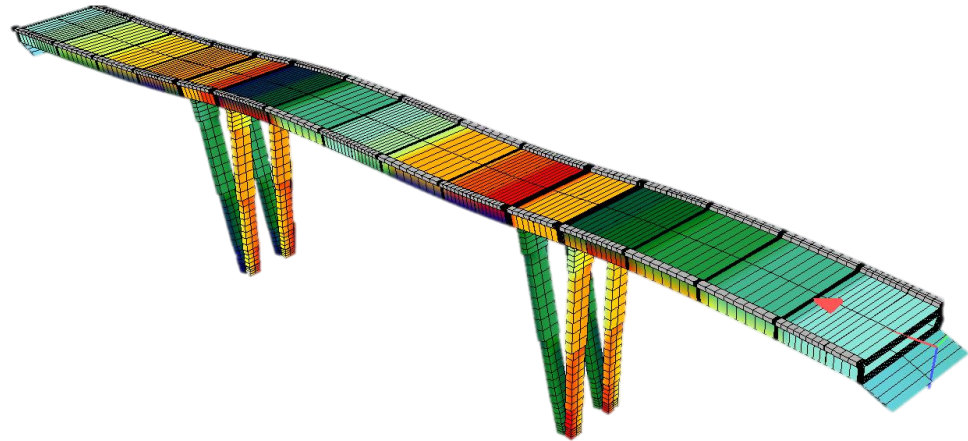
Figure 8. Numerical model of the Case Study bridge, first modal shape (longitudinal).

modal shapes were calculated; the results show that the first dominant mode is shaped as a translation in the longitudinal direction, while the second (with a smaller period) is a translation in the transverse direction. The first modal shape is presented in Figure 8, while the resulting modal parameters (periods, target displacements, and response spectrum values for obtained periods) for the first two modal shapes are provided in Table 4.

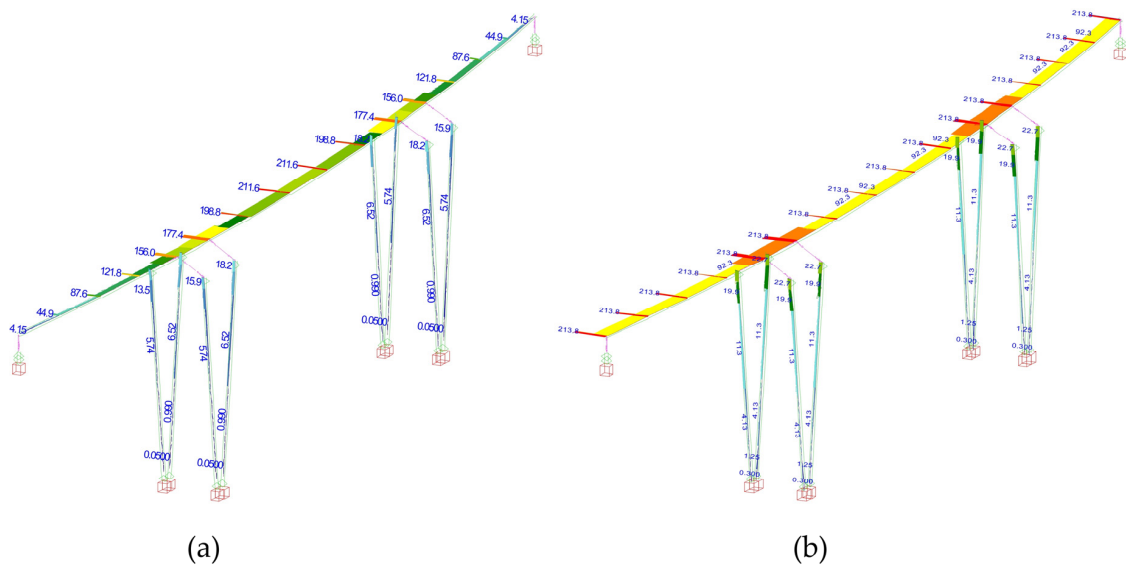
Figure 9. (a) horizontal load distribution along the superstructure; (b) horizontal load in proportion with dominant modal shape.

The target displacement for the first modal shape (Table 1) is 76 mm; while the existing expansion joint was designed to allow a maximum longitudinal displacement of 70 mm, when exceeded this would cause a collision between the superstructure and abutment wall. Therefore, the Case Study bridge was reassessed using the static nonlinear pushover analysis. A total of four cases were calculated with two types of load distributions for each direction, as presented in Figure 9 for first modal shape.

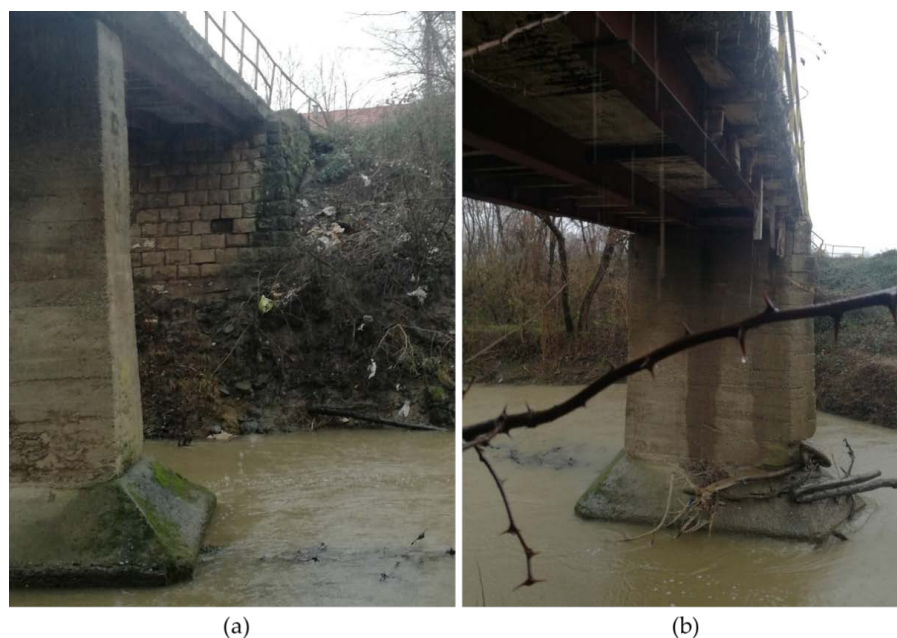
Figure 13. (a) Masonry abutment and (b) composite superstructure of the bridge to Majske Poljane.

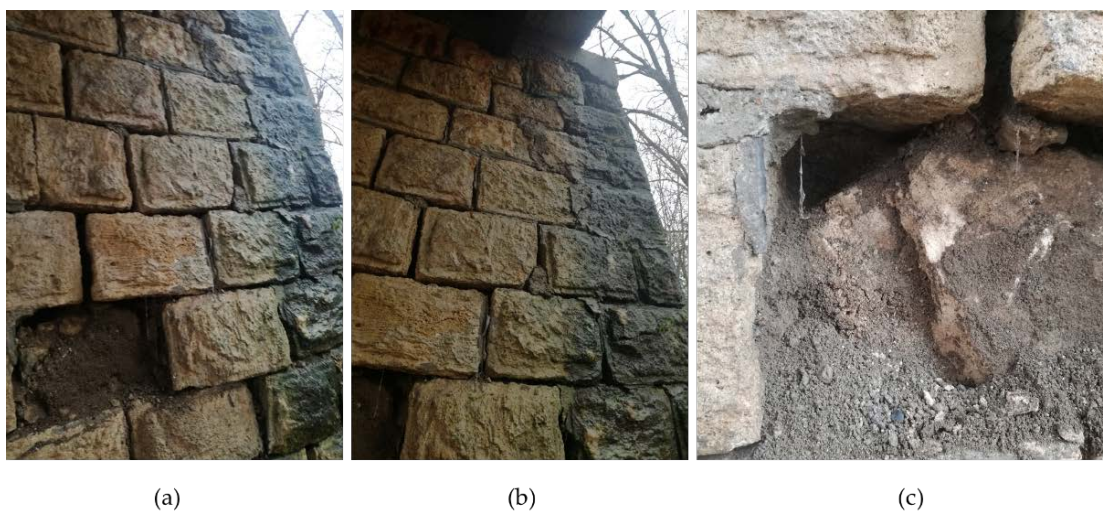
Figure 14. (a,b) Damage to the masonry walls of the abutment; (c) escarpment of infill material from the abutment.

During the visual inspection of the bridge to Majske Poljane, it was found that the masonry abutment had structural damage affecting its stability, with immediate action needed in order to allow heavy traffic over the bridge. The damage to the abutment is shown in Figure 14. The stone blocks from both the abutment wall and the wing walls were damaged and started to fall off. As the abutment was constructed as shallow with land infill that to transfer the vertical loads to the foundations, there was a danger that the collapse of the wing walls would result in the collapse of the bridge.
