Seismic Assessment and Retrofitting of Existing Road Bridges: State of the Art Review

Keywords: seismic assessment; retrofitting; existing road bridges; bridge assessment; Croatia earthquake; urgent strengthening

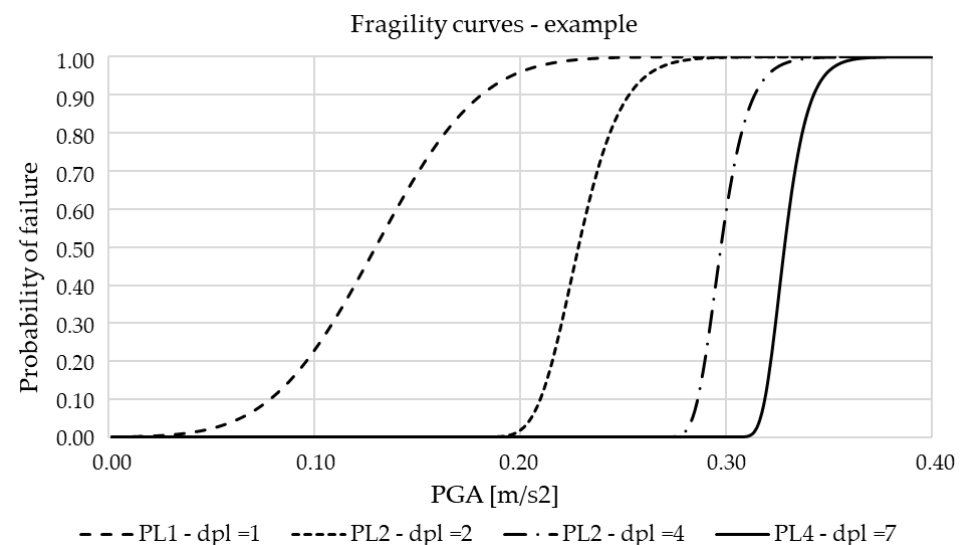
Figure 1. Example of fragility curves for bridge piers without adequate seismic capacity.

Fragility curves can be developed empirically based on historical data on past earthquakes or analytically using one of the methods listed in Table 1. The latter approach is more common, because there is insufficient data to empirically produce reliable curves [37]. Fragility curves are, in general, developed for one of the bridge components, mainly for the substructure parts, e.g., piers, abutments, and bearings. For each element, demand and capacity parameters are defined as a part of the analytical process in terms of displacements, lateral forces, rotation, etc., along with defined thresholds. A number of authors have dealt with this issue in the last two decades, as presented in detail in [37]. For example, Choi et al. [39] consider four limit states for bridge piers in terms of the damage index (d_{pl}), which is defined as a ratio between the current horizontal displacement (e.g., of the top of the pier) and a displacement at the same point in a significant cross-section (e.g., the bottom of the pier). Theoretical fragility curves based on [39] are presented in Figure 1, each for one of the defined damage states.

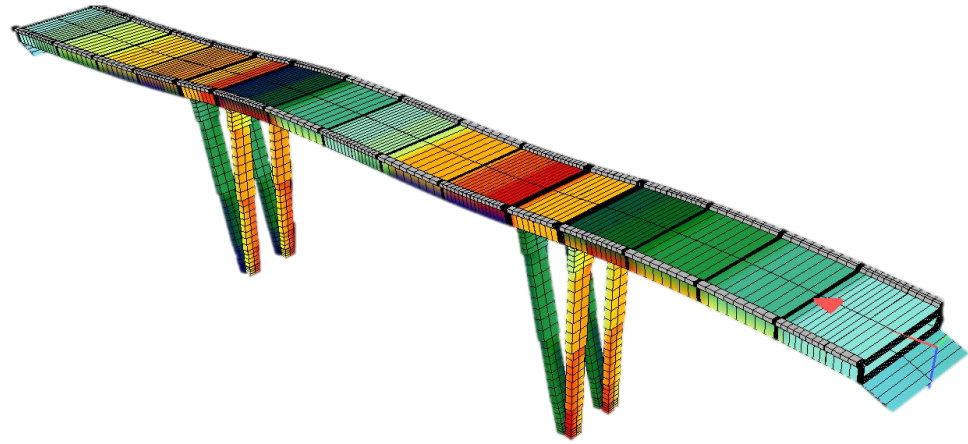
Figure 8. Numerical model of the Case Study bridge, first modal shape (longitudinal).

modal shapes were calculated; the results show that the first dominant mode is shaped as a translation in the longitudinal direction, while the second (with a smaller period) is a translation in the transverse direction. The first modal shape is presented in Figure 8, while the resulting modal parameters (periods, target displacements, and response spectrum values for obtained periods) for the first two modal shapes are provided in Table 4.

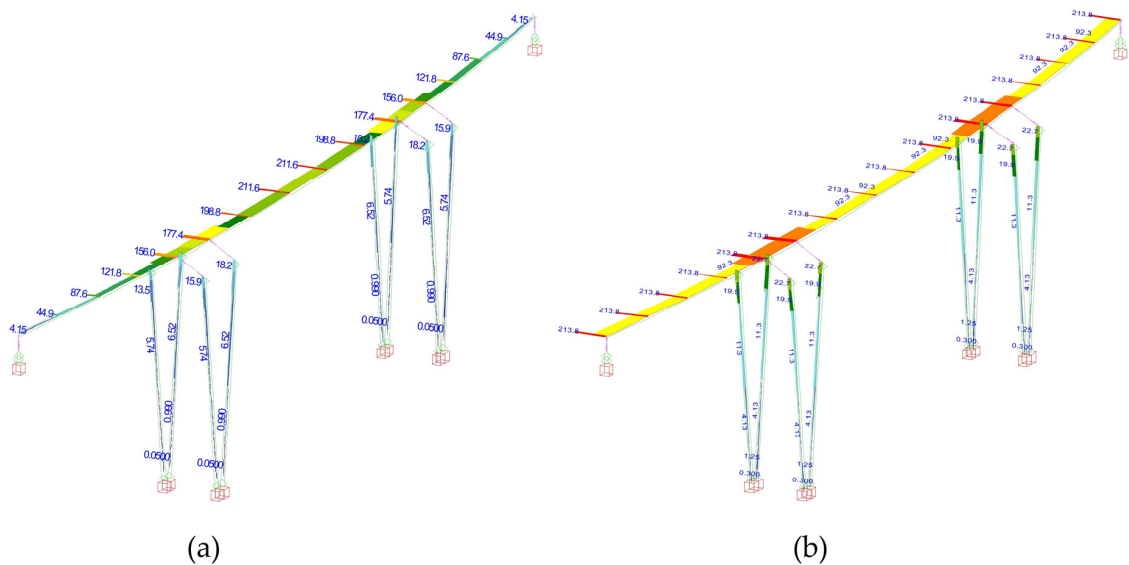
Figure 9. (a) horizontal load distribution along the superstructure; (b) horizontal load in proportion with dominant modal shape.

The target displacement for the first modal shape (Table 1) is 76 mm; while the existing expansion joint was designed to allow a maximum longitudinal displacement of 70 mm, when exceeded this would cause a collision between the superstructure and abutment wall. Therefore, the Case Study bridge was reassessed using the static nonlinear pushover analysis. A total of four cases were calculated with two types of load distributions for each direction, as presented in Figure 9 for first modal shape.
