# Influence of Stray Current on Fastening System Components in Urban Railway Tracks

Vranešić, Katarina; Lakušić, Stjepan; Serdar, Marijana

Source / Izvornik: **Applied Sciences**, 2023, 13

**Journal article, Published version**

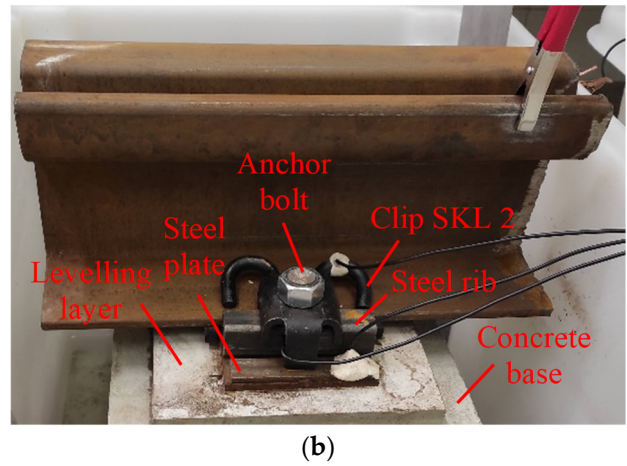
Figure 2. Fastening system ZG 3/2: (a) cross section and (b) sample for testing.

Laboratory tests were performed on four different types of fastening systems that are characteristic of the tram track infrastructure in Zagreb: ZG 3/2, PPE, DEPP, and ZG 21-CTT. ZG 3/2 and PPE are direct fastening systems, where the rails are laid on elastic rail pads and steel plates and fastened using clips and anchor bolts (Figures 2 and 3). Anchor bolts were used to anchor the fastening system to a concrete base. In the PPE fastening system, an elastomer pad was placed between the steel plate and the leveling layer, whereas in the ZG 3/2 fastening system, the steel plate was in direct contact with the leveling layer. In the ZG 3/2 fastening system, the SKL-2 clip was placed on a steel rib, whereas in the PPE fastening system, the SKL-1 clip was placed on a plastic rib.

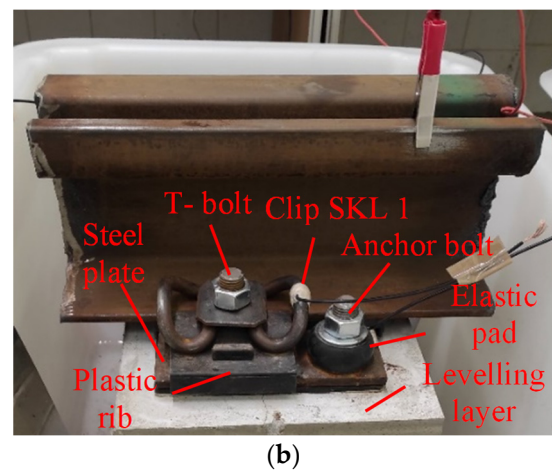
Figure 4. Fastening system DEPP: (a) cross section and (b) sample for testing.

In the DEPP and Zagreb 21-CTT fastening systems, the rails are laid on the rail pad and steel plate but are fastened to the steel plate using clips and T-bolts (Figures 4 and 5). The anchor bolts are dislocated and used only to anchor the fastening system to the concrete base. In the Zagreb 21-CTT fastener, the underside of the steel plate is vulcanized. The bores for the anchor bolts on the steel plate are also vulcanized such that the anchor bolts do not directly contact the steel plate (Figure 5a).

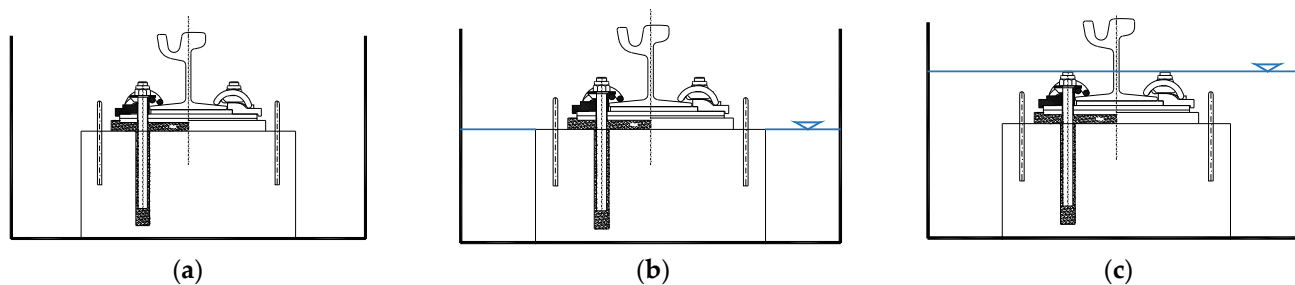
**Figure 7.** Different water levels in which the samples were immersed: (a) dry condition, (b) water level to the top of the concrete block, and (c) immersed condition.

- The samples are dry (Figure 7a),
- Water on the top of the concrete base (Figure 7b)
- In the immersed condition: the water level was half the height of the neck of the rail (Figure 7c).

Different water levels simulate different conditions that can occur on tram tracks. In tracks embedded in lanes shared by road vehicles, the drying process is very slow; therefore, the concrete base is wet for most of the year. These conditions were simulated using the water level at the top of the concrete base. If track drainage is inadequate, water will remain in the track, resulting in direct contact between the rail and the fastening system with the electrolyte. These conditions were simulated by immersing the samples in water to half the height of the neck of the rail. Before immersing the samples in water, the electrical conductivity of water was measured using an SI Analytics Lab 945 conductometer. The electrical conductivity of water was 0.0775 S/m. The electrical conductivity of water affects the electrical resistance of the entire sample. Therefore, it is important that the conductivity of water be the same in all samples. Notably, the electrical resistance of the water retained in the track structure depends on the substances dissolved in the water, mainly salt. This experiment can also be performed using water containing dissolved salts to accelerate the corrosion process. However, because the aim of this study was to determine the influence of stray currents on rails and fasteners, the experiment was carried out with tap water with a defined electrical conductivity.

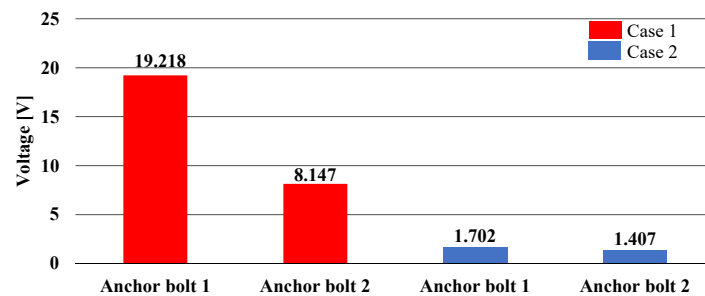
**Figure 9.** Measured voltages in anchor bolts for cases 1 and 2 for the DEPP fastening system.

The measured voltages are shown in Figure 9. After removing the elastic pads from the anchor bolts (case 2), the voltage in the anchor bolts was 1.7 V on bolt 1 and 1.4 V on bolt 2, indicating that the electrical connection between the anchor bolt and steel plate was established through the elastomer pad.

In addition, notably, a large difference was observed between the voltages measured in Case 1 for anchor bolts 1 and 2 (Figure 9), even though the anchor bolts were connected to the steel plates with the same type of nuts and elastic pads. The electrical resistance of the elastic pads was measured to determine whether the different resistance values were responsible for the different voltages in the anchor bolts. The resistance of the elastic pad for anchor bolt 1 was 2.29 k $\Omega$ , and the resistance of the pad for anchor bolt 2 was 1980.28 k $\Omega$ , which confirmed the original assumption that the differing values of the electrical resistance of the elastic pads caused the difference in the measured voltages in the anchor bolts.

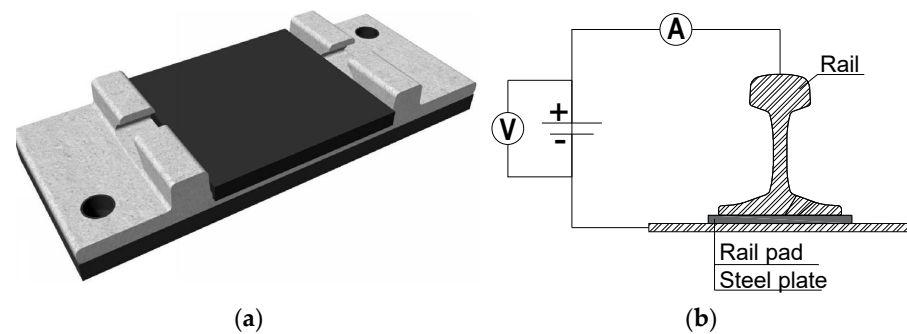
**Figure 10.** (a) Vulcanized steel plate for the Zagreb 21-CTT fastening system with the rail pad. (a) Cross section of the Zagreb 21-CTT fastening system in contact with the steel plate and anchor bolt CTT. (b) Current circuit during the measurement of the electrical resistance of the rail pad.

In the Zagreb 21-CTT fastening system, the underside of the steel plate and bores for the anchor bolts at the plate were vulcanized (Figure 10a) to prevent current from leaking from the steel plate to the anchor bolts and lower parts of the track. Because the steel plate of the Zagreb 21-CTT fastening system is vulcanized, the anchor bolts should be isolated from the plate. However, a high voltage was detected in anchor bolt 2. All elastomer elements of the Zagreb 21-CTT fastening system were made of the same material during vulcanization. To determine the electrical resistivity of the material, measurements were performed using a GWInstek GDM9061 multimeter and a direct-current source on the rail pad. The rail pad was placed between the steel plate and rail. The rail was connected to the positive terminal of the current source, and the steel plate was connected to the negative terminal (Figure 10b). The current and voltage were measured using a multimeter, and the calculated electrical resistivity of the rail pad was 1.14 k $\Omega$ m. The low electrical resistivity of the elastomer elements in the Zagreb 21-CTT fastening system resulted in a current flow from the steel plate to the anchor bolts, which led to a high voltage detected in the anchor bolts.

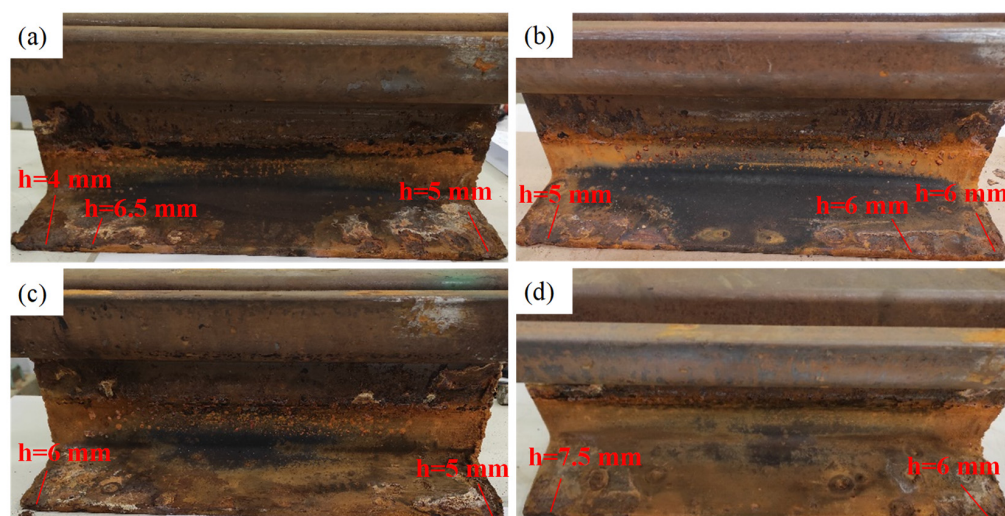
**Figure 12.** Condition of the rails after testing was completed: (a) ZG 3/2, (b) PPE, (c) DEPP, (d) Zagreb 21-CTT.

In all samples, material loss occurred at the edges of the rail foot. Figure 12 shows the conditions of the rails after the completion of the test. The measured minimum dimensions of rail foot height are shown in the figures. At the measured locations, the reference height of the rail foot was 8 mm, indicating that corrosion caused thinning of the rail foot by up to 4 mm for the ZG 3/2 fastening system, 3 mm for the PPE and DEPP fastening systems, and 2 mm for the Zagreb 21-CTT fastening system.

- Low corrosion level: thinning of the rail foot up to maximum 1 mm,
- Medium corrosion level: thinning of the rail foot from 1 to 3 mm, and
- High corrosion level: thinning of the rail foot of more than 3 mm.
