Influence of Stray Current on Fastening System Components in Urban Railway Tracks

Source / Izvornik: **Applied Sciences**, 2023, 13

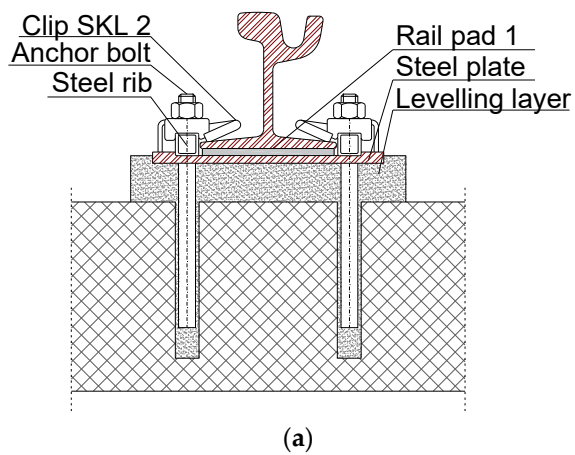
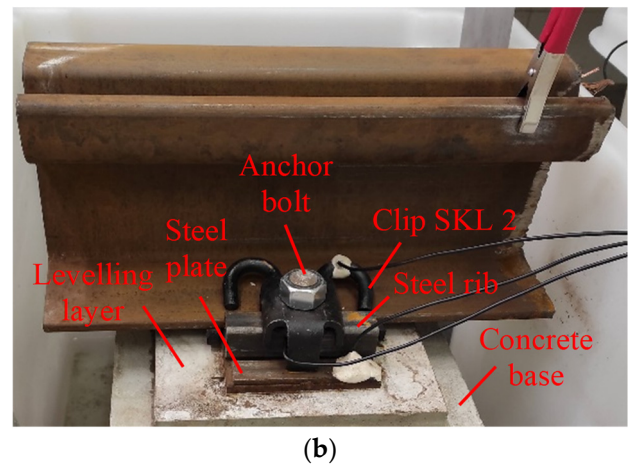
Figure 2. Fastening system ZG 3/2: (a) cross section and (b) sample for testing.

Laboratory tests were performed on four different types of fastening systems that are characteristic of the tram track infrastructure in Zagreb: ZG 3/2, PPE, DEPP, and ZG 21-CTT. ZG 3/2 and PPE are direct fastening systems, where the rails are laid on elastic rail pads and steel plates and fastened using clips and anchor bolts (Figures 2 and 3). Anchor bolts were used to anchor the fastening system to a concrete base. In the PPE fastening system, an elastomer pad was placed between the steel plate and the leveling layer, whereas in the ZG 3/2 fastening system, the steel plate was in direct contact with the leveling layer. In the ZG 3/2 fastening system, the SKL-2 clip was placed on a steel rib, whereas in the PPE fastening system, the SKL-1 clip was placed on a plastic rib.

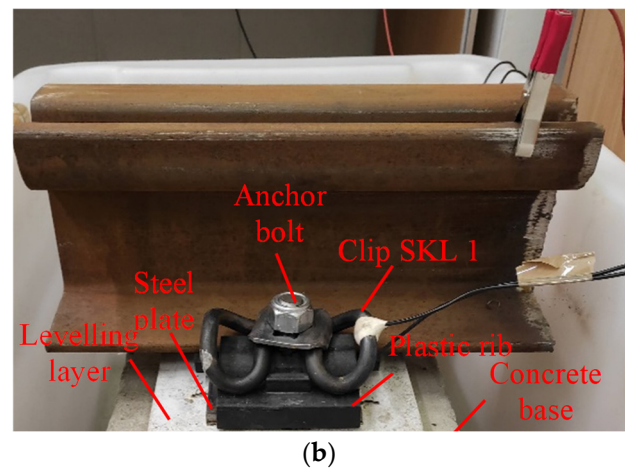
Figure 3. Fastening system PPE: (a) cross section and (b) sample for testing.

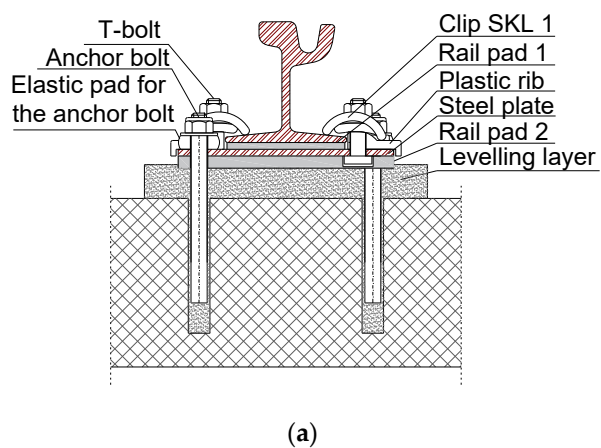
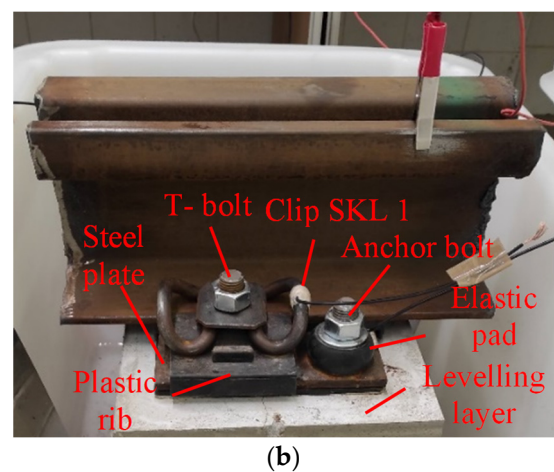
Figure 4. Fastening system DEPP: (a) cross section and (b) sample for testing.

In the DEPP and Zagreb 21-CTT fastening systems, the rails are laid on the rail pad and steel plate but are fastened to the steel plate using clips and T-bolts (Figures 4 and 5). The anchor bolts are dislocated and used only to anchor the fastening system to the concrete base. In the Zagreb 21-CTT fastener, the underside of the steel plate is vulcanized. The bores for the anchor bolts on the steel plate are also vulcanized such that the anchor bolts do not directly contact the steel plate (Figure 5a).

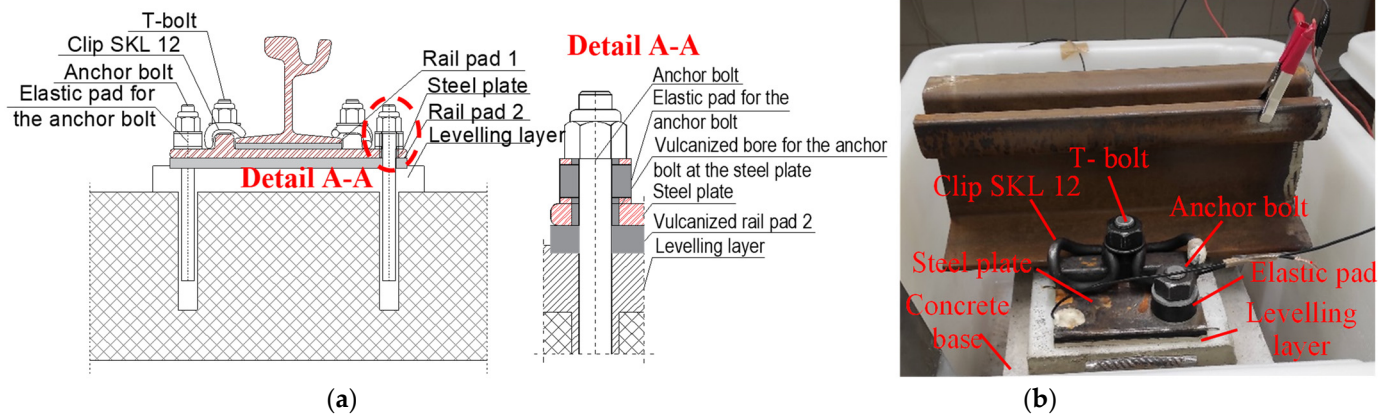
Figure 5. Fastening system Zagreb 21-CTT: (a) cross section and (b) sample for testing.

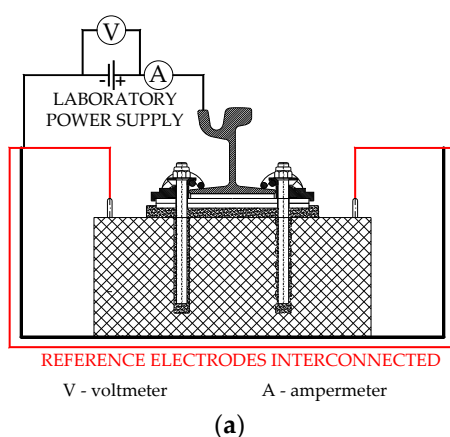
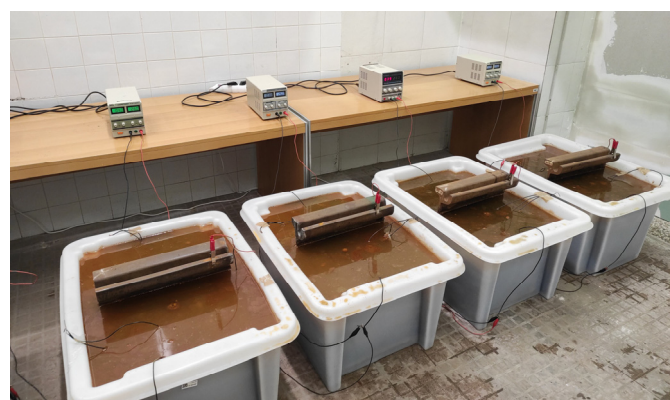
Figure 6. (a) Current circuit during testing and (b) samples during testing.

The samples were placed in plastic tubes and treated with a DC current from a laboratory power supply. Each sample was connected to a separate DC source. A voltage of 26 V was applied to the samples, and the current value depended on their electrical resistance. The rail was connected to the positive terminal of the power supply, and the circuit was closed using a steel rib built into the concrete (Figure 6a). In this circuit, current flows into the rail and fastening system and through the electrolyte (in these cases, concrete or water) back to the negative terminal of the power supply.

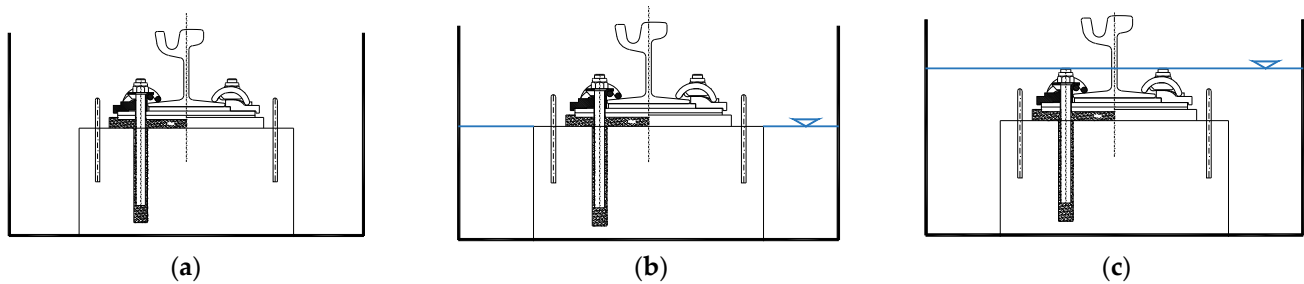
Figure 7. Different water levels in which the samples were immersed: (a) dry condition, (b) water level to the top of the concrete block, and (c) immersed condition.

- The samples are dry (Figure 7a),
- Water on the top of the concrete base (Figure 7b)
- In the immersed condition: the water level was half the height of the neck of the rail (Figure 7c).

Different water levels simulate different conditions that can occur on tram tracks. In tracks embedded in lanes shared by road vehicles, the drying process is very slow; therefore, the concrete base is wet for most of the year. These conditions were simulated using the water level at the top of the concrete base. If track drainage is inadequate, water will remain in the track, resulting in direct contact between the rail and the fastening system with the electrolyte. These conditions were simulated by immersing the samples in water to half the height of the neck of the rail. Before immersing the samples in water, the electrical conductivity of water was measured using an SI Analytics Lab 945 conductometer. The electrical conductivity of water was 0.0775 S/m. The electrical conductivity of water affects the electrical resistance of the entire sample. Therefore, it is important that the conductivity of water be the same in all samples. Notably, the electrical resistance of the water retained in the track structure depends on the substances dissolved in the water, mainly salt. This experiment can also be performed using water containing dissolved salts to accelerate the corrosion process. However, because the aim of this study was to determine the influence of stray currents on rails and fasteners, the experiment was carried out with tap water with a defined electrical conductivity.

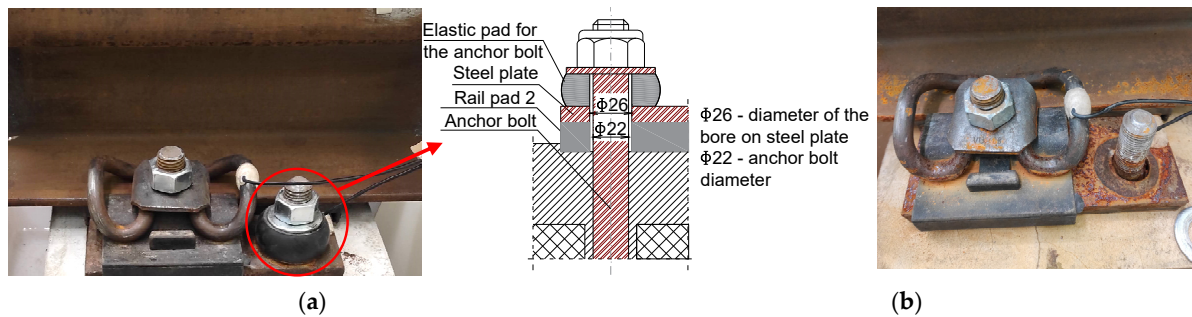
Figure 8. DEPP fastening system: (a) Case 1: elastic pad and nut at the anchor bolt. (b) Case 2: elastic pad and nut removed from the anchor bolts.

- Case 1: Elastic pads and nuts were placed on the anchor bolts (Figure 8a).
- Case 2: The elastic pads and nuts were removed from the anchor bolts (Figure 8b).

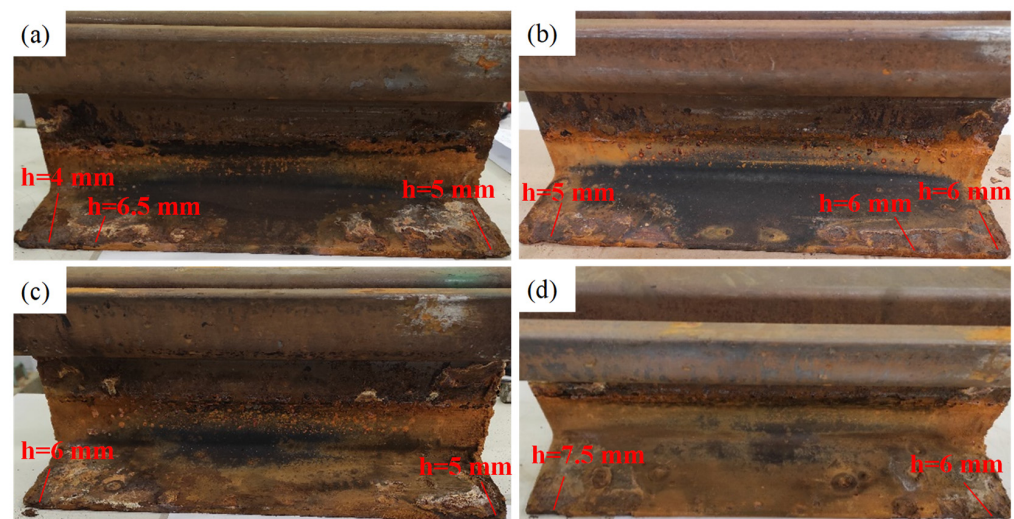
Figure 12. Condition of the rails after testing was completed: (a) ZG 3/2, (b) PPE, (c) DEPP, (d) Zagreb 21-CTT.

In all samples, material loss occurred at the edges of the rail foot. Figure 12 shows the conditions of the rails after the completion of the test. The measured minimum dimensions of rail foot height are shown in the figures. At the measured locations, the reference height of the rail foot was 8 mm, indicating that corrosion caused thinning of the rail foot by up to 4 mm for the ZG 3/2 fastening system, 3 mm for the PPE and DEPP fastening systems, and 2 mm for the Zagreb 21-CTT fastening system.

The dimensions of the rail base surface affected by corrosion and the depth of the corrosion damage were measured for each rail sample. For each corrosion damage point, the corrosion level was classified as follows:

- Low corrosion level: thinning of the rail foot up to maximum 1 mm,
- Medium corrosion level: thinning of the rail foot from 1 to 3 mm, and
- High corrosion level: thinning of the rail foot of more than 3 mm.

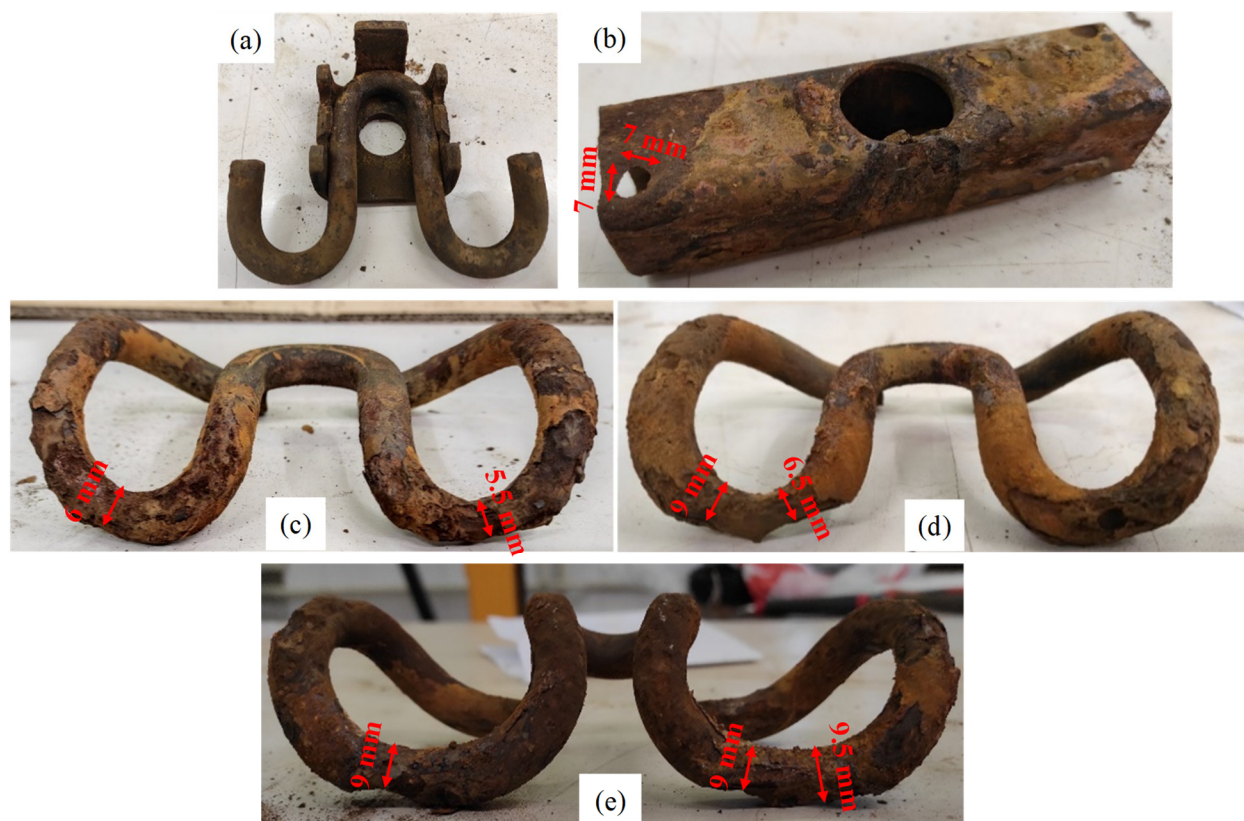
Figure 13. Condition of clips and steel rib after testing was completed: (a) ZG 3/2-clip, (b) ZG 3/2-steel rib, (c) PPE, (d) DEPP, (e) Zagreb 21-CTT.

For the PPE, DEPP, and Zagreb 21-CTT fastening systems, corrosion was observed at the lowest part of the clips. For the PPE fastening system, the maximum reduction in the clip cross section was from 13 mm to 5.5 mm. For the DEPP fastening system, the cross section of the clips decreased from 13 mm to 6.5 mm, and for the Zagreb 21-CTT fastening system, the current resulted in a reduction of the cross section from 13 mm to 9 mm. In the case of the ZG 3/2 fastening system, no corrosion was observed on the clips. However, severe corrosion deterioration was observed on the steel rib in direct contact with the clip. Therefore, it was assumed that the current flowed from the clip into the steel rib and from the steel rib into the electrolyte (water). Because the same type of deterioration was observed in both clips of each tested sample, the condition of one clip from each sample after the test was completed is shown in Figure 13. In addition, the condition of the steel rib after the completion of the test is shown for the ZG 3/2 fastening system.

The percentage of cross-sectional thinning of the clips at the points of most severe clip degradation was calculated using the reference diameter and the diameter measured after completion of the laboratory test. Based on the corrosion percentage, the corrosion level was classified as follows:

- Low corrosion level: cross-sectional thinning of up to 25%
- Medium corrosion level: cross-sectional thinning of 25% to 50%
- High corrosion level: cross-sectional thinning of more than 50%.

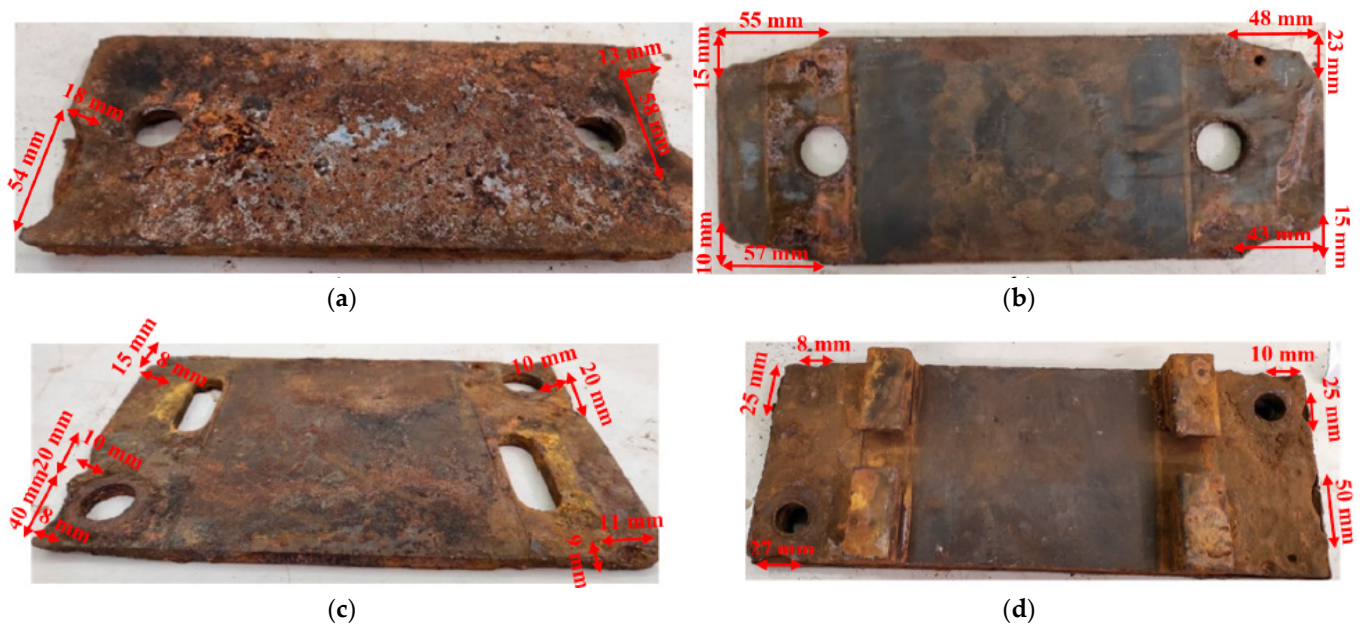
Figure 14. Condition of the steel plate after testing was completed: (a) ZG 3/2, (b) PPE, (c) DEPP, and (d) Zagreb 21-CTT.

After the samples were disassembled, a massive deterioration of the steel plate at the edges was also noted. The conditions of the steel plate after the completion of the test are shown in Figure 14. The dimensions of the corroded areas are defined for each steel plate.

Corrosion of the steel plate was detected at the edge of the plate for all test samples. The percentage of corroded surfaces was calculated for each test sample (Table 6). Owing to the large dimensions of the plate, the corroded area was very small. Thus, the corrosion was classified as follows:

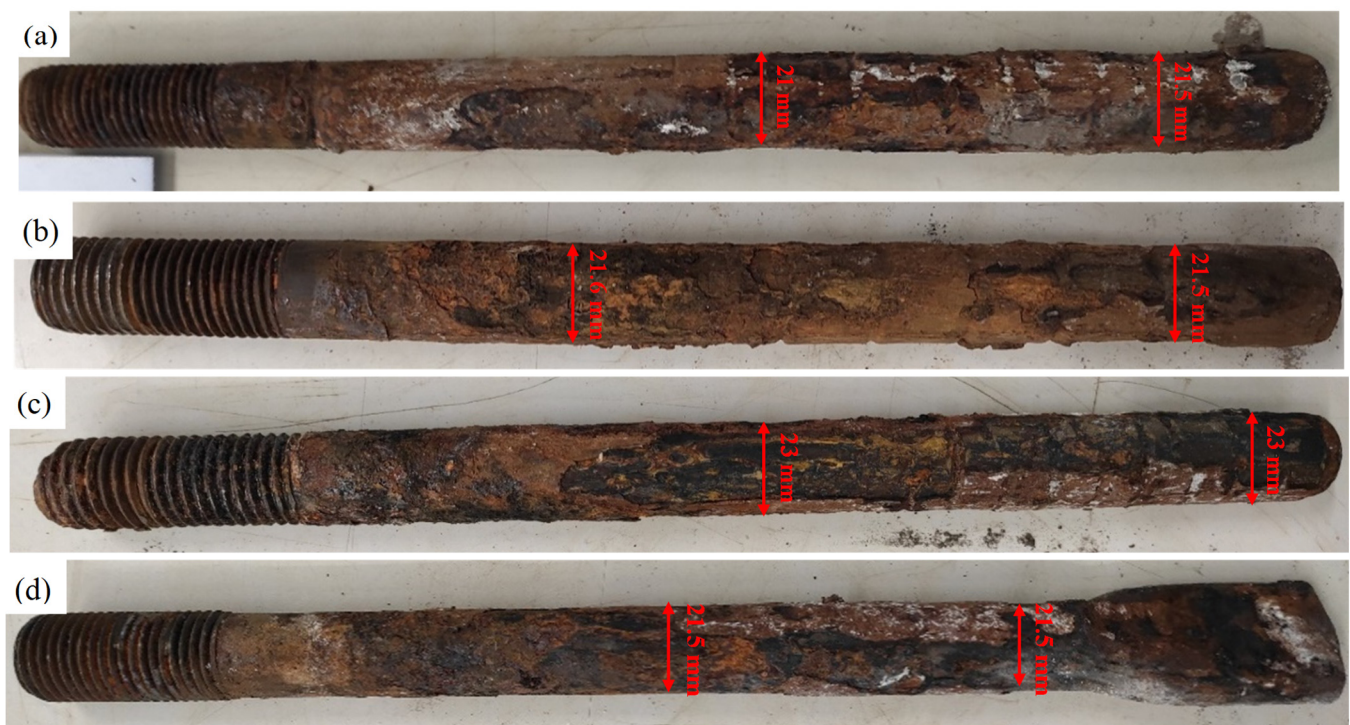
Figure 15. Condition of the anchor bolts after testing was completed: (a) ZG 3/2, (b) PPE, (c) DEPP, and (d) Zagreb 21-CTT.

The conditions of the anchor bolts were also analyzed after the completion of the test. Corrosion was observed on the parts of the anchors that were in contact with concrete. Figure 15 shows the condition of one anchor from each sample after completion of the test.

Because the anchor bolts are built in concrete, in addition to the corrosion area and thinning of the anchor cross section, the cracks observed in the leveling layer and in the concrete base (Figure 11) are also considered for the corrosion classification. The percentage of anchor bolt diameter thinning was calculated for all samples, as listed in Table 7. The corrosion damage was classified as follows:

- Low corrosion level: corroded surface up to 10%, small cracks in the concrete, no cross-sectional thinning of the anchor bolt
- Medium corrosion level: corroded surface from 10 to 20%, small or medium cracks in the concrete, cross-sectional thinning up to 0.5 mm, and
- High corrosion level: corroded surface of more than 20%, large or medium cracks in the concrete, cross-sectional thinning of 0.5 to 1 mm.
