# Influence of Stray Current on Fastening System Components in Urban Railway Tracks

Source / Izvornik: **Applied Sciences**, 2023, 13

**Journal article, Published version**

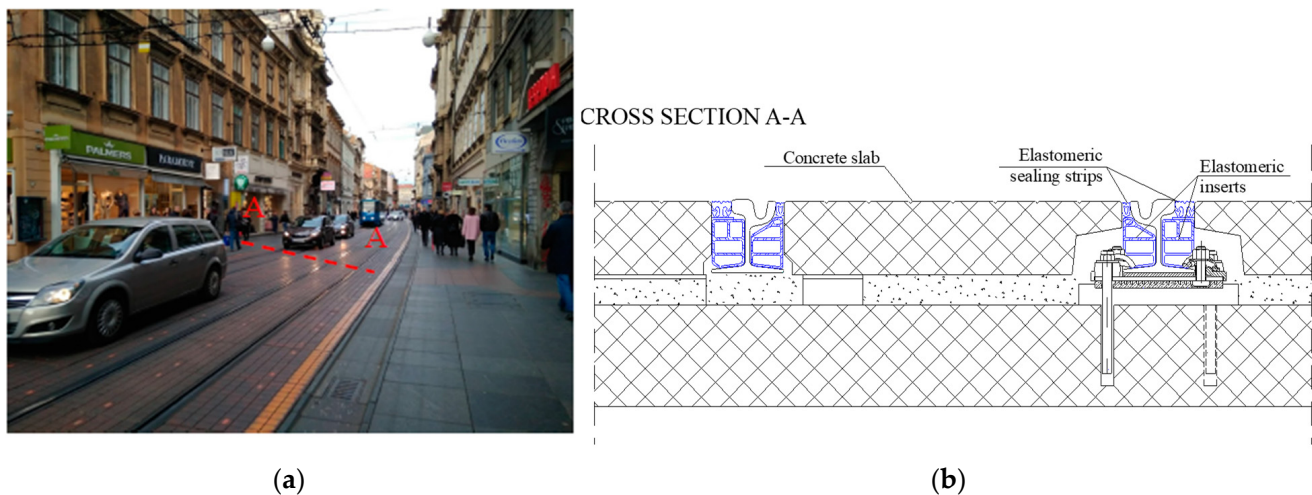
**Figure 1.** (a) Paved tram track structure in Zagreb, Croatia, built as part of the road surface, as a discretely fastened track and its (b) cross section.

According to [35], the rail-to-ground resistance is required to control the stray current. The resistance depends on the type of track and rail insulation [17]. For tracks with continuously supported and fastened rails, where the rails are fully insulated with an elastic material, a high rail-to-ground resistance is achieved and stray current is prevented. For tracks with discretely supported and fastened rails, it is very difficult to ensure sufficient resistance between the rail and ground; therefore, stray currents can greatly affect the track and metal objects near the track. Because the type and properties of fastening systems are selected depending on the required elasticity of the track, planned traffic load, and type of rail [48], the electrical resistance of the fastening system is not defined in the specifications. According to [36,42], even perfect rail insulation lasts only a few years if the tracks are not properly maintained; therefore, rail-to-ground resistance depends on the electrical resistance of the concrete base layer and the soil, which can vary greatly depending on the location of the tracks. Consequently, the rail-to-ground resistance values provided in the guidelines vary across countries for the same type of track construction, as shown in [49,50]. The corrosion rate and stray current are higher in closed urban tracks because it is very difficult to provide adequate drainage, and the tracks dry very slowly. Thus, the remaining water accelerates the corrosion and stray current. Urban tracks embedded in lanes shared by road vehicles (Figure 1a,b) are also exposed to chlorides that are used in winter to prevent icing of the pavement [29]. These chlorides dissolve in water and enter the tracks [30], which results in a decrease in the electrical resistance between the rail and ground.

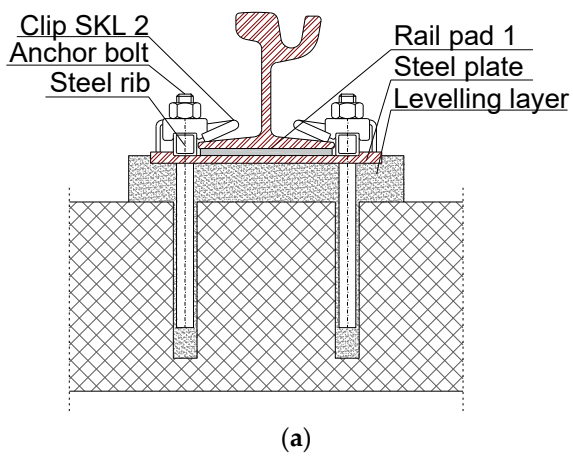
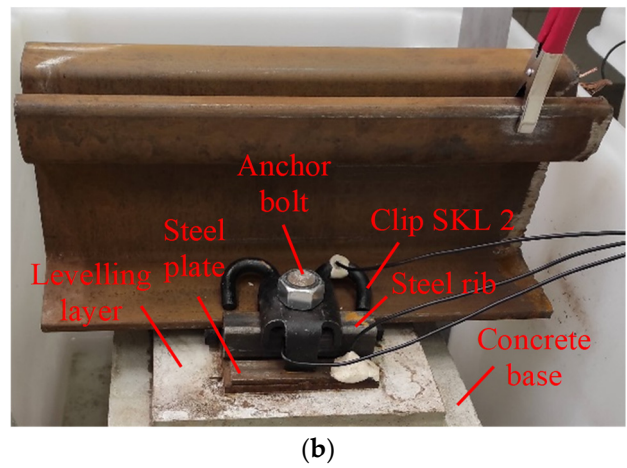
Figure 2. Fastening system ZG 3/2: (a) cross section and (b) sample for testing.

Laboratory tests were performed on four different types of fastening systems that are characteristic of the tram track infrastructure in Zagreb: ZG 3/2, PPE, DEPP, and ZG 21-CTT. ZG 3/2 and PPE are direct fastening systems, where the rails are laid on elastic rail pads and steel plates and fastened using clips and anchor bolts (Figures 2 and 3). Anchor bolts were used to anchor the fastening system to a concrete base. In the PPE fastening system, an elastomer pad was placed between the steel plate and the leveling layer, whereas in the ZG 3/2 fastening system, the steel plate was in direct contact with the leveling layer. In the ZG 3/2 fastening system, the SKL-2 clip was placed on a steel rib, whereas in the PPE fastening system, the SKL-1 clip was placed on a plastic rib.

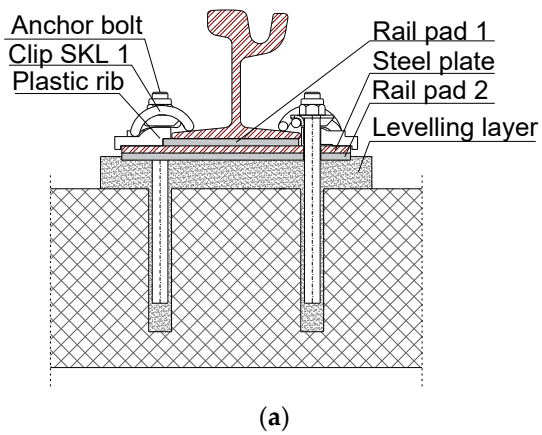
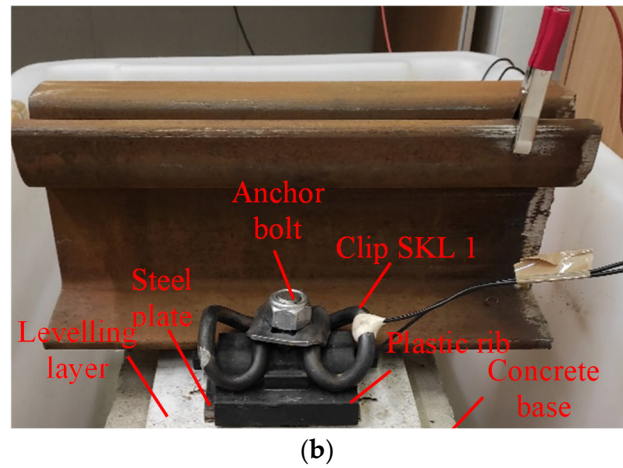
Figure 3. Fastening system PPE: (a) cross section and (b) sample for testing.

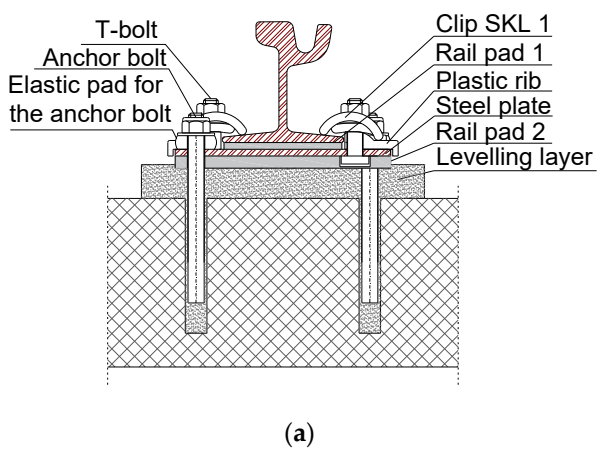
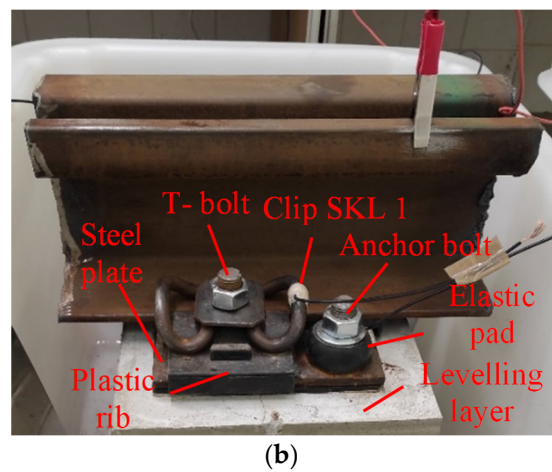
Figure 4. Fastening system DEPP: (a) cross section and (b) sample for testing.

In the DEPP and Zagreb 21-CTT fastening systems, the rails are laid on the rail pad and steel plate but are fastened to the steel plate using clips and T-bolts (Figures 4 and 5). The anchor bolts are dislocated and used only to anchor the fastening system to the concrete base. In the Zagreb 21-CTT fastener, the underside of the steel plate is vulcanized. The bores for the anchor bolts on the steel plate are also vulcanized such that the anchor bolts do not directly contact the steel plate (Figure 5a).

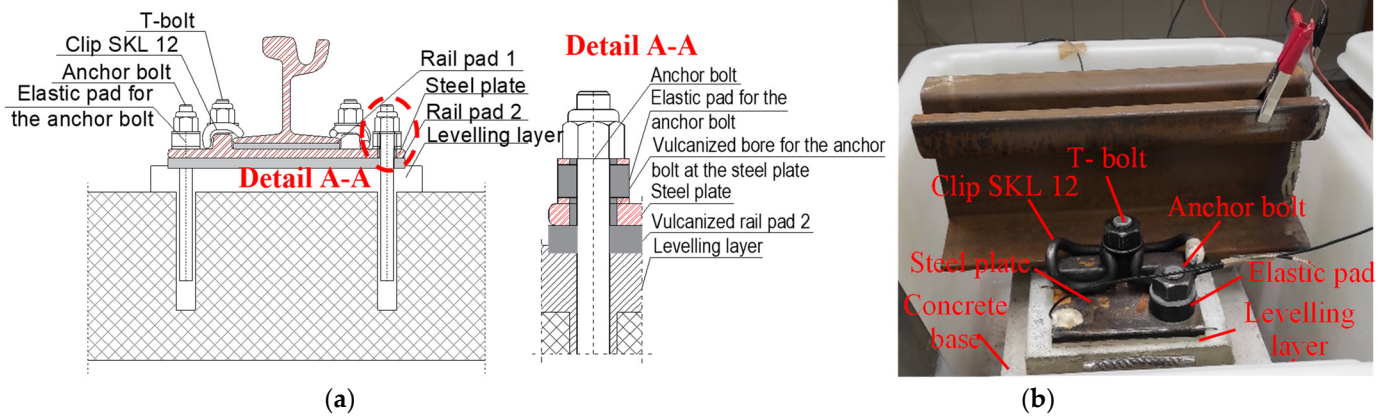
Figure 5. Fastening system Zagreb 21-CTT: (a) cross section and (b) sample for testing.

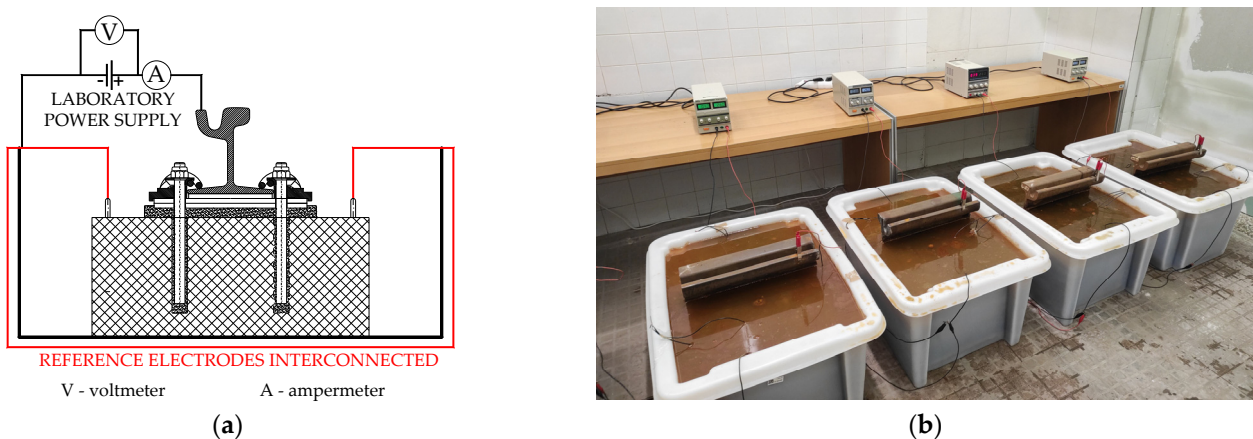
Figure 6. (a) Current circuit during testing and (b) samples during testing.

The samples were placed in plastic tubes and treated with a DC current from a laboratory power supply. Each sample was connected to a separate DC source. A voltage of 26 V was applied to the samples, and the current value depended on their electrical resistance. The rail was connected to the positive terminal of the power supply, and the circuit was closed using a steel rib built into the concrete (Figure 6a). In this circuit, current flows into the rail and fastening system and through the electrolyte (in these cases, concrete or water) back to the negative terminal of the power supply.

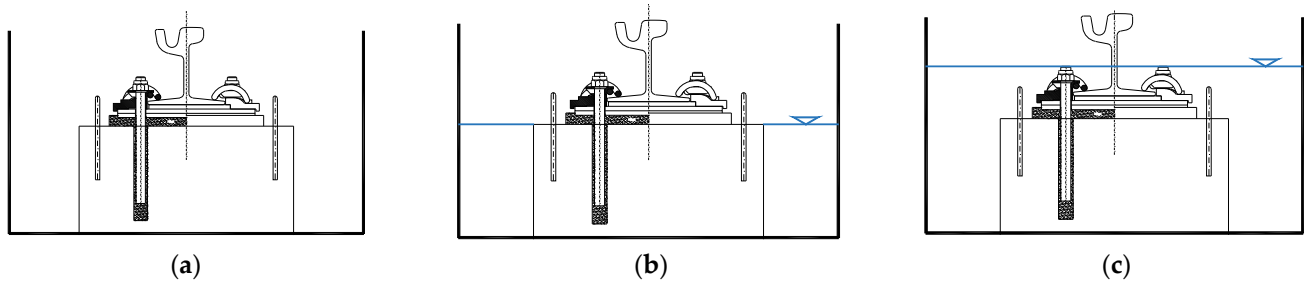
**Figure 7.** Different water levels in which the samples were immersed: (a) dry condition, (b) water level to the top of the concrete block, and (c) immersed condition.

- The samples are dry (Figure 7a),
- Water on the top of the concrete base (Figure 7b)
- In the immersed condition: the water level was half the height of the neck of the rail (Figure 7c).

Different water levels simulate different conditions that can occur on tram tracks. In tracks embedded in lanes shared by road vehicles, the drying process is very slow; therefore, the concrete base is wet for most of the year. These conditions were simulated using the water level at the top of the concrete base. If track drainage is inadequate, water will remain in the track, resulting in direct contact between the rail and the fastening system with the electrolyte. These conditions were simulated by immersing the samples in water to half the height of the neck of the rail. Before immersing the samples in water, the electrical conductivity of water was measured using an SI Analytics Lab 945 conductometer. The electrical conductivity of water was 0.0775 S/m. The electrical conductivity of water affects the electrical resistance of the entire sample. Therefore, it is important that the conductivity of water be the same in all samples. Notably, the electrical resistance of the water retained in the track structure depends on the substances dissolved in the water, mainly salt. This experiment can also be performed using water containing dissolved salts to accelerate the corrosion process. However, because the aim of this study was to determine the influence of stray currents on rails and fasteners, the experiment was carried out with tap water with a defined electrical conductivity.

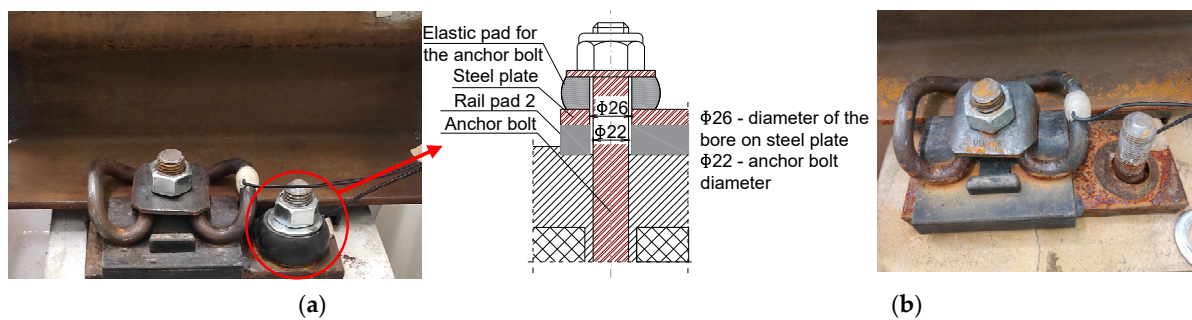
**Figure 8.** DEPP fastening system: (a) Case 1: elastic pad and nut at the anchor bolt. (b) Case 2: elastic pad and nut removed from the anchor bolts.

- Case 1: Elastic pads and nuts were placed on the anchor bolts (Figure 8a).
- Case 2: The elastic pads and nuts were removed from the anchor bolts (Figure 8b).

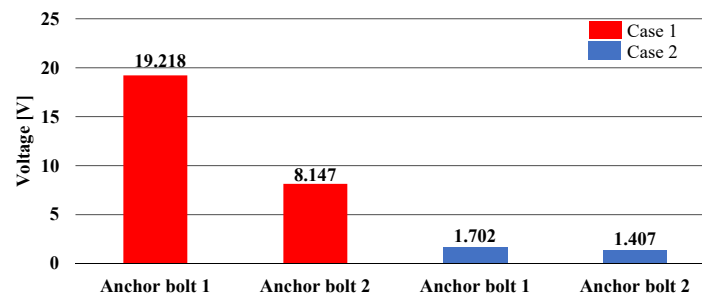
**Figure 9.** Measured voltages in anchor bolts for cases 1 and 2 for the DEPP fastening system.

The measured voltages are shown in Figure 9. After removing the elastic pads from the anchor bolts (case 2), the voltage in the anchor bolts was 1.7 V on bolt 1 and 1.4 V on bolt 2, indicating that the electrical connection between the anchor bolt and steel plate was established through the elastomer pad.

In addition, notably, a large difference was observed between the voltages measured in Case 1 for anchor bolts 1 and 2 (Figure 9), even though the anchor bolts were connected to the steel plates with the same type of nuts and elastic pads. The electrical resistance of the elastic pads was measured to determine whether the different resistance values were responsible for the different voltages in the anchor bolts. The resistance of the elastic pad for anchor bolt 1 was 2.29 k $\Omega$ , and the resistance of the pad for anchor bolt 2 was 1980.28 k $\Omega$ , which confirmed the original assumption that the differing values of the electrical resistance of the elastic pads caused the difference in the measured voltages in the anchor bolts.

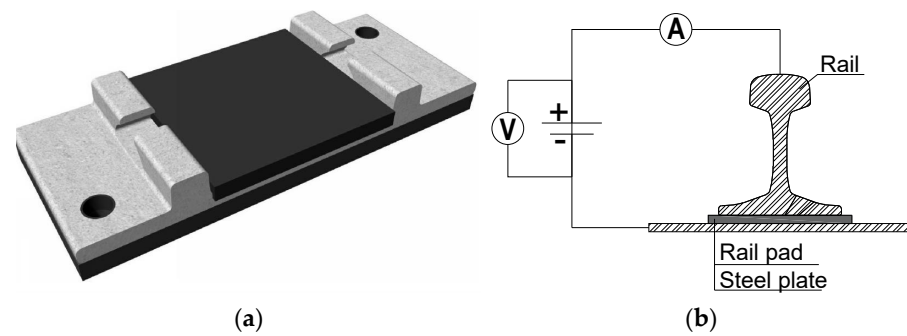
**Figure 10.** (a) Vulcanized steel plate for the Zagreb 21-CTT fastening system with the rail pad. (a) Cross section of the Zagreb 21-CTT fastening system in contact with the steel plate and anchor bolt CTT. (b) Current circuit during the measurement of the electrical resistance of the rail pad.

In the Zagreb 21-CTT fastening system, the underside of the steel plate and bores for the anchor bolts at the plate were vulcanized (Figure 10a) to prevent current from leaking from the steel plate to the anchor bolts and lower parts of the track. Because the steel plate of the Zagreb 21-CTT fastening system is vulcanized, the anchor bolts should be isolated from the plate. However, a high voltage was detected in anchor bolt 2. All elastomer elements of the Zagreb 21-CTT fastening system were made of the same material during vulcanization. To determine the electrical resistivity of the material, measurements were performed using a GWInstek GDM9061 multimeter and a direct-current source on the rail pad. The rail pad was placed between the steel plate and rail. The rail was connected to the positive terminal of the current source, and the steel plate was connected to the negative terminal (Figure 10b). The current and voltage were measured using a multimeter, and the calculated electrical resistivity of the rail pad was 1.14 k $\Omega$ m. The low electrical resistivity of the elastomer elements in the Zagreb 21-CTT fastening system resulted in a current flow from the steel plate to the anchor bolts, which led to a high voltage detected in the anchor bolts.

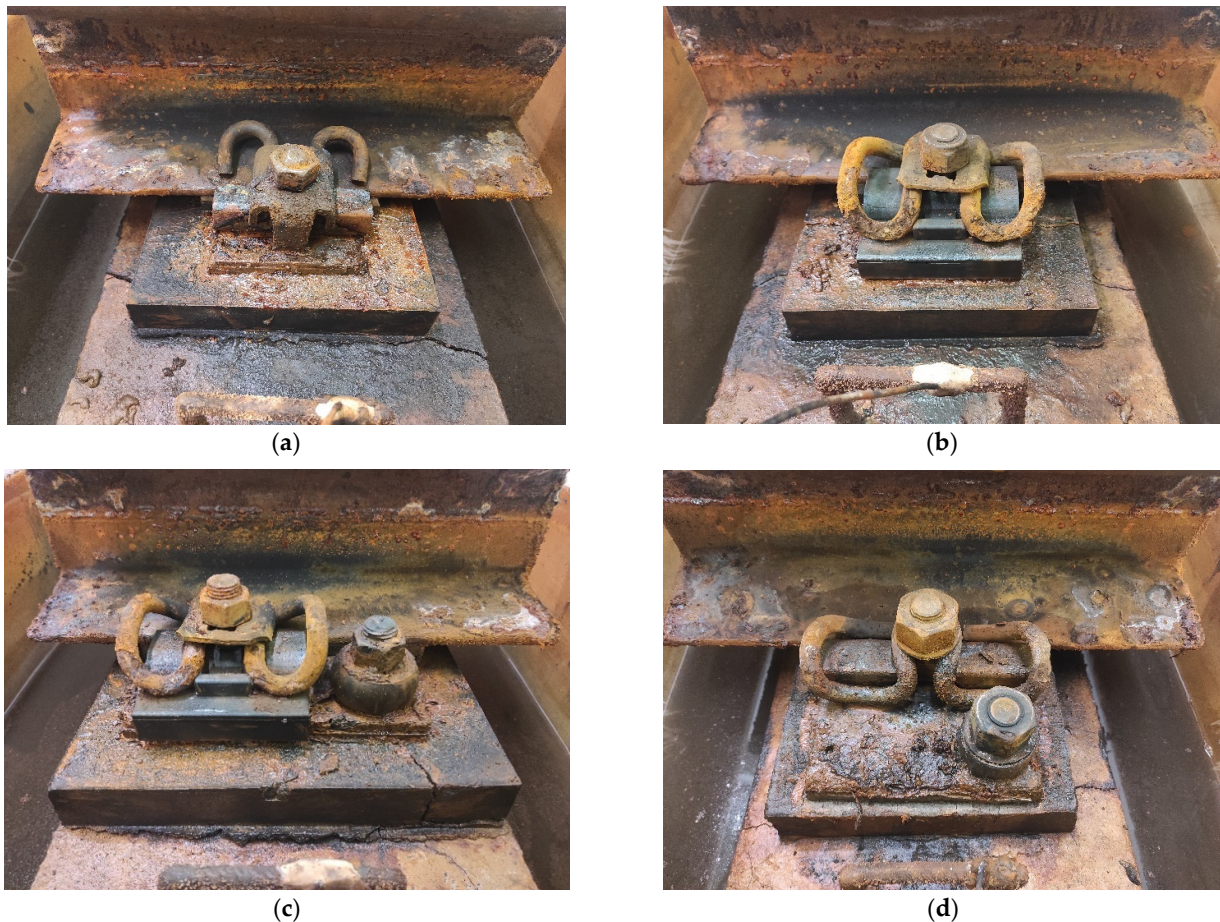
**Figure 11.** Conditions of all samples after testing was completed: (a) ZG 3/2, (b) PPE, (c) DEPP, (d) Zagreb 21-CTT.

When the ZG 3/2 fastening system was dry, and the water level was at the top of the concrete base, no local corrosion was observed in the elements of the rail or fastening system. Under these conditions, current flows from the rail through the rail clip and steel rib to the steel plate and anchor bolts. From the bolts and plate, the current flowed into the concrete base and leveling layer, such that corrosion occurred only at the point of contact of the steel plate with the leveling layer and at the point of contact of the anchor bolts with the concrete base. Under immersed conditions, current flows from the rail, steel rib, and steel plate directly into the water, causing corrosion and deterioration of the components of the fastening system. In the PPE fastening system, under dry conditions, despite the insulation pads used under the rail, clip, and steel plate, current can leak directly into the concrete and return to the negative terminal at the laboratory power supply because of the direct contact between the rail, clip, and anchor bolt. When dry, only the anchor bolts are in contact with the concrete; therefore, they corrode. When the water level reaches half the height of the rail neck, the current from all the elements flows into the water and causes corrosion. Under dry conditions, in the DEPP and Zagreb 21-CTT fastening systems, corrosion can also occur only at the anchor bolt, i.e., at the part of the bolt that is in contact with the electrolyte; however, because the anchor bolts in these fastening systems are partly insulated, the corrosion rate will be lower than that on the ZG 3/2 and PPE fastening systems. Visual inspection revealed that the current did not flow uniformly from the metal elements into the water when the samples were immersed. Discharge points occurred on the metal surface where localized material loss was observed. In addition to the corrosion of rails and fastening systems, cracks were observed in the leveling layers and concrete bases. These cracks resulted from the deposition of corrosion products at the contact between the bolt and the concrete. The cracks were classified based on a visual inspection (Figure 11) and were divided into three groups: large, medium, and small.

The ZG 3/2 fastening system exhibits cracks across the entire width of the concrete base (Figure 11a). The maximum measured width of the crack was 4.5 mm, which is considered large. In the PPE and DEPP fastening systems (Figure 11b,c), cracks were observed in the leveling layer and in the concrete base near the anchor bolts, which are referred to as medium cracks. The maximum crack widths for the DEPP- and PPE-fastening systems were 2 mm, and the maximum crack width for the PPE fastening system is 1.8 mm. The width of the largest crack detected in the concrete block using the Zagreb 21-CTT fastening system was 0.8 mm (Figure 11d). This crack was considered small.

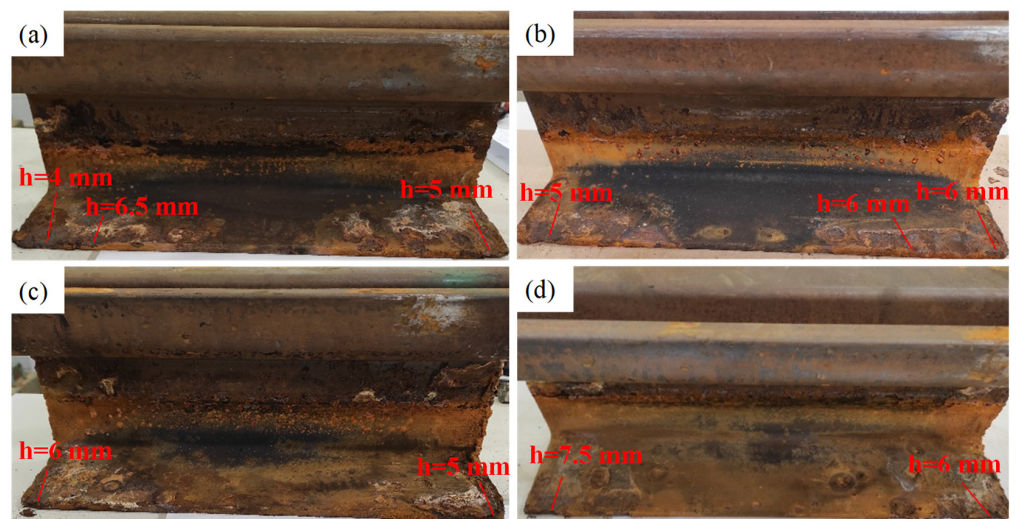
**Figure 12.** Condition of the rails after testing was completed: (a) ZG 3/2, (b) PPE, (c) DEPP, (d) Zagreb 21-CTT.

In all samples, material loss occurred at the edges of the rail foot. Figure 12 shows the conditions of the rails after the completion of the test. The measured minimum dimensions of rail foot height are shown in the figures. At the measured locations, the reference height of the rail foot was 8 mm, indicating that corrosion caused thinning of the rail foot by up to 4 mm for the ZG 3/2 fastening system, 3 mm for the PPE and DEPP fastening systems, and 2 mm for the Zagreb 21-CTT fastening system.

The dimensions of the rail base surface affected by corrosion and the depth of the corrosion damage were measured for each rail sample. For each corrosion damage point, the corrosion level was classified as follows:

- Low corrosion level: thinning of the rail foot up to maximum 1 mm,
- Medium corrosion level: thinning of the rail foot from 1 to 3 mm, and
- High corrosion level: thinning of the rail foot of more than 3 mm.

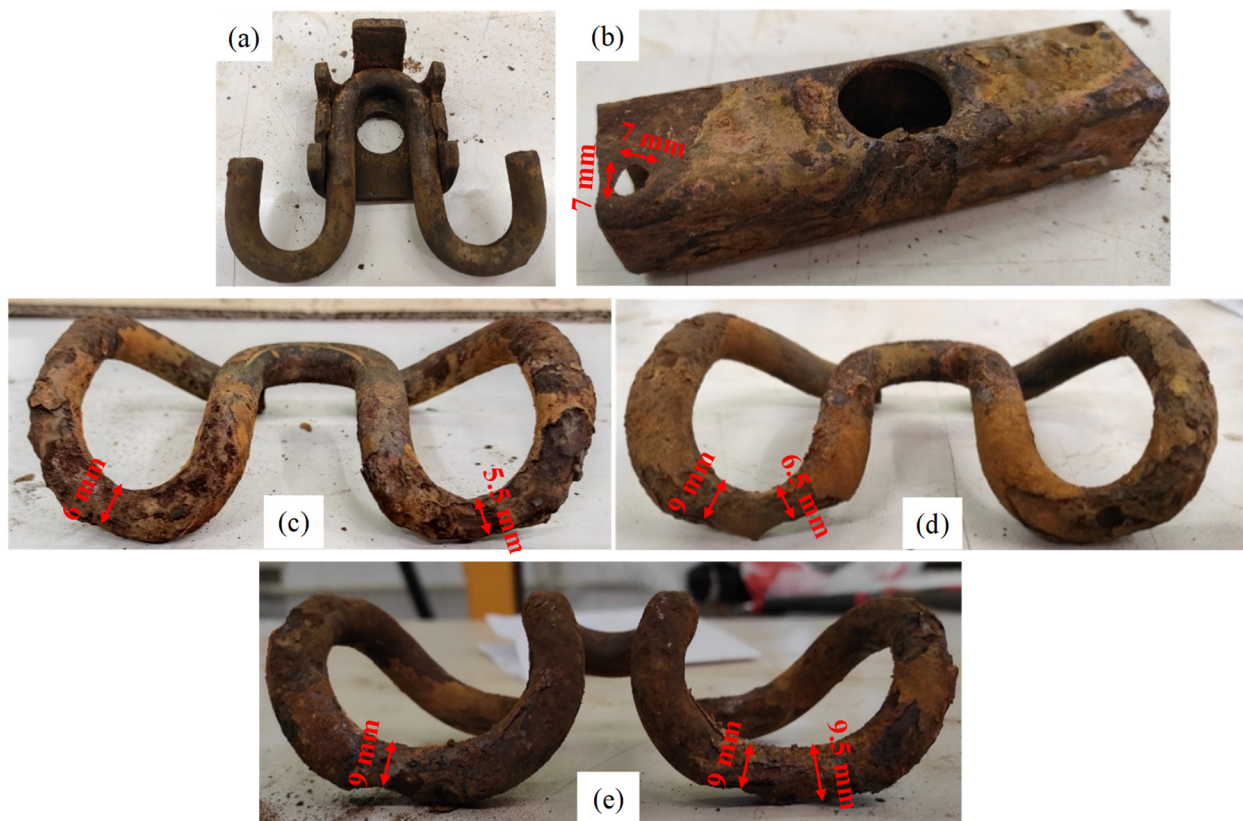
Figure 13. Condition of clips and steel rib after testing was completed: (a) ZG 3/2-clip, (b) ZG 3/2-steel rib, (c) PPE, (d) DEPP, (e) Zagreb 21-CTT.

For the PPE, DEPP, and Zagreb 21-CTT fastening systems, corrosion was observed at the lowest part of the clips. For the PPE fastening system, the maximum reduction in the clip cross section was from 13 mm to 5.5 mm. For the DEPP fastening system, the cross section of the clips decreased from 13 mm to 6.5 mm, and for the Zagreb 21-CTT fastening system, the current resulted in a reduction of the cross section from 13 mm to 9 mm. In the case of the ZG 3/2 fastening system, no corrosion was observed on the clips. However, severe corrosion deterioration was observed on the steel rib in direct contact with the clip. Therefore, it was assumed that the current flowed from the clip into the steel rib and from the steel rib into the electrolyte (water). Because the same type of deterioration was observed in both clips of each tested sample, the condition of one clip from each sample after the test was completed is shown in Figure 13. In addition, the condition of the steel rib after the completion of the test is shown for the ZG 3/2 fastening system.

The percentage of cross-sectional thinning of the clips at the points of most severe clip degradation was calculated using the reference diameter and the diameter measured after completion of the laboratory test. Based on the corrosion percentage, the corrosion level was classified as follows:

- Low corrosion level: cross-sectional thinning of up to 25%
- Medium corrosion level: cross-sectional thinning of 25% to 50%
- High corrosion level: cross-sectional thinning of more than 50%.

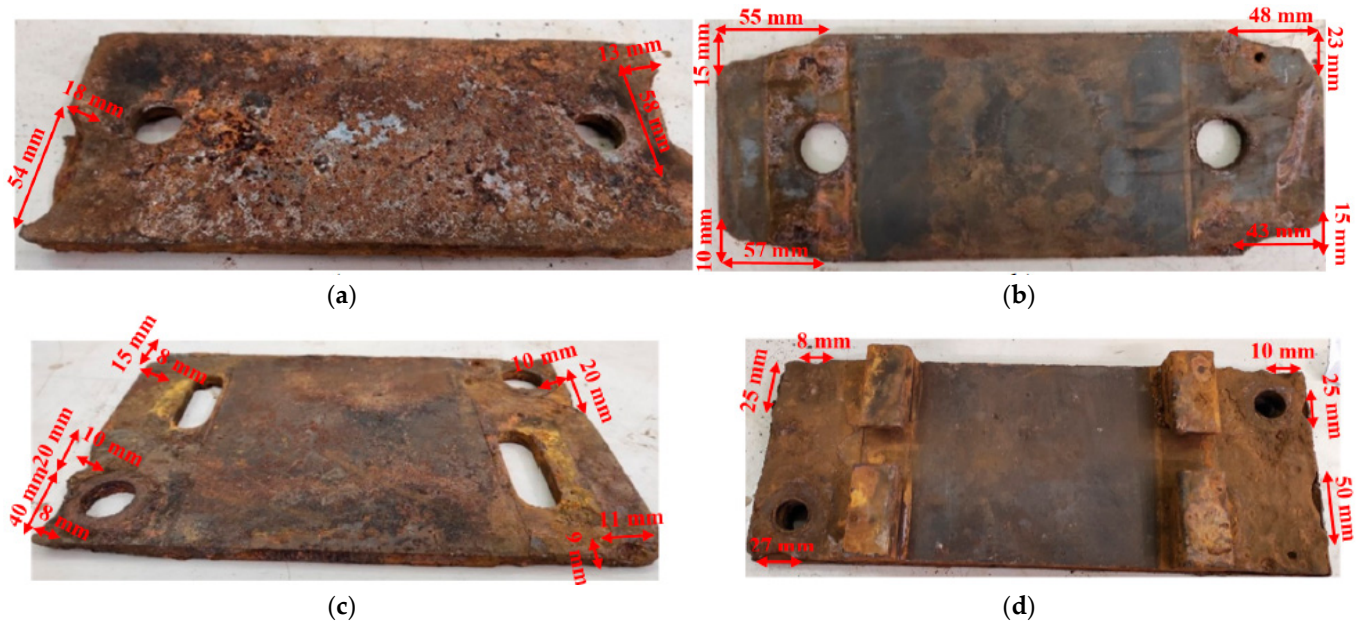
**Figure 14.** Condition of the steel plate after testing was completed: (a) ZG 3/2, (b) PPE, (c) DEPP, and (d) Zagreb 21-CTT.

After the samples were disassembled, a massive deterioration of the steel plate at the edges was also noted. The conditions of the steel plate after the completion of the test are shown in Figure 14. The dimensions of the corroded areas are defined for each steel plate.

Corrosion of the steel plate was detected at the edge of the plate for all test samples. The percentage of corroded surfaces was calculated for each test sample (Table 6). Owing to the large dimensions of the plate, the corroded area was very small. Thus, the corrosion was classified as follows:

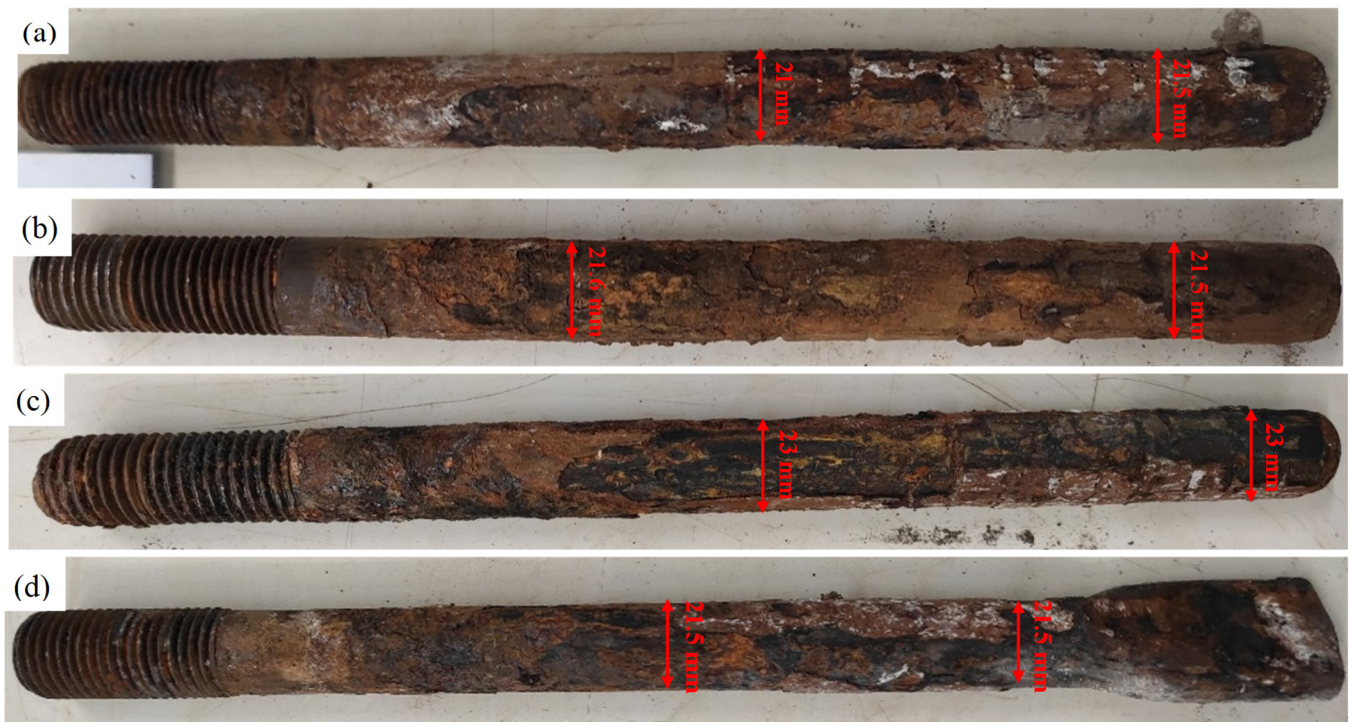
**Figure 15.** Condition of the anchor bolts after testing was completed: (a) ZG 3/2, (b) PPE, (c) DEPP, and (d) Zagreb 21-CTT.

The conditions of the anchor bolts were also analyzed after the completion of the test. Corrosion was observed on the parts of the anchors that were in contact with concrete. Figure 15 shows the condition of one anchor from each sample after completion of the test.

Because the anchor bolts are built in concrete, in addition to the corrosion area and thinning of the anchor cross section, the cracks observed in the leveling layer and in the concrete base (Figure 11) are also considered for the corrosion classification. The percentage of anchor bolt diameter thinning was calculated for all samples, as listed in Table 7. The corrosion damage was classified as follows:
