Influence of Stray Current on Fastening System Components in Urban Railway Tracks

Source / Izvornik: **Applied Sciences**, 2023, 13

Journal article, Published version

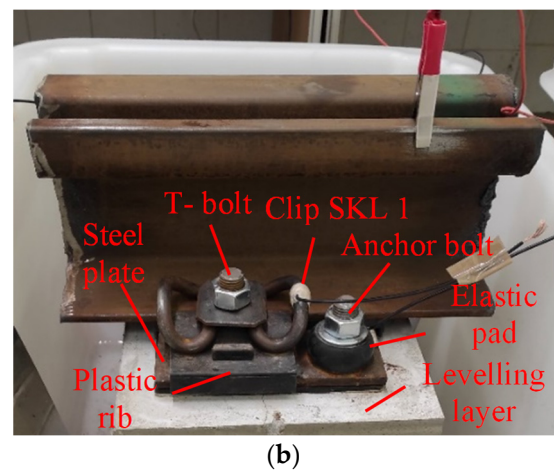
Figure 4. Fastening system DEPP: (a) cross section and (b) sample for testing.

In the DEPP and Zagreb 21-CTT fastening systems, the rails are laid on the rail pad and steel plate but are fastened to the steel plate using clips and T-bolts (Figures 4 and 5). The anchor bolts are dislocated and used only to anchor the fastening system to the concrete base. In the Zagreb 21-CTT fastener, the underside of the steel plate is vulcanized. The bores for the anchor bolts on the steel plate are also vulcanized such that the anchor bolts do not directly contact the steel plate (Figure 5a).

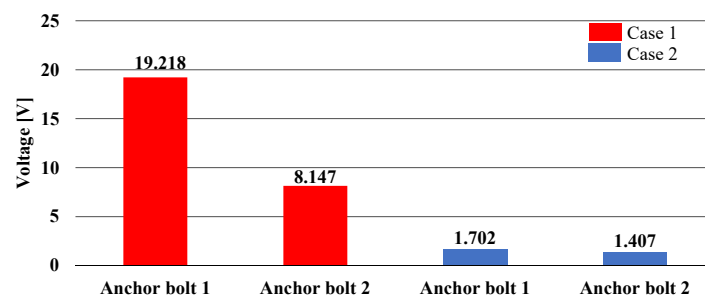
Figure 9. Measured voltages in anchor bolts for cases 1 and 2 for the DEPP fastening system.

The measured voltages are shown in Figure 9. After removing the elastic pads from the anchor bolts (case 2), the voltage in the anchor bolts was 1.7 V on bolt 1 and 1.4 V on bolt 2, indicating that the electrical connection between the anchor bolt and steel plate was established through the elastomer pad.

In addition, notably, a large difference was observed between the voltages measured in Case 1 for anchor bolts 1 and 2 (Figure 9), even though the anchor bolts were connected to the steel plates with the same type of nuts and elastic pads. The electrical resistance of the elastic pads was measured to determine whether the different resistance values were responsible for the different voltages in the anchor bolts. The resistance of the elastic pad for anchor bolt 1 was 2.29 k Ω , and the resistance of the pad for anchor bolt 2 was 1980.28 k Ω , which confirmed the original assumption that the differing values of the electrical resistance of the elastic pads caused the difference in the measured voltages in the anchor bolts.
