Damage assessment after the Zagreb earthquake - the case study of the educational building

Conference paper / Rad u zborniku

Damage assessment after the Zagreb earthquake – the case study of the educational building

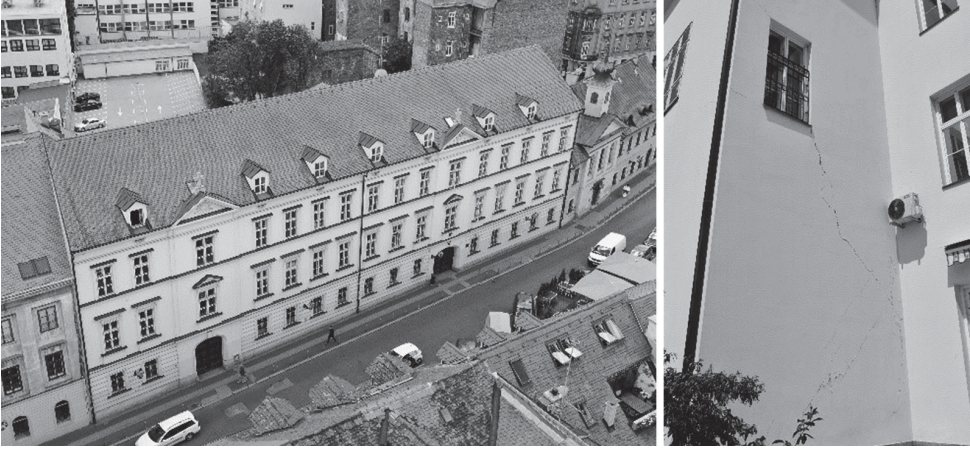
Masonry buildings account for a big part of housing in Croatia [3]. Hence, initial assessments are essential to inform the tenants about their damaged homes' usability and safety. The rapid assessments began only a few hours after the main earthquake. Damage classification in rapid assessments was made in accordance with the modified EMS-98 scale [4]. The educational building shown in Fig.2 and Fig.3 is an old unreinforced masonry building located in the old town of Zagreb. Its floor heights range from 3.2 to 4 m, and wall thicknesses range from 28 to 70 cm. It was one of the structures assessed by the ARES project team. In the initial assessment, it was classified as temporary unusable due to observed damage. A detailed inspection was required - the building has moderate damage without likely collapse. The load-bearing capacity is partially impaired, and it was not recommended to stay in the building. After some time, a more detailed evaluation was done, and the building's damage and possible behavior were analyzed.

Figure 2. Educational building and damage by the earthquake
