**Proceedings of the
International Conference
on Sustainable Materials,
Systems and Structures
(SMSS2019)**

**Durability, Monitoring and
Repair of Structures**

International Conference on Sustainable Materials, Systems and Structures (SMSS 2019)
Durability, Monitoring and Repair of Structures
20-22 March 2019 – Rovinj, Croatia

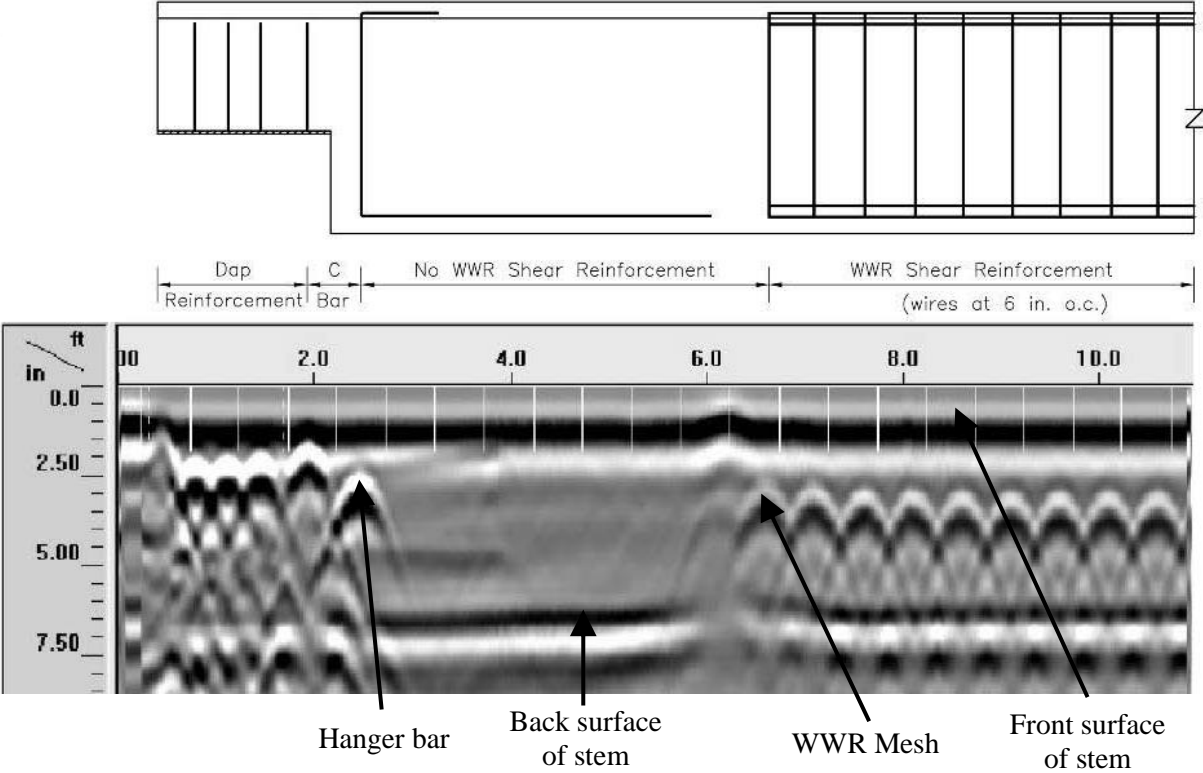
Ground-Penetrating Radar also known as pulsed radar, is a geophysical nondestructive testing technique for the evaluation of structural elements and materials. The method involves using electromagnetic waves to assess the internal characteristics of the material. GPR surveys performed on structural concrete elements allow for the detection and location of embedded objects, assessment of member geometry, and identification of internal conditions (such as poor consolidation and flaws). The technique involves the use of a high-frequency radar antenna that transmits electromagnetic radar pulses along a discrete longitudinal scan at the surface of the element. Electromagnetic signals are reflected from material interfaces of differing dielectric properties. Signals are collected by the antennae, amplified, and displayed for subsequent interpretation. An example of a horizontal GPR scan collected on the lateral face of a stem along with an elevation view of the stem showing the embedded reinforcing is provided in Figure 3. Structural calculations confirmed that shear reinforcing was required and the beams were under-strength. GPR was a cost-effective, reliable, nondestructive approach that not only identified the problem, but helped define the scope of required repairs.

Figure 3: Elevation view of double tee stem and as-built reinforcing (top) and longitudinal GPR scan

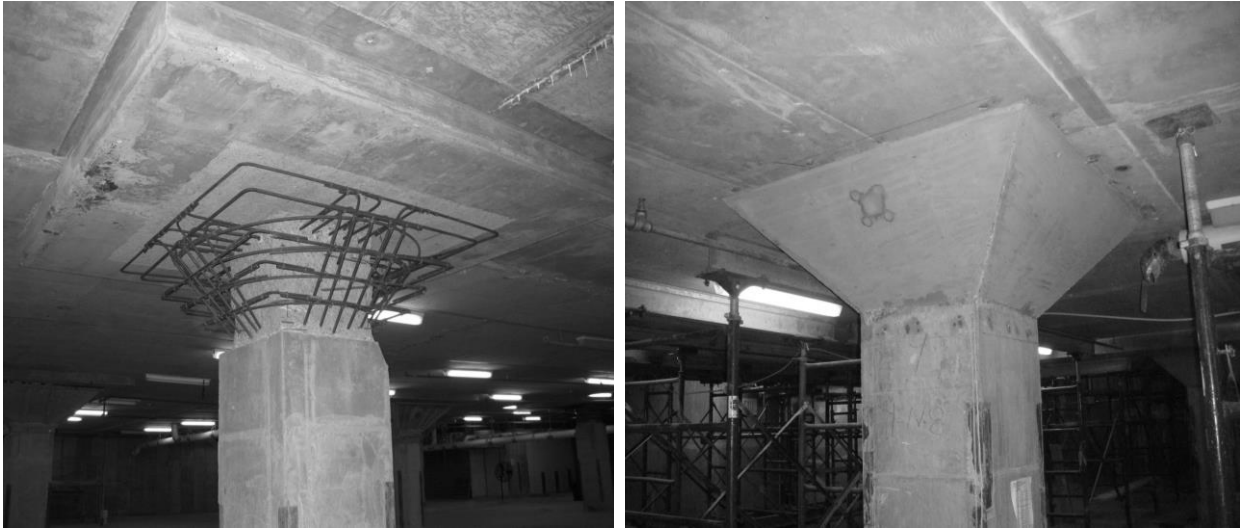
An economical repair approach incorporating supplemental concrete column capitals and drop panels at each column and strengthening of selected slab spans using FRP was selected. The conventionally-reinforced square capitals and supplemental drop panels were doweled into the top of the existing columns and were poured using a concrete mix design which allowed the repair material to be pumped into the forms from below the existing slab. Photographs of a supplemental column capital prior to and after concrete placement is shown in Figure 4.

Figure 4: Column capital prior to and after concrete placement

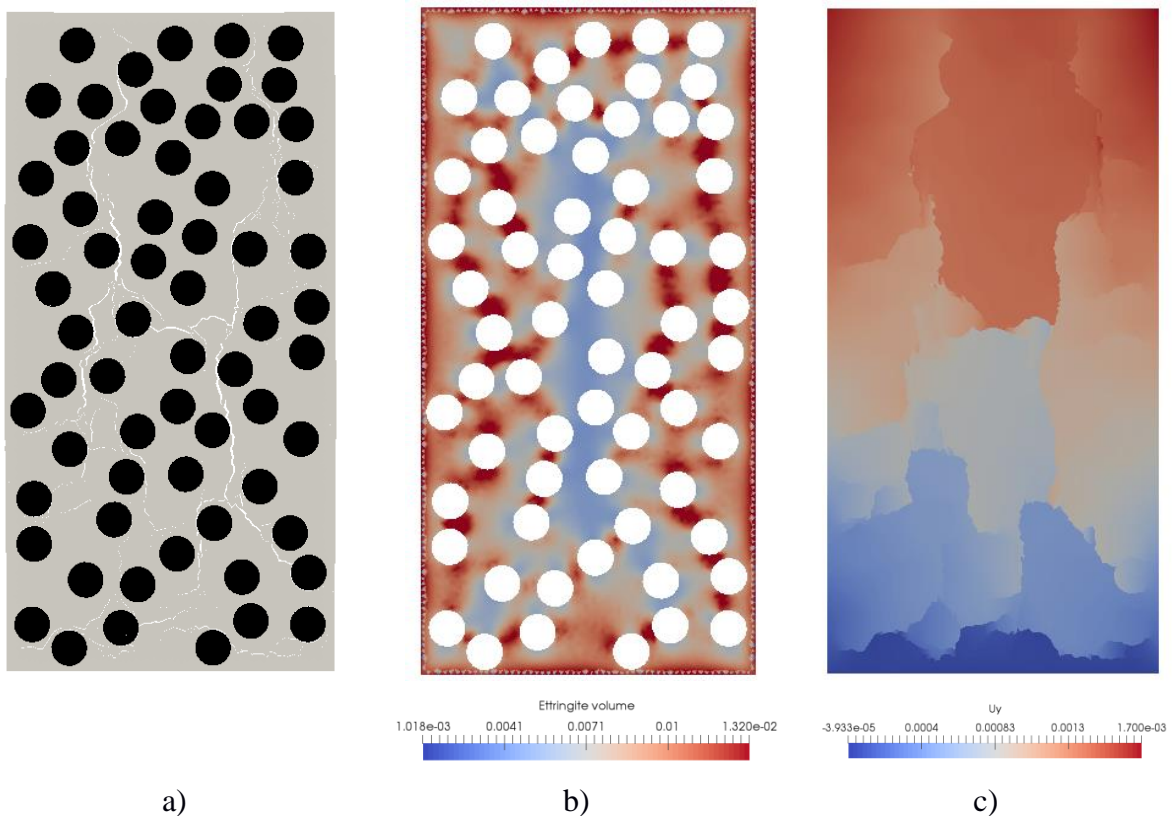
The first results show diffuse cracking due to DEF mostly at the interface between mortar and granulates, which seems to agree with experimental observations [4] (Figure 4 a). Ettringite precipitates in the entire sample (Figure 4 b). The localization of precipitation depends strongly on the microstructure: diffusion coefficient aggregates and cracks. The longitudinal displacement field depends on crack localization and boundary conditions (Figure 4 c). The swelling is thus not homogenous in the sample.

Figure 4: a) cracking profile (crack in white, mortar in gray and granulates in black), b) ettringite volume field [m^3] (granulates in white) and c) longitudinal displacement [m]

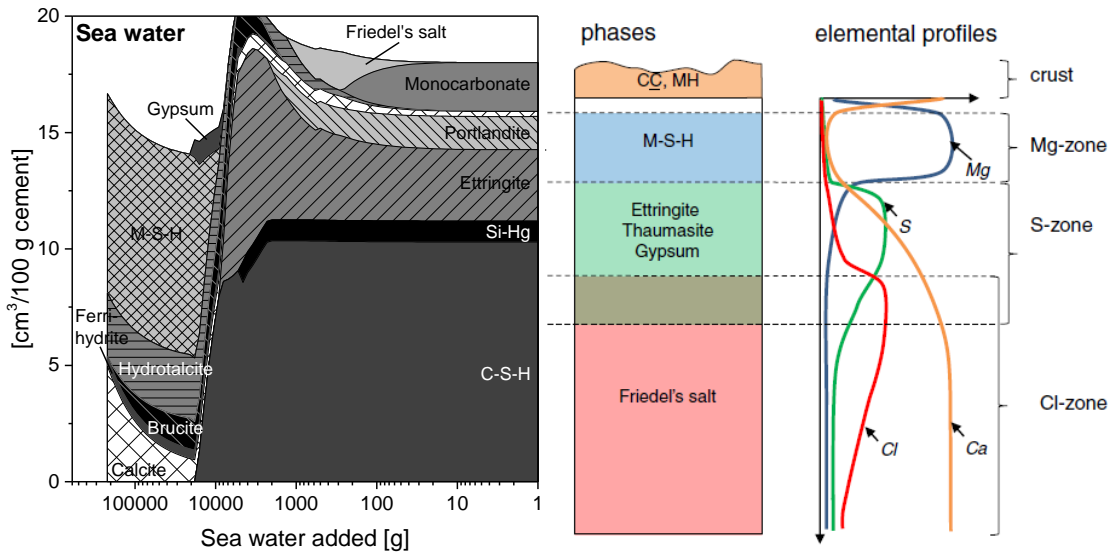
Figure 5: Thermodynamic predictions of the phase changes of Portland cement exposed to seawater (56 mM Mg, 580 mM Cl, 500 mM Na, 20 mM sulfate) reproduced from [12] and observed changes in samples exposed for two years to seawater adapted from [1].

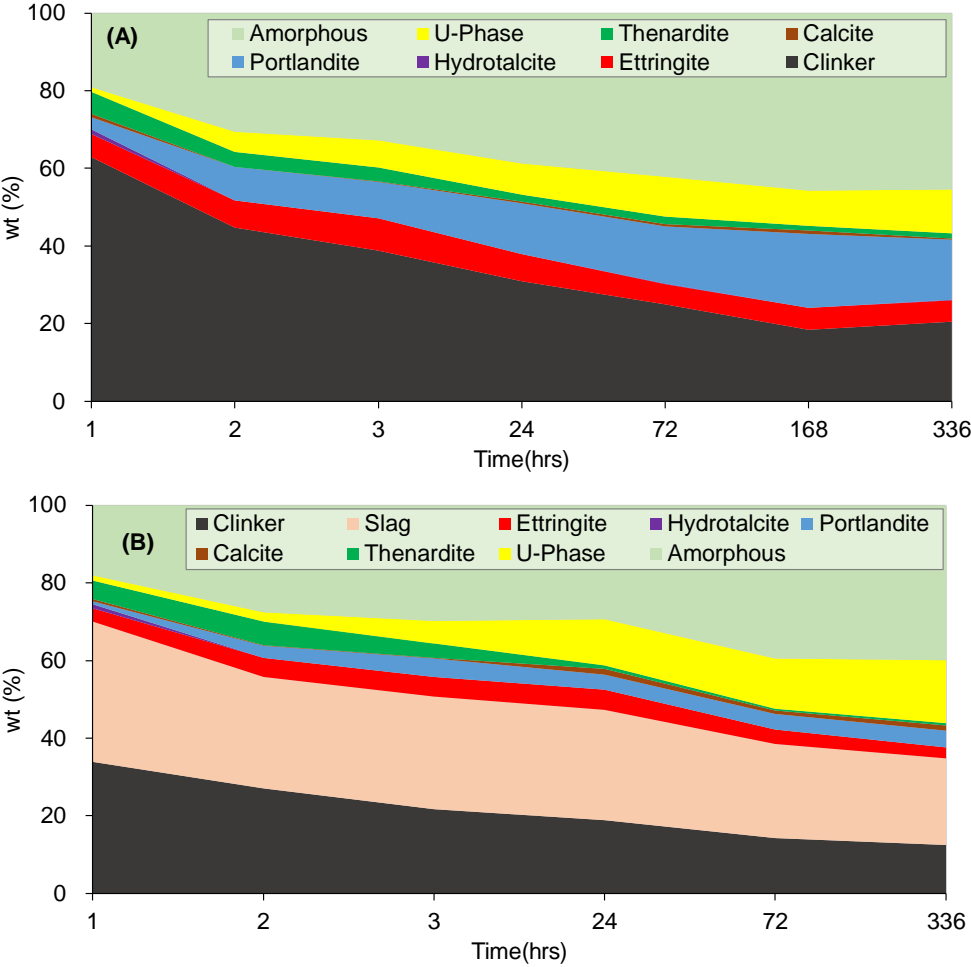
Figure 1: Phase distribution of hydrating, (A) WPC; (B) slag-blended WPC, in 15% of Na_2SO_4 solution

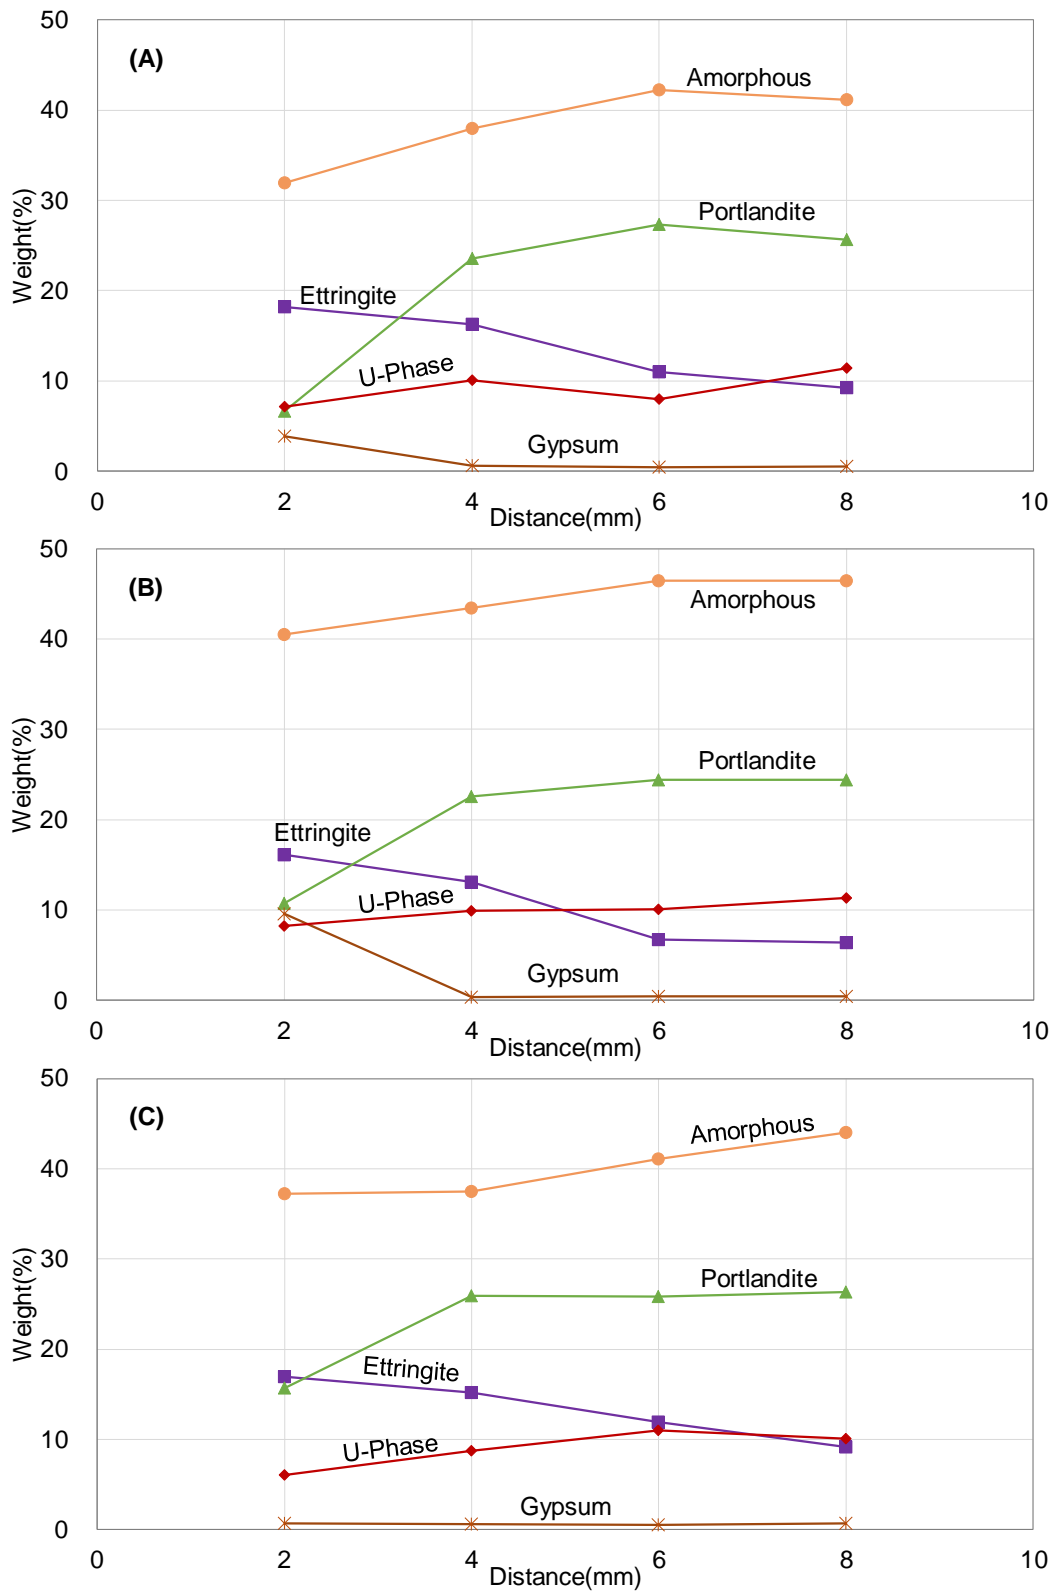
Figure 3: Spatial distribution of solid phases deduced by XRD/Rietveld analysis in WPC exposed to: (A) 1300 mmol/L Na₂SO₄; (B) 1300 mmol/L MgSO₄; (C) water for one month

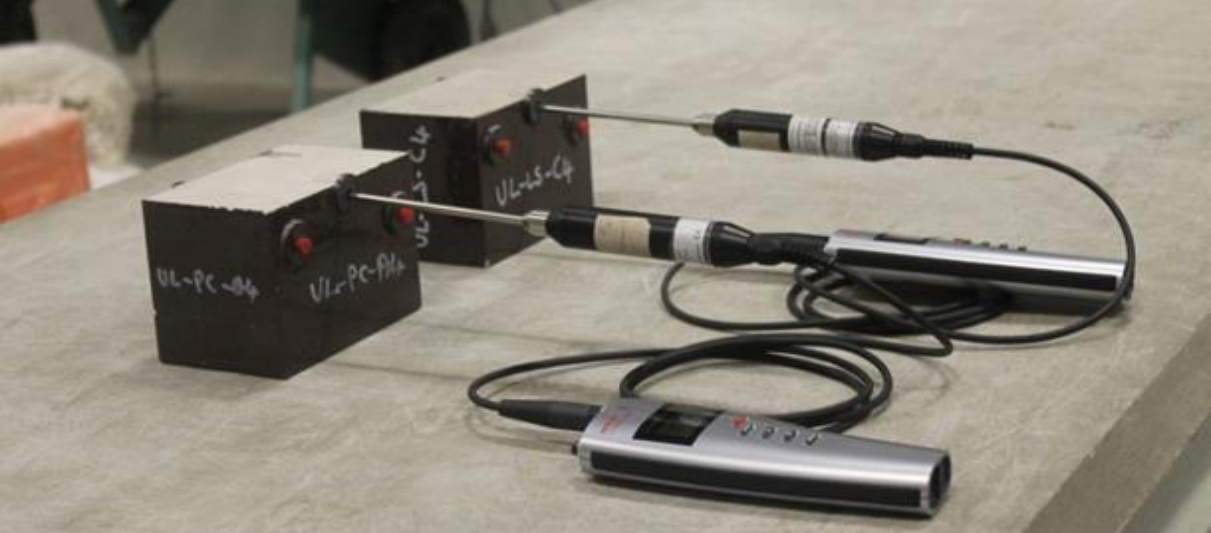
Figure 2: Experimental program for RH measurement

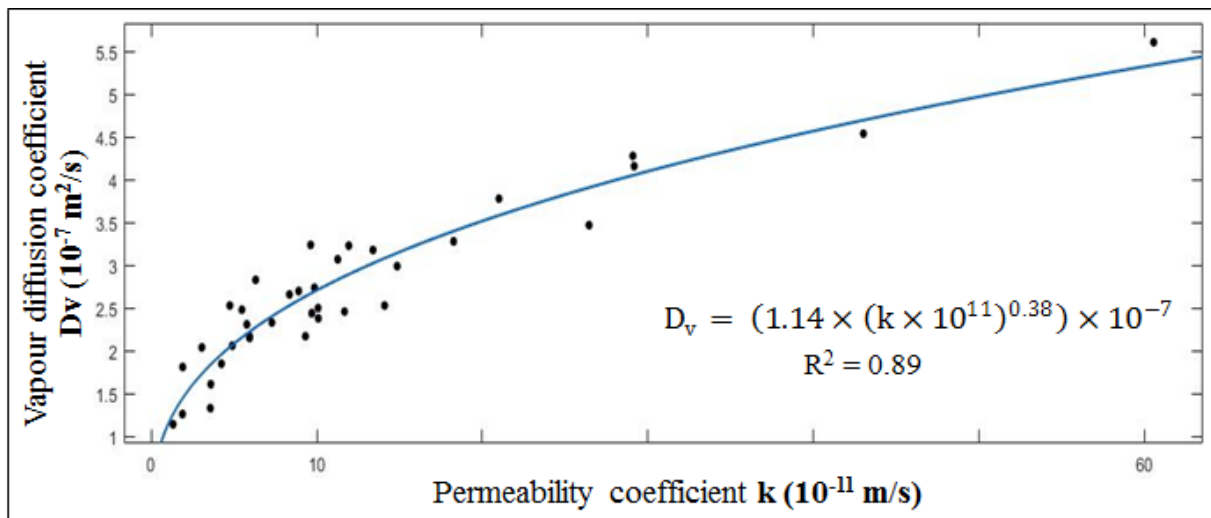
Figure 5: Correlation between vapour diffusion coefficient and permeability coefficient

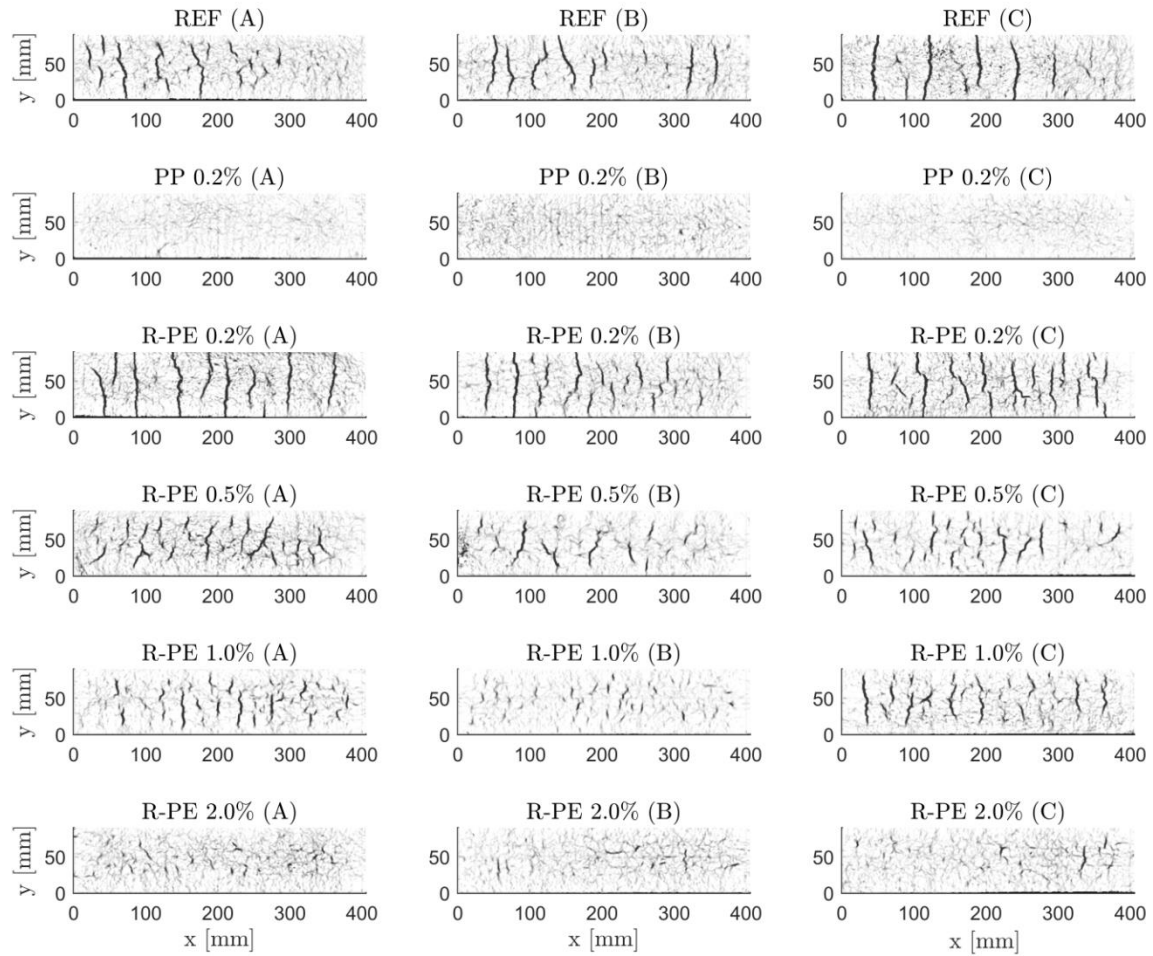
Figure 4: Principal strain for specimens at $t = 25$ h. White colour represents uncracked area with strain $\epsilon_{x,y} = 0\%$; Black colour represents surface cracks with strain $\epsilon_{x,y} = 5\%$.

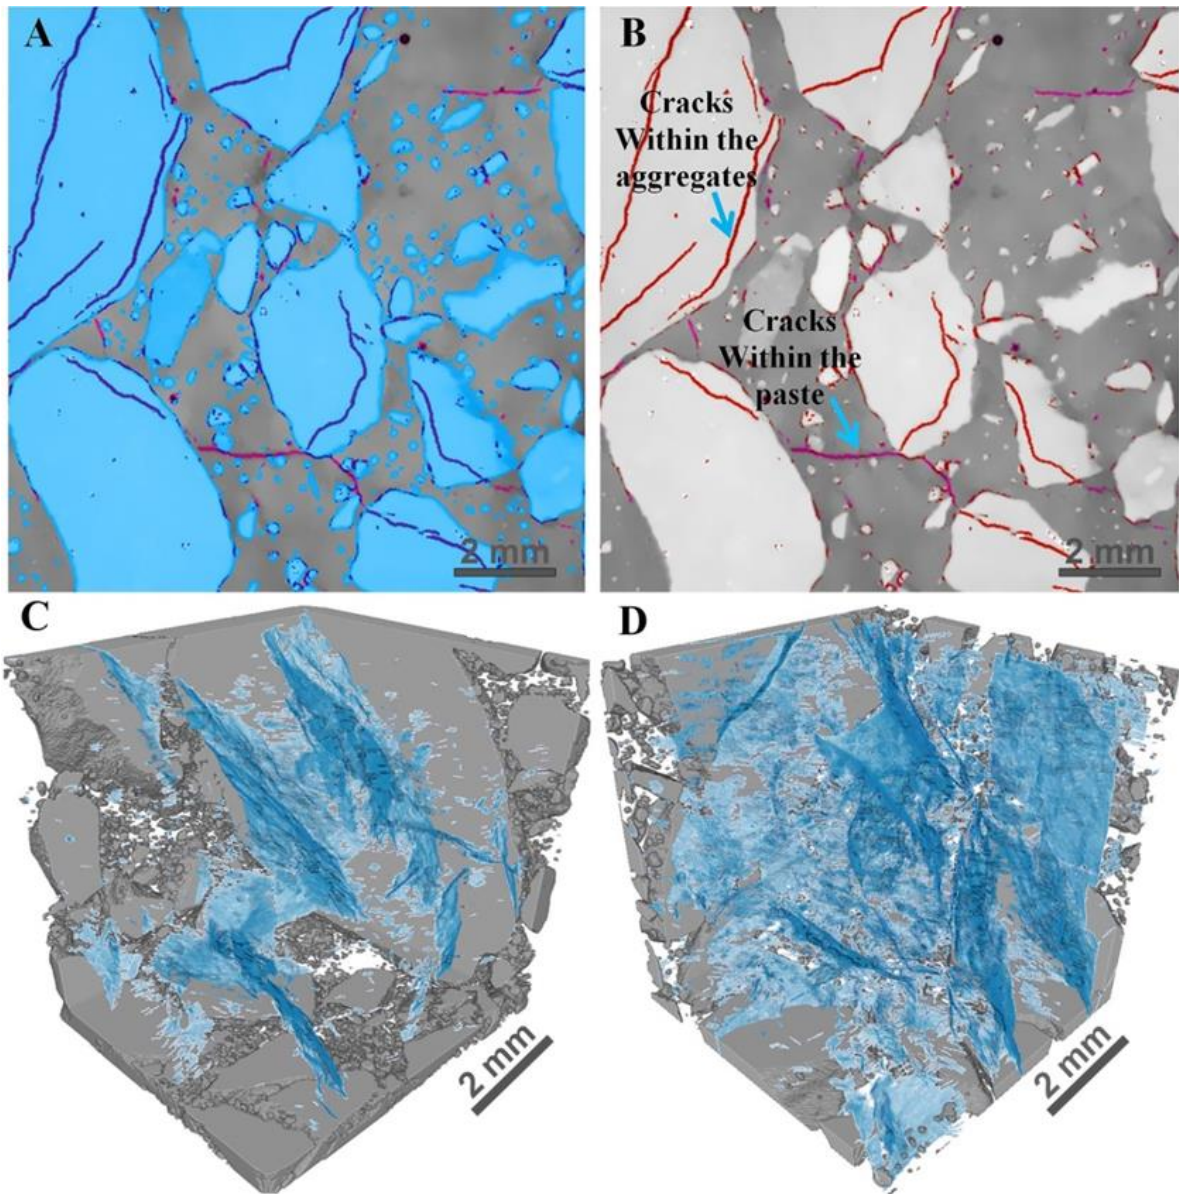
Figure 5: A close-up (A) from a selected 2D digital cross-section (“slice”) from the tomographically reconstructed volume of the field exposed concrete sample, illustrating the segmentation of the cracks (dark purple and pink) and of the aggregates (light blue); (B) same slice as in (A) but highlighting only the cracks with distinction by color between those within the aggregates (labelled in red) and the ones within the mortar matrix (labelled in pink); 3D rendering of all the cracks within the scanned volume of the lab-tested sample (C) and the field exposed sample (D). Part of the segmented aggregates is also visualized in the background of the cracks in both (C) and (D).

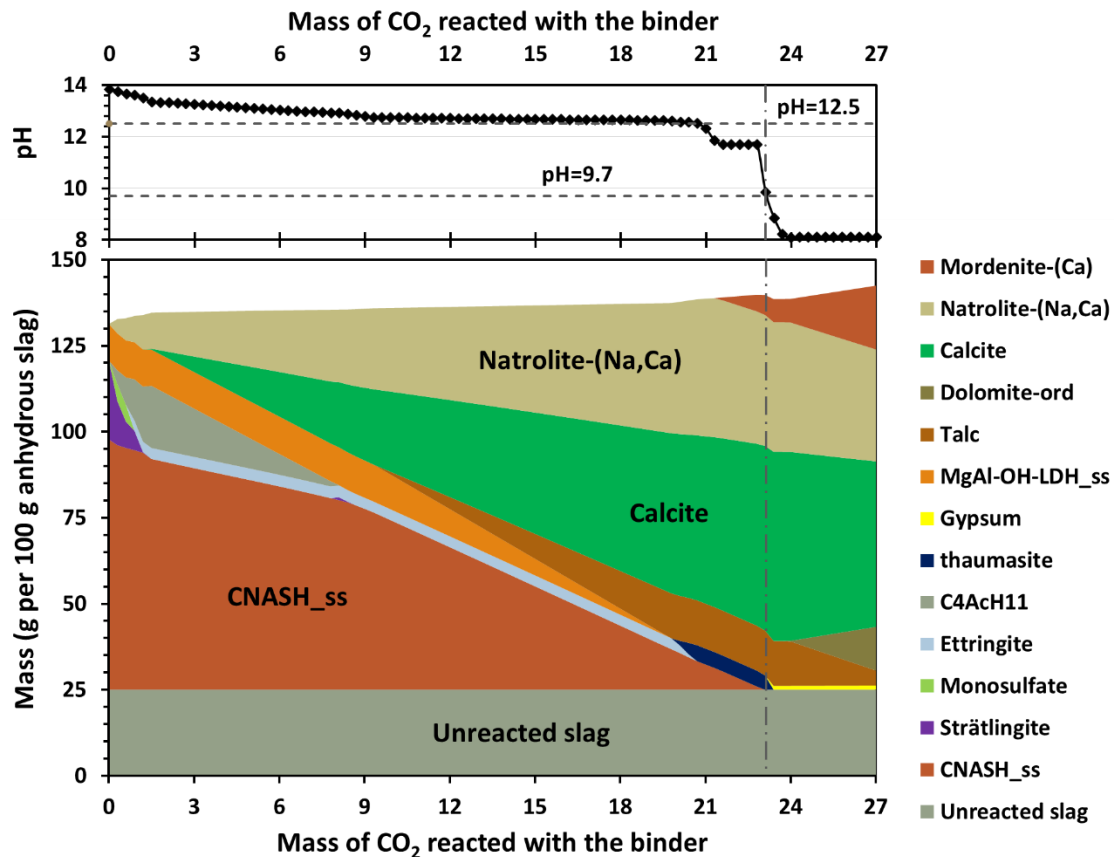
Figure 1. Phase assemblage of alkali-activated slag paste predicted under step-wise accelerated carbonation, and the corresponding pH in the aqueous phase (pore solution). The horizontal dashed lines represent pH values of 12.5 and 9.7 respectively, and the vertical dash-dot line indicates the predicted phase assemblage when the pH in the pore solution dropped to 9.7 (the colour change boundary of the phenolphthalein indicator).

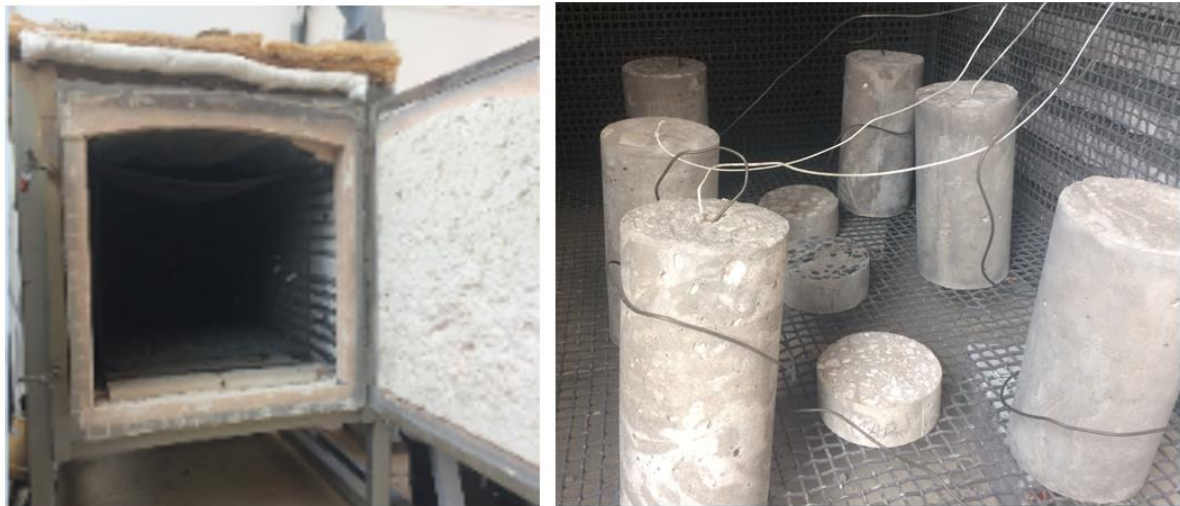
Figure 1: Left: electric arc furnace for specimens heating; right: specimens instrumented with inner thermocouples.

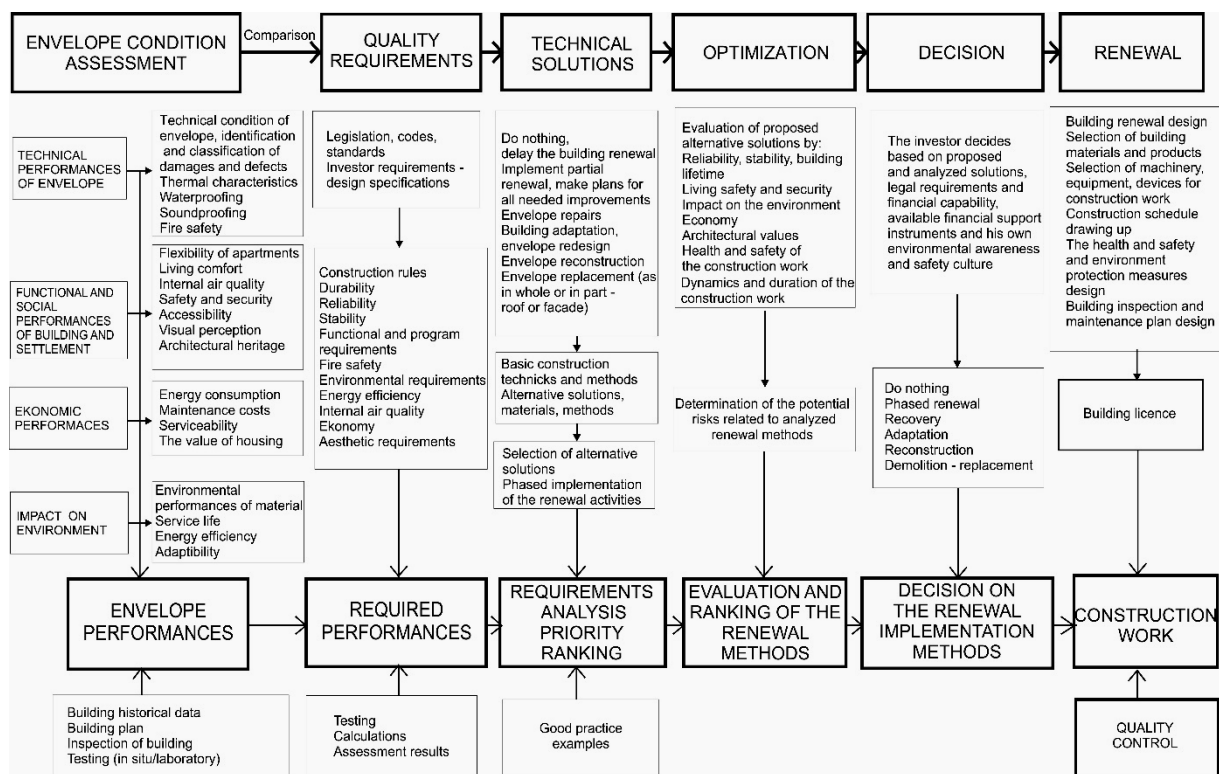
Figure 4. Integrated model of building envelope renewal

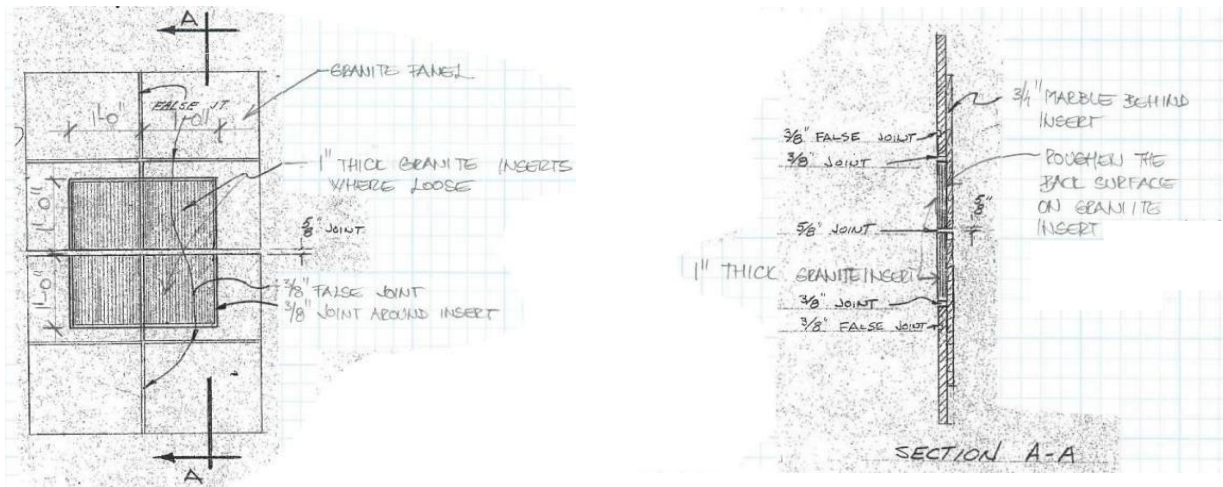
Figure 6 - Granite inserts attached with epoxy adhesive that has failed.
As built conditions are different than designed

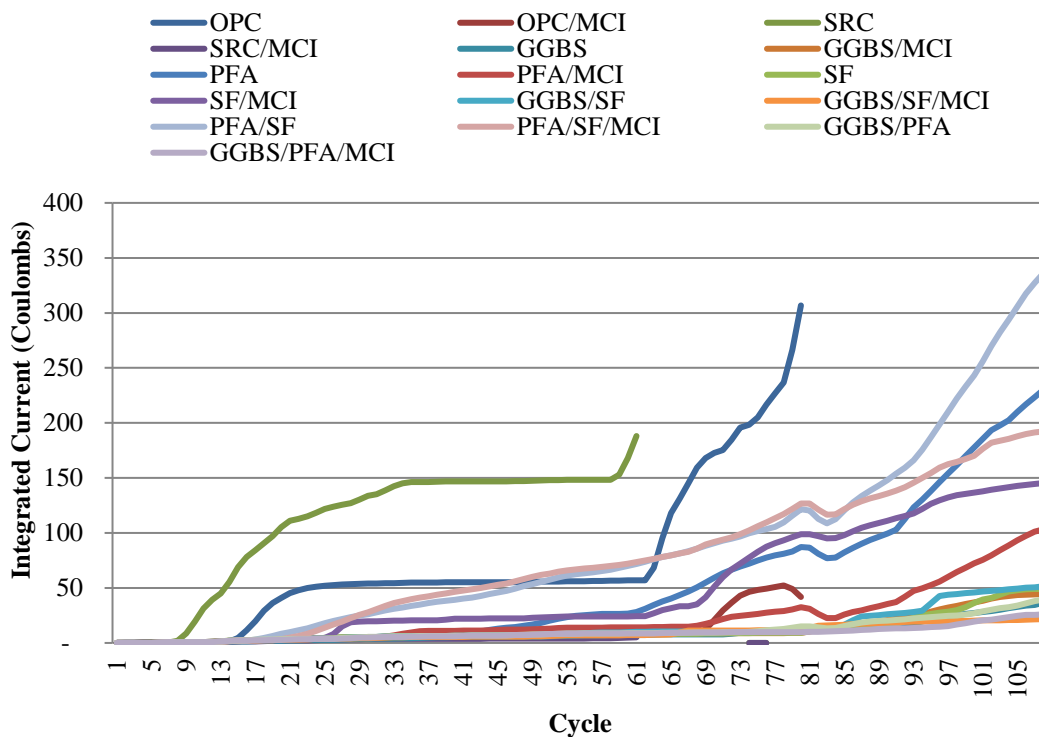
Figure 3 Integrated current (Coulombs) v. number of cycles for all mixes

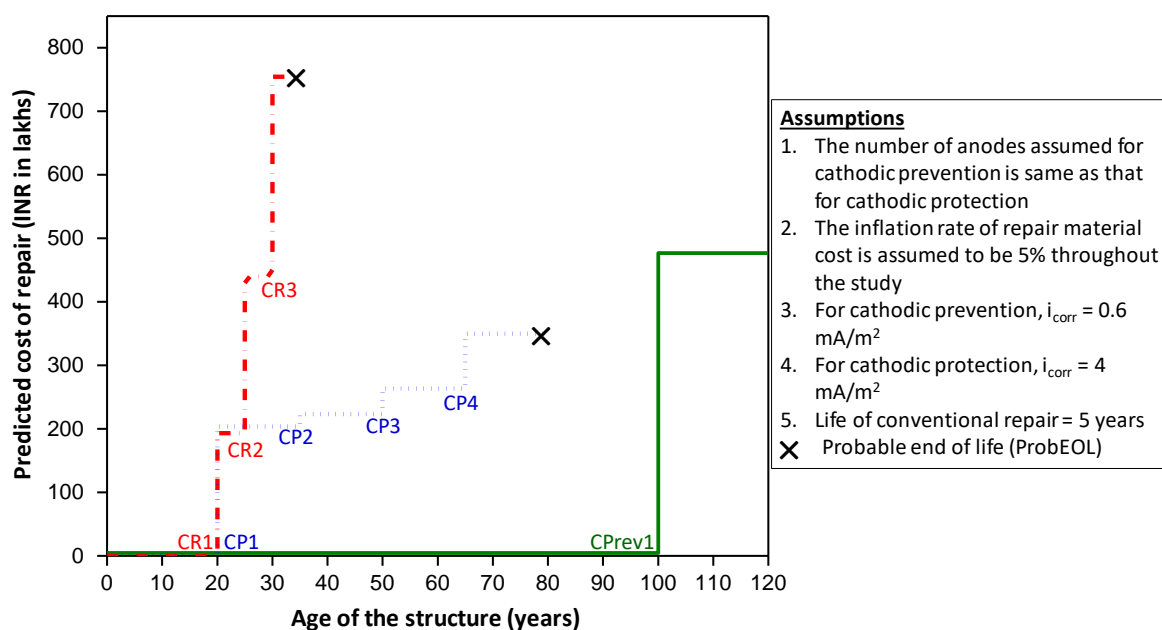
Figure 5: Life-cycle cost of repair for finger jetty

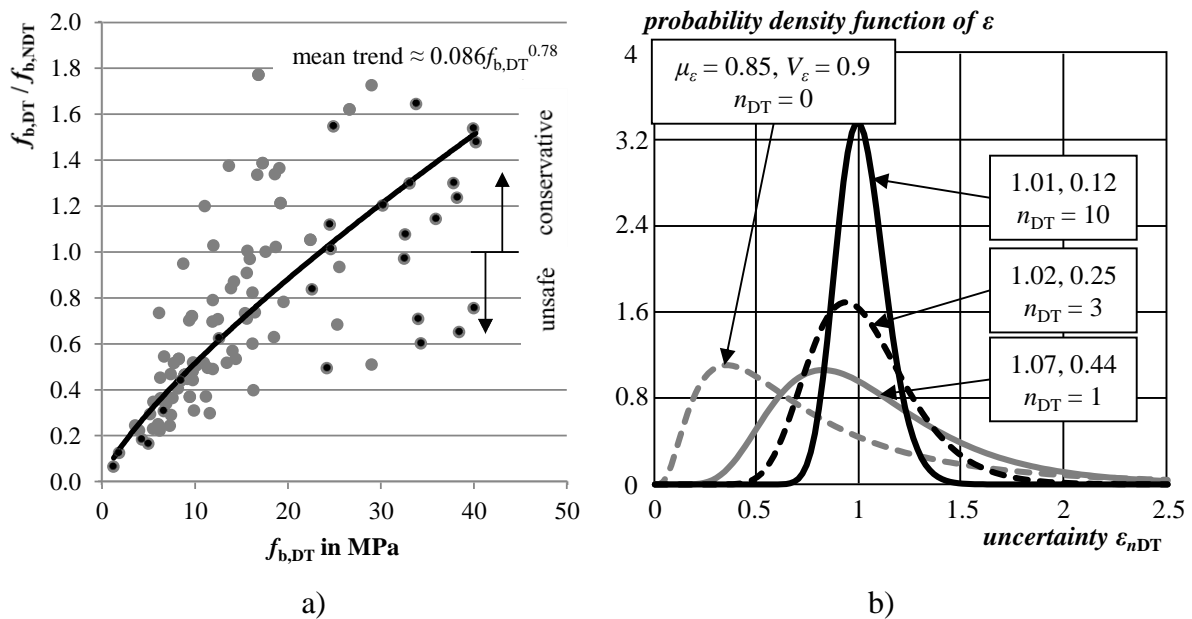
Figure 1: a) Variation of measurement uncertainty $f_{b,DT} / f_{b,NDT}$ with $f_{b,DT}$ (grey dots – clay bricks; black dots – stones); b) Probability density function of uncertainty ε_{nDT}

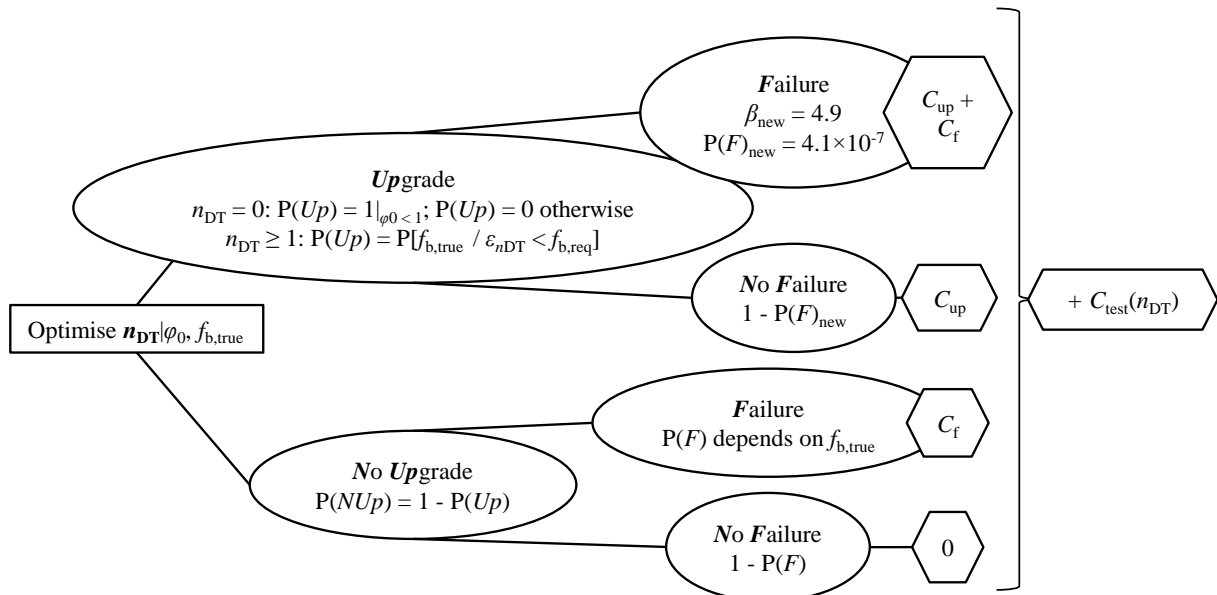
Figure 3: Decision tree for a given $f_{b,\text{true}}$

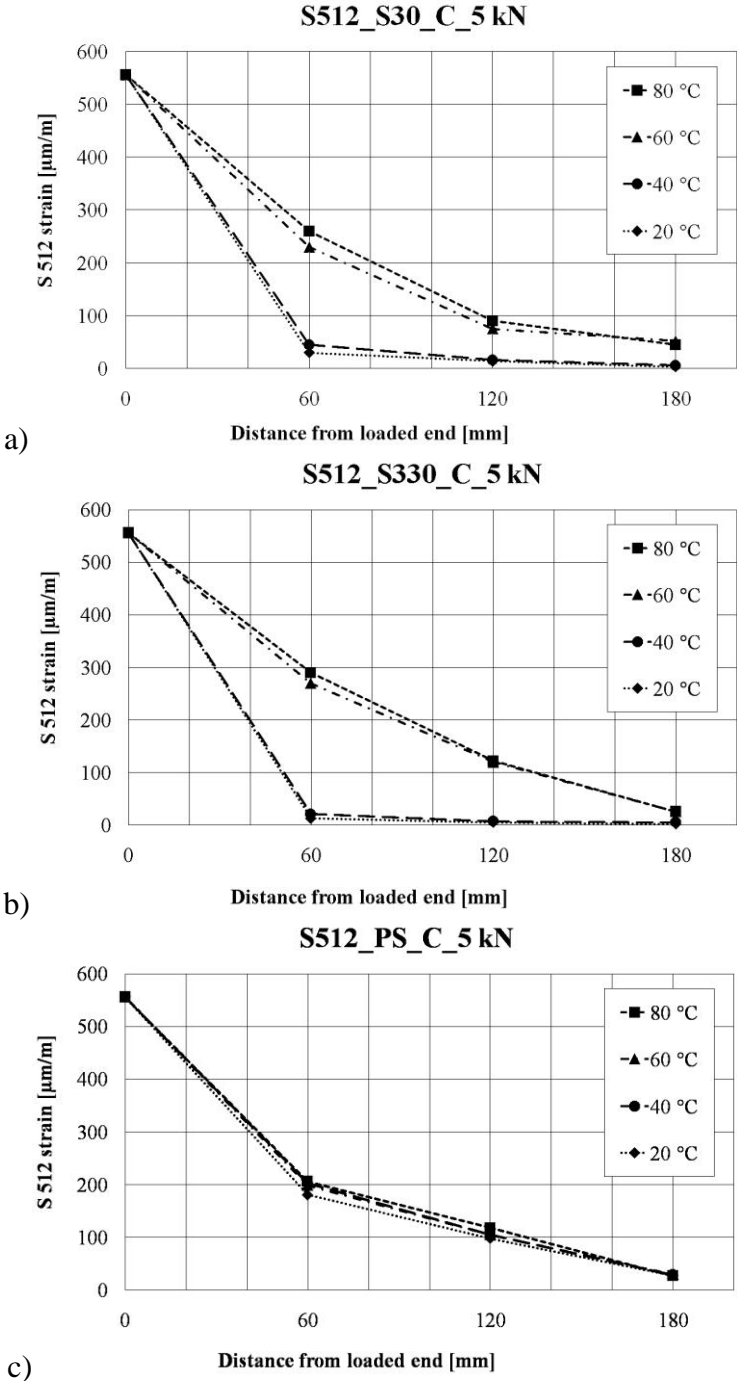
Figure 3: Strain distribution at S512 bonded to concrete substrate on epoxy S30 (a), S330 (b) and polyurethane Sika®PS (c), tested under load of 5 kN in temperatures: 20, 40, 60 and 80°C

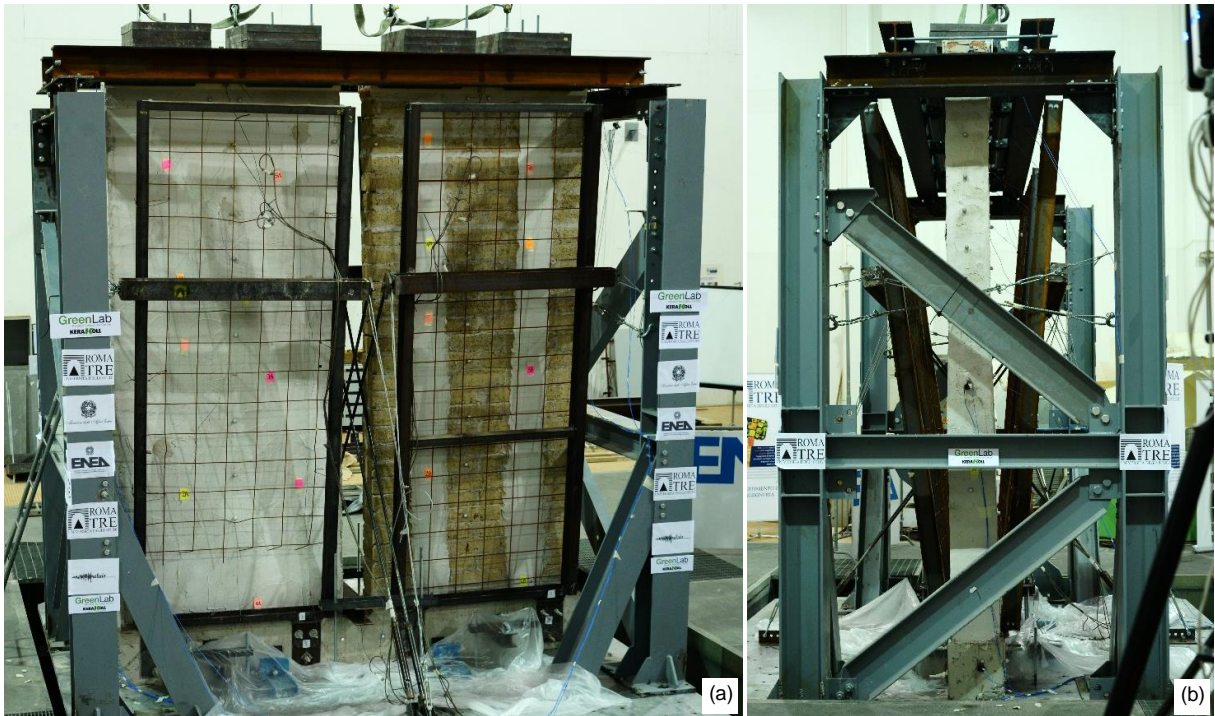
Figure 1: Front (a) and side (b) views of the experimental setup

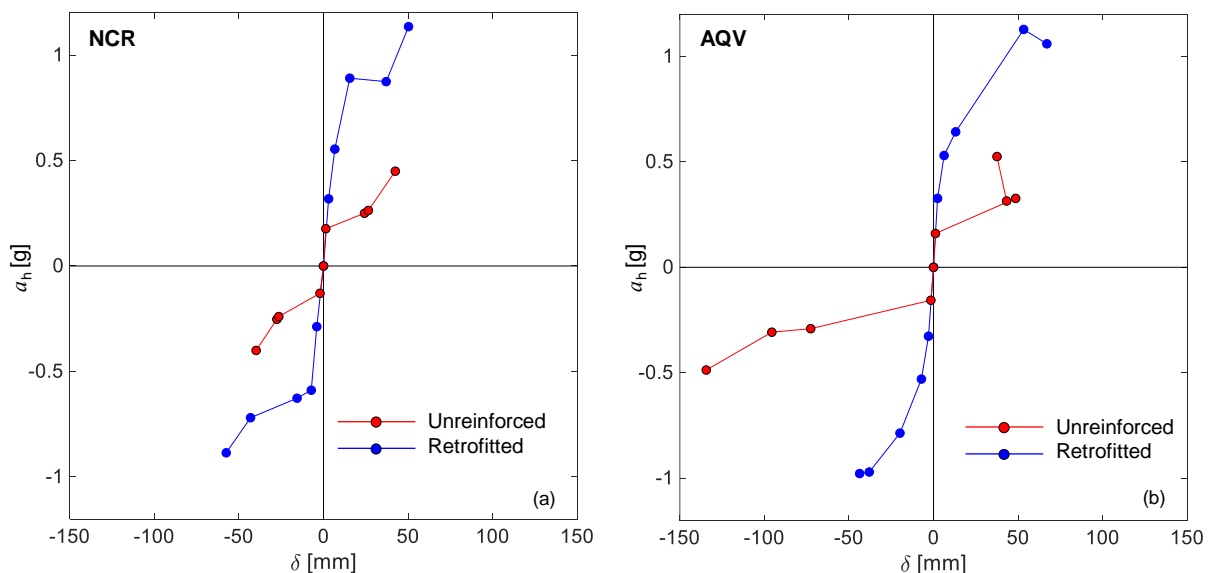
Figure 3: Maximum base acceleration vs maximum out-of-plane displacement of the stone wall before and after retrofitting with BTRM under NCR (a) and AQV (b) input signals

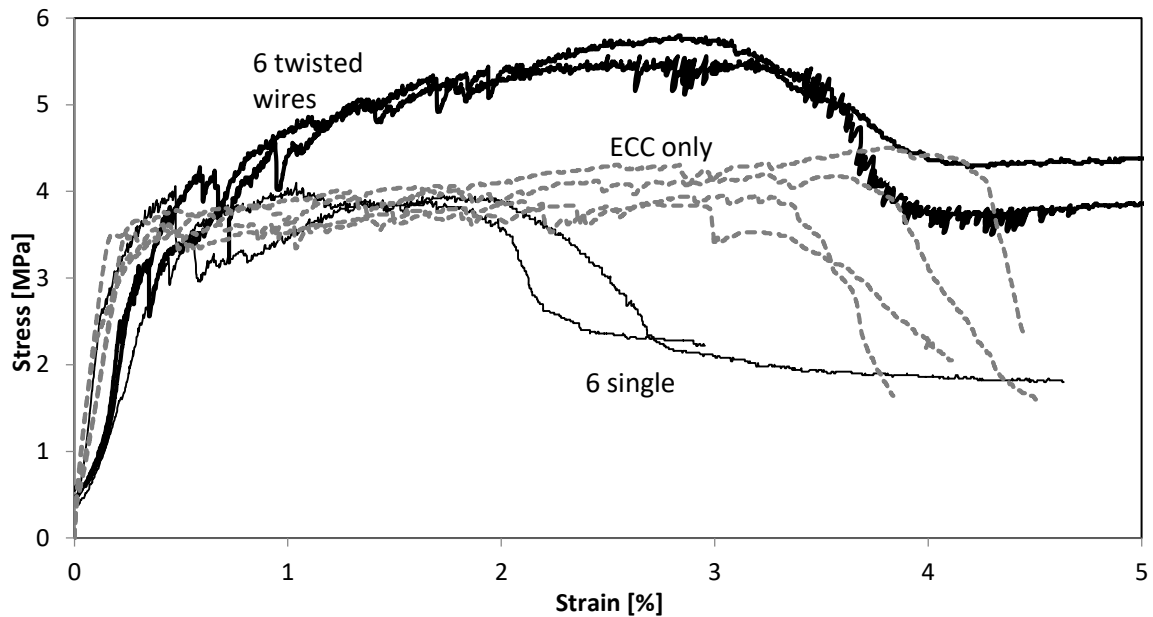
Figure 7: Tensile stress – strain responses of the ECC-Nitinol composites tested with single and twisted wires.

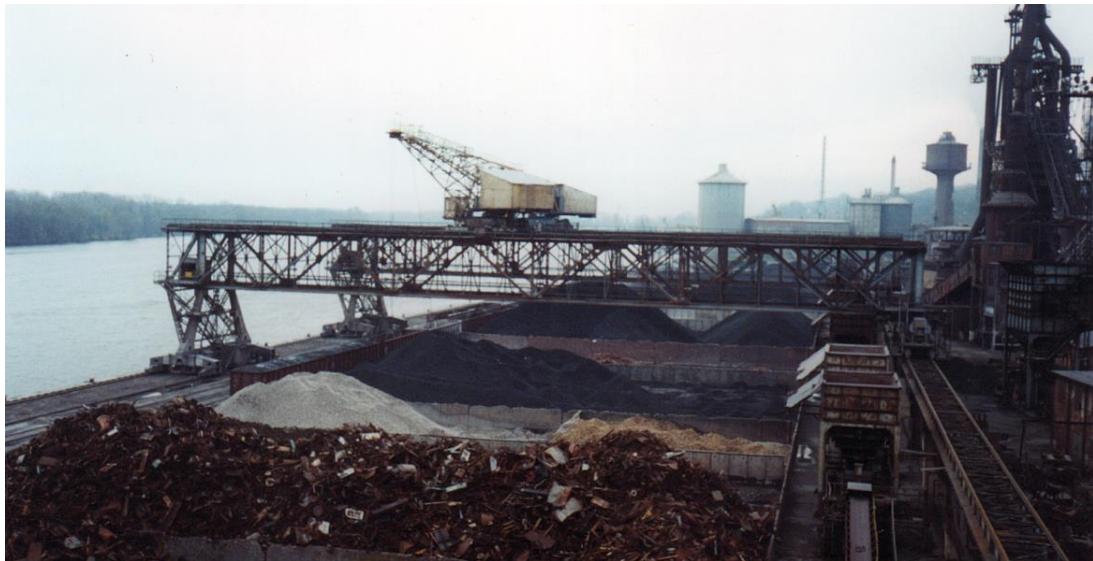
Figure 1: Semi-gantry cranes on the port wharf: a) general view, b) structure scheme
