Source / Izvornik: **Case studies in construction materials, 2022, 17, 1 - 17**

Seismic upgrading of cultural heritage – A case study using an educational building in Croatia from the historicism style

Antonela Moretić^a, Mislav Stepinac^{a,*}, Paulo B. Lourenço^b

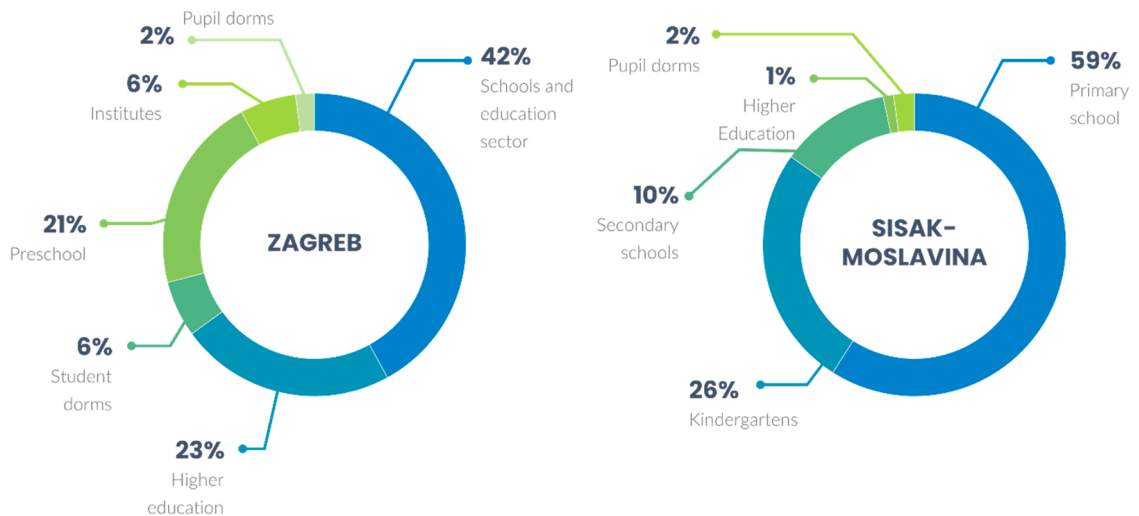
Fig. 2. Damaged buildings of the education sector in the 2020 Croatia earthquakes and two different regions [3,4].

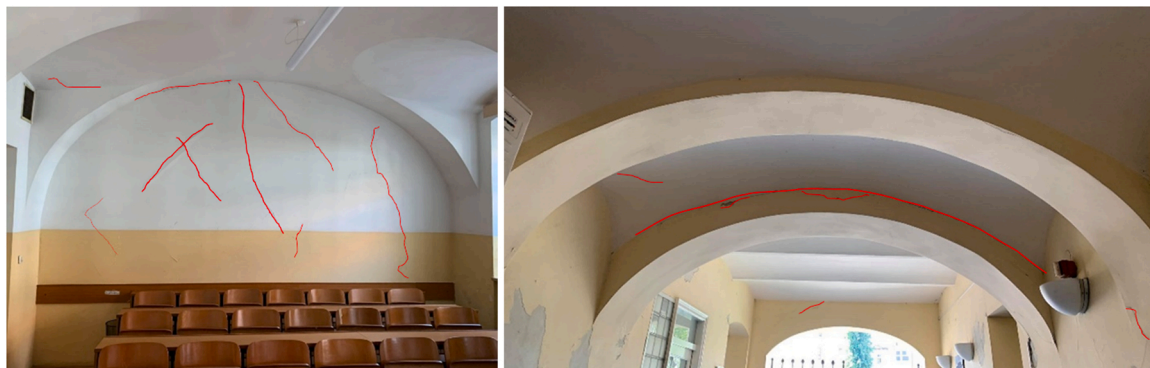
Fig. 6. Characteristic cracks, marked with a red line (photo credit: Mislav Stepinac).

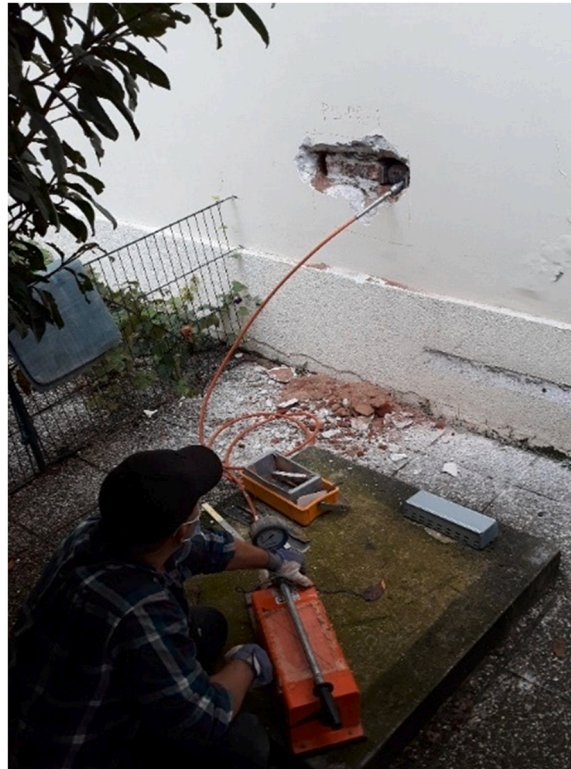
Fig. 8. Shear strength test of masonry [12].

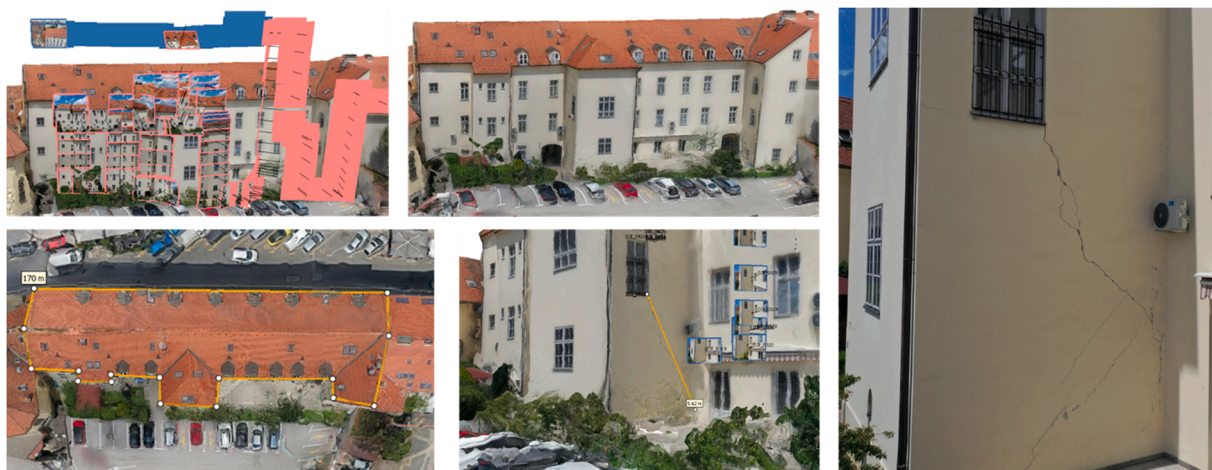
Fig. 9. Photogrammetric view of the building, respectively with positions of the camera, photogrammetric model, measuring of the roof geometry, measuring of a crack, photo of a crack.

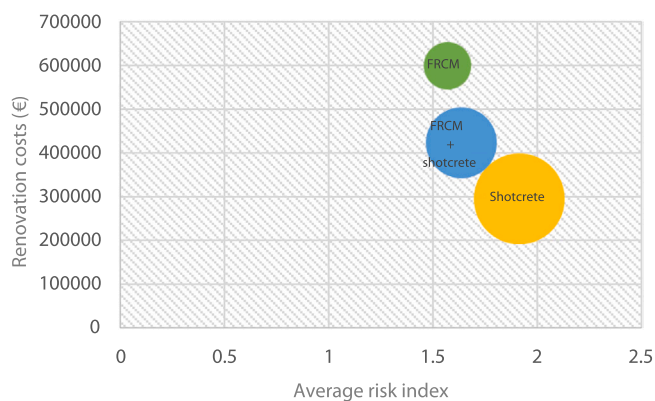
Fig. 19. Renovation costs, average risk indices and environmental impact.

Fig. 19 shows the comparison of strengthening variants considering capacity and renovation costs. Given that the requirements of sustainability in the construction sector are becoming more and more important, the approximate environmental impact was also calculated. The diameter of the circles represents the ratio of CO₂ emissions during the production of the required quantities of materials for each variant of strengthening. It must be noted that ratios do not include the emissions of CO₂ during the phases of transportation, construction, use and demolishing or recycling but only during the material production phase. Carbon dioxide emissions are calculated using software SimaPro [44]. The following values were taken (referring to climate change impact category only): 3,91 kg CO₂/kg fibers, 282 kg CO₂/m³ concrete, 5,01 kg CO₂/kg steel (Table 12). Carbon cost in Croatia in 2020 was estimated to 25,6 €/t CO₂, while it is expected to increase to 93,1 €/t CO₂ by 2050 [45]. Total carbon costs for each strengthening variant are displayed in Fig. 20. Although the application of shotcrete is often used in practice and is the only variant by which the resistance of the structure is brought to the level 4 defined by the relevant codes, in this case, its invasiveness and environmental impact should not be neglected.

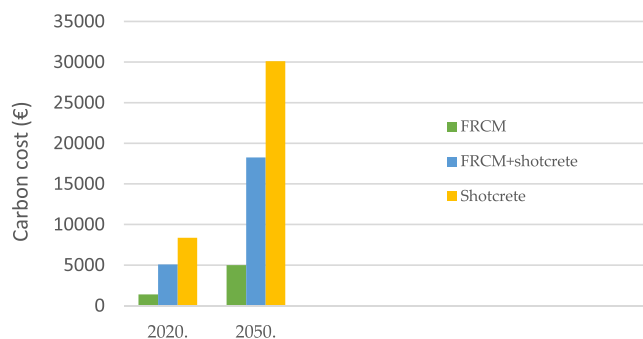
Fig. 20. Carbon costs for current market and future projections.
