Condition Assessment and Seismic Upgrading Strategy of RC Structures—A Case Study of a Public Institution in Croatia

Abstract: In 2020, Croatia was struck by two catastrophic earthquakes, resulting in more than 50,000 damaged structures. The majority of these are masonry buildings, but there are a number of reinforced concrete structures that suffered moderate to extensive damage. In this paper, the seismic condition assessment and upgrading of existing RC structures are presented with a case study building in Zagreb. The assessment procedure includes initial visual inspection, rapid preliminary evaluation, detailed in situ measurements, and non- and semi-destructive methods. New technologies were applied and followed by numerical modeling and verifications. Strengthening proposals are made that respect owner needs and the needs for the energy retrofitting of the existing RC building. As the integrated approach should be respected in the renovation of existing buildings, this case study can represent an example of good practice in the process of seismic and energy retrofitting.

Keywords: assessment; RC; earthquake; Zagreb; case study; NDT; seismic analysis

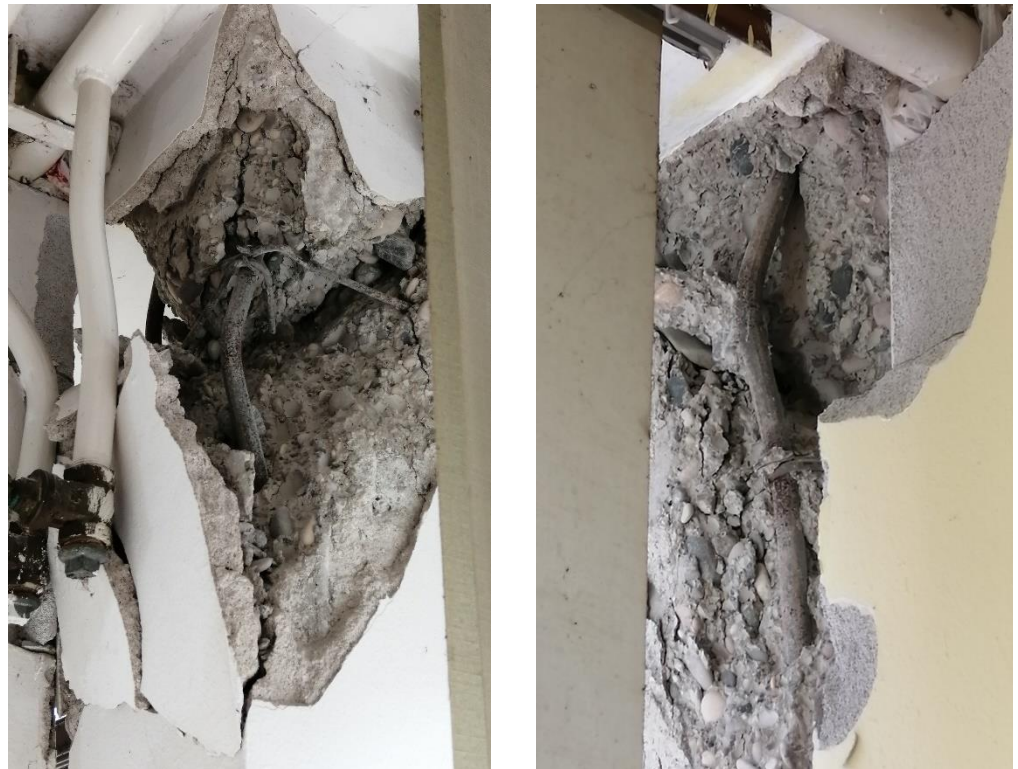
Figure 1. Buckling of plain bar reinforcement on top of the RC piers.

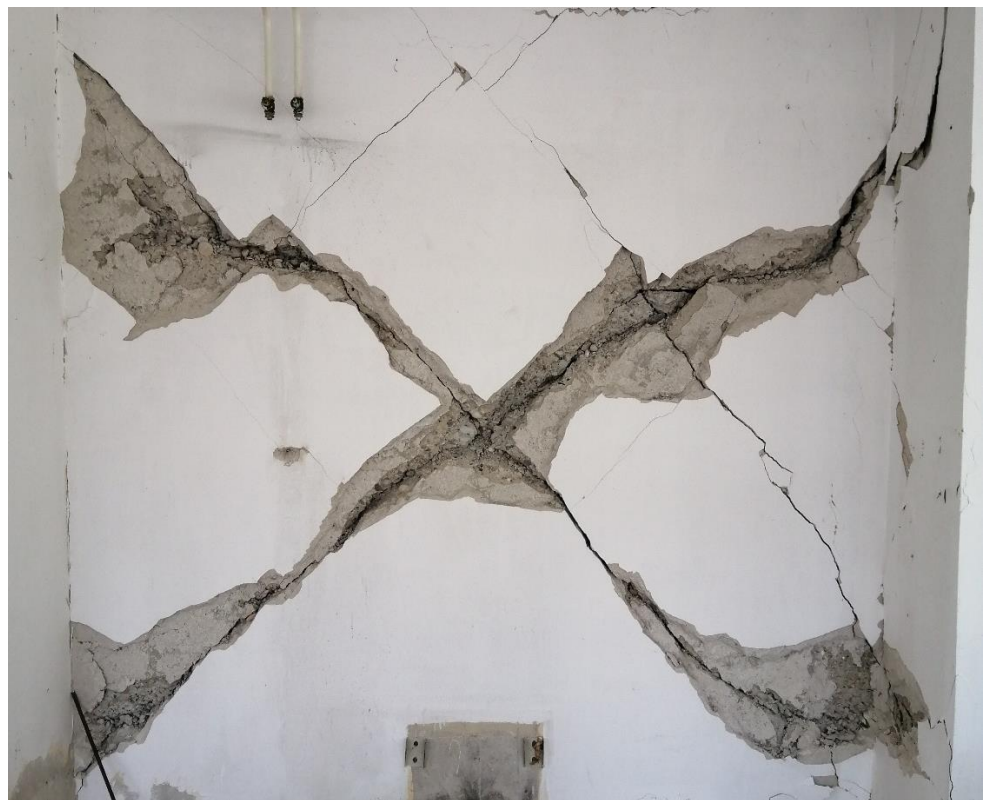
Figure 2. Diagonal cracks in the lightly reinforced RC shear wall.

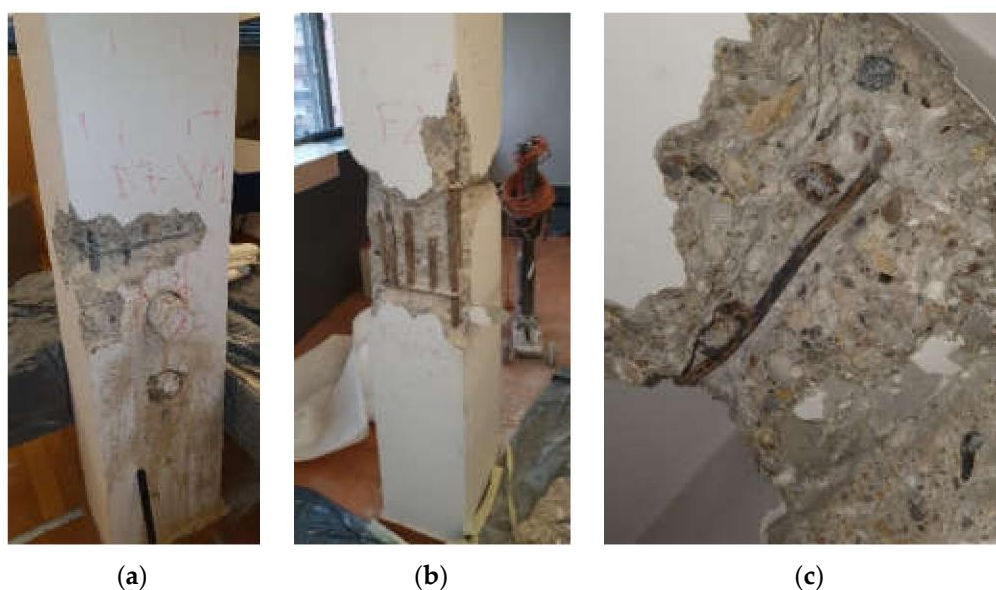
In the columns on the ground floor and the second floor, and the reinforced concrete beam above, the second-floor concrete cover was removed to inspect the reinforcements (Figure 13).

Figure 13. Column on the ground floor (a), second floor (b), and a beam on the 2nd floor (c).

In situ testing (Section 3.1.3.) showed that the shear walls are reinforced with an uneven mesh on each side of the wall, consisting of Ø8 bars spaced 15 cm in the vertical direction and 25 cm in the horizontal direction. It is assumed that the corners of each wall are reinforced with four Ø20 plain bars. The shear failure verification was conducted for each wall on each story, and an example of the results is given in Table 9 for axis A on the basement level. As the shear force V_{Ed} exceeds $V_{Rd,s}$, the wall was not validated as safe.

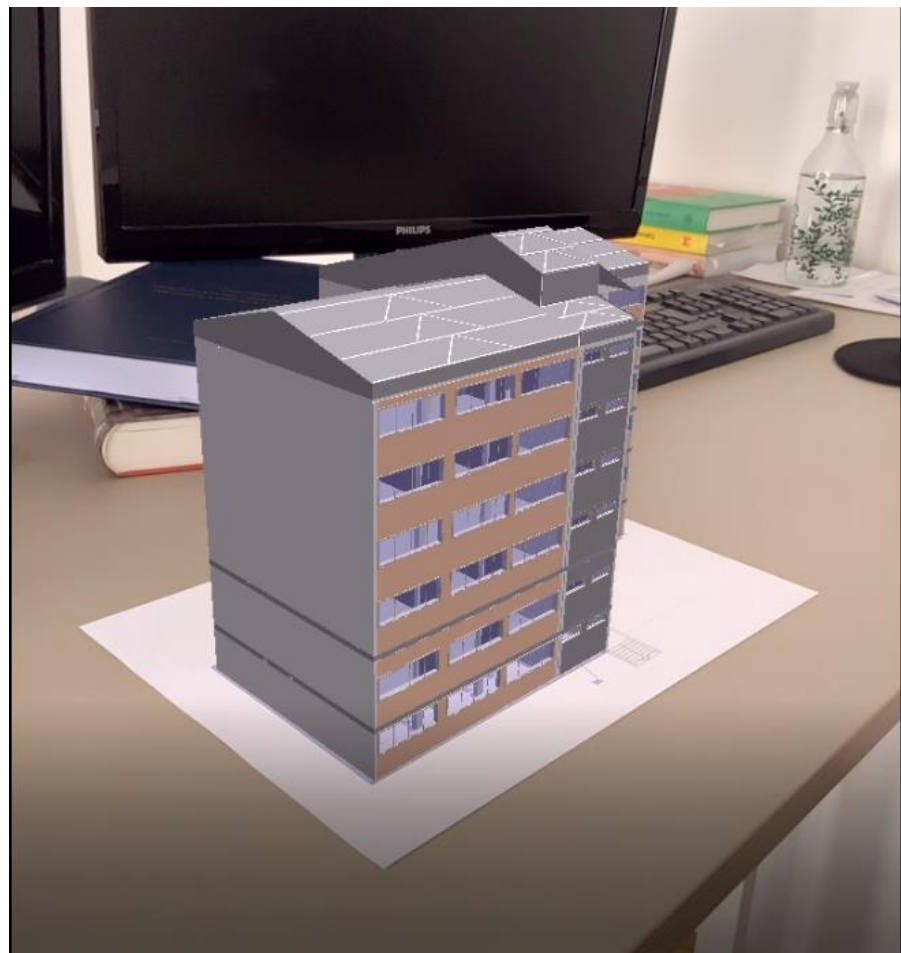
The model can be scaled from a smaller size (Figure 16) to a real-size object that can be inspected and compared to an existing building.

Figure 16. Scaled-down BIM model in augmented reality.
