Condition Assessment and Seismic Upgrading Strategy of RC Structures-A Case Study of a Public Institution in Croatia

Source / Izvornik: **Buildings**, 2022, 12, 1 - 28

Condition Assessment and Seismic Upgrading Strategy of RC Structures—A Case Study of a Public Institution in Croatia

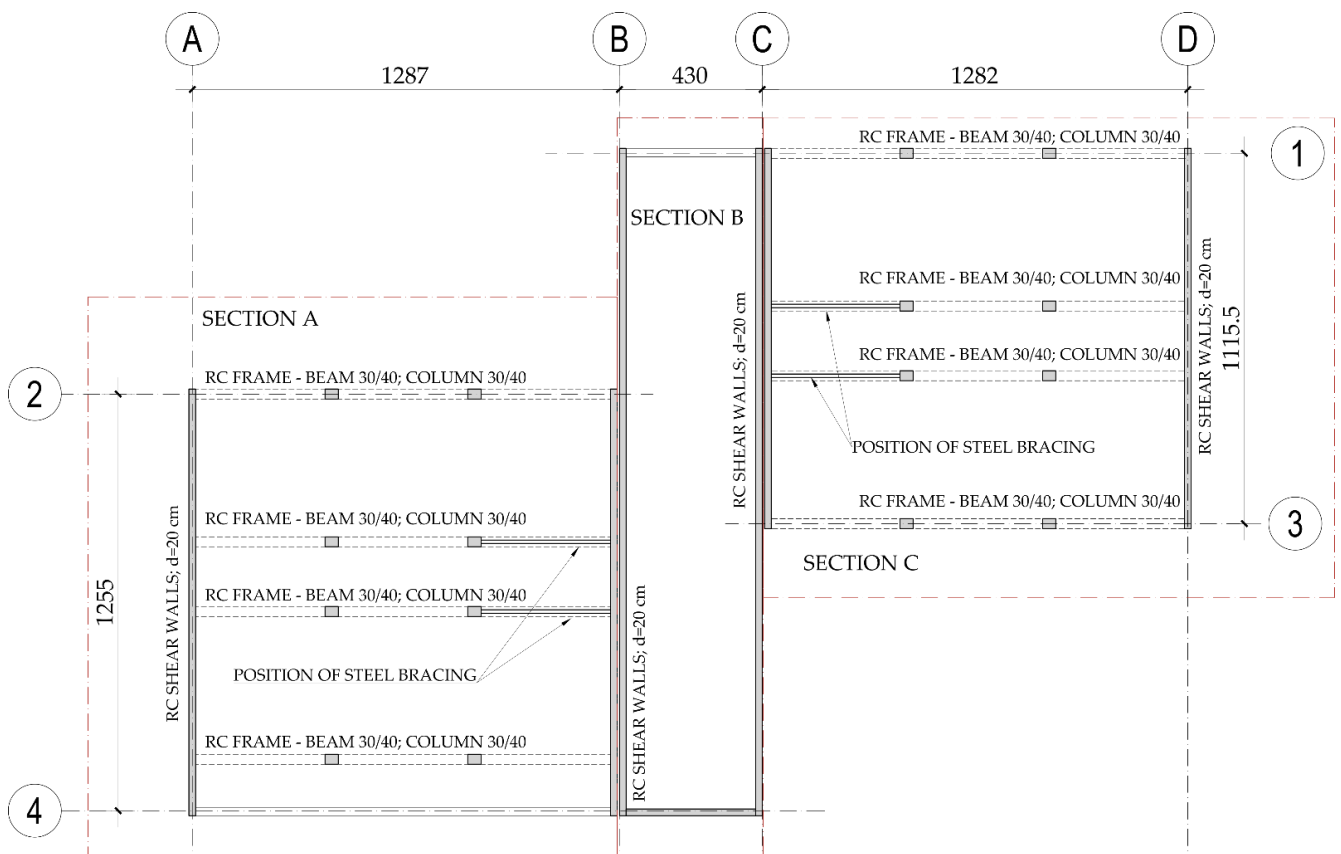
The case study building is divided into three structural sections, labeled as sections A to C. Each section is a structural system of its own, with a 7 cm joint between them, in accordance with the seismic joint condition, part 4.4.2.7. in EN 1998-1 [15]. The structural system of sections A and C is a combination of uncoupled shear walls and frames, while section B is comprised only of shear walls, as shown on the characteristic floorplan in Figure 5. Reinforced concrete walls are 20 cm thick (except in the basement where the walls are 30 cm thick), and the columns have a cross-section of 30 × 40 cm on which the beams with a height of 40 cm are supported. Floor structures are RC slabs, with a thickness of 14 cm. There are a total of six stories, including the basement and attic, with a total height of 18.53 m. The foundations are constructed as pad foundations for the columns and foundation beams for the shear walls.

Figure 5. Characteristic floorplan of the case study building (all units in cm).
