# Assessment of Performance Indicators of a Large-Span Reinforced Concrete Arch Bridge in a Multi-Hazard Environment

Source / Izvornik: **Buildings**, 2022, 12(7)

**Abstract:** Assessment of a single bridge and management system for all bridges in the network is still a major challenge, although much research has been carried out and implemented in existing networks over the last four decades. This paper presents a case study of a long-span arch bridge, the Maslenica Motorway Bridge, located in a multi-hazard maritime environment. Although special attention was paid to durability during design, the bridge required repair after 20 years of operation. The analysis includes an overview of the design project, structural health monitoring during construction and operation, numerous laboratory and in-situ testing, numerical analysis of structural capacity and remaining service life, and meteorological monitoring of the bridge site. A new approach to bridge assessment is presented that includes not only a deterioration index, but five groups of key performance indicators: (1) safety, reliability, and security; (2) availability and maintainability; (3) costs; (4) the environment; and (5)

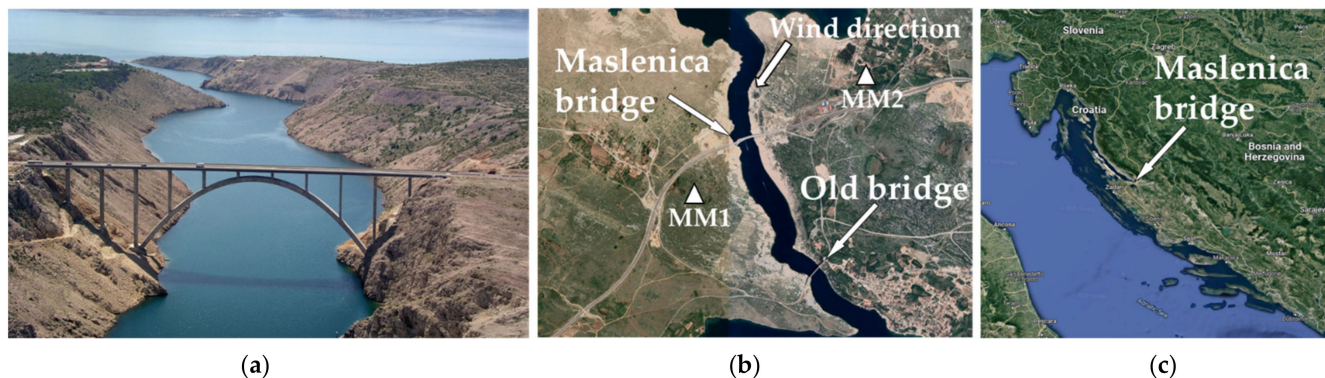
**Figure 1.** The Case Study—Maslenica Motorway Bridge: (a) view, (b) micro-location with meteorological stations (MM1 and MM2), and (c) macro-location.

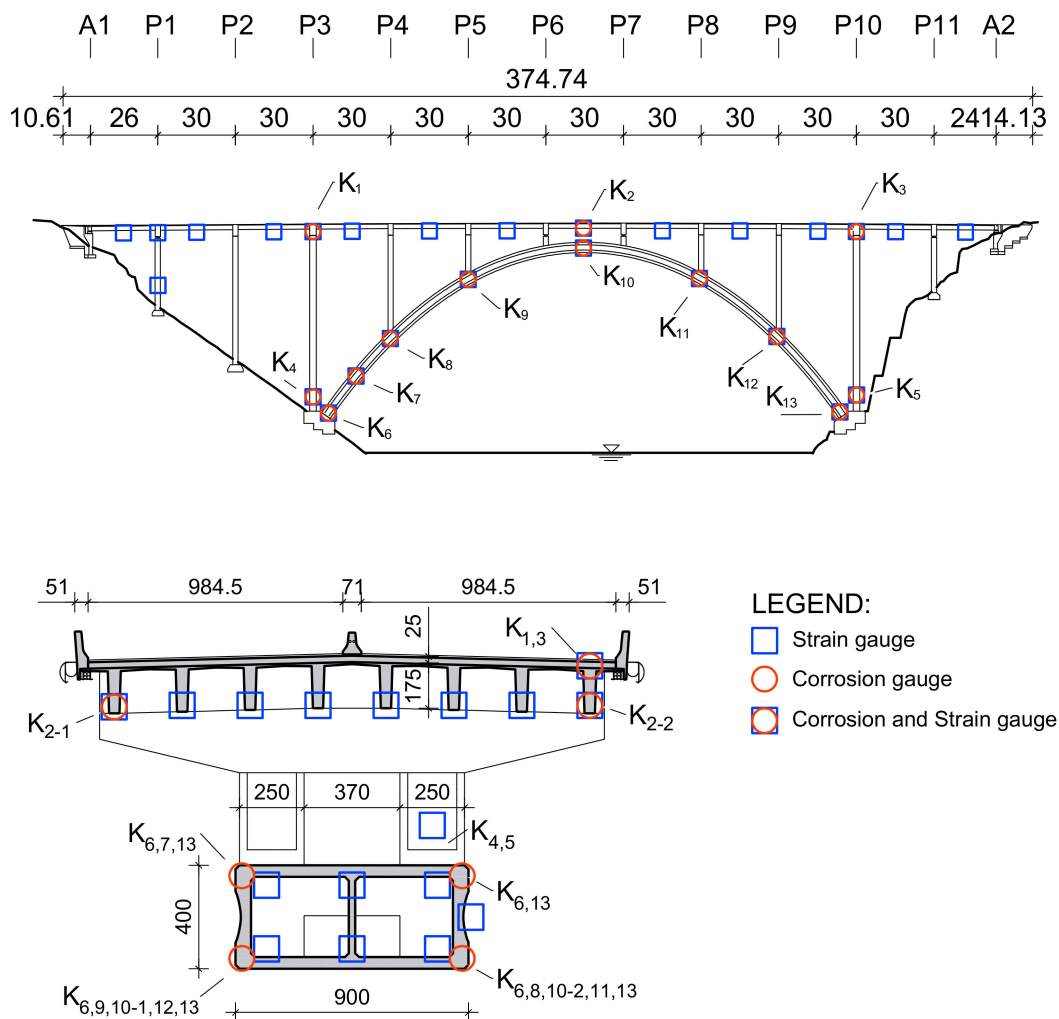
The installed monitoring system included (Figure 2):

- Ninety-two strain gauges (18 on the concrete and 74 on the reinforcement);
- Forty temperature sensors;
- Twenty-one corrosion sensors (anode-ladder);

Figure 2. Location of strain and corrosion gauges installed on the Maslenica Bridge.

These were placed at carefully selected locations on the arch and girders of the superstructure (Figure 2).

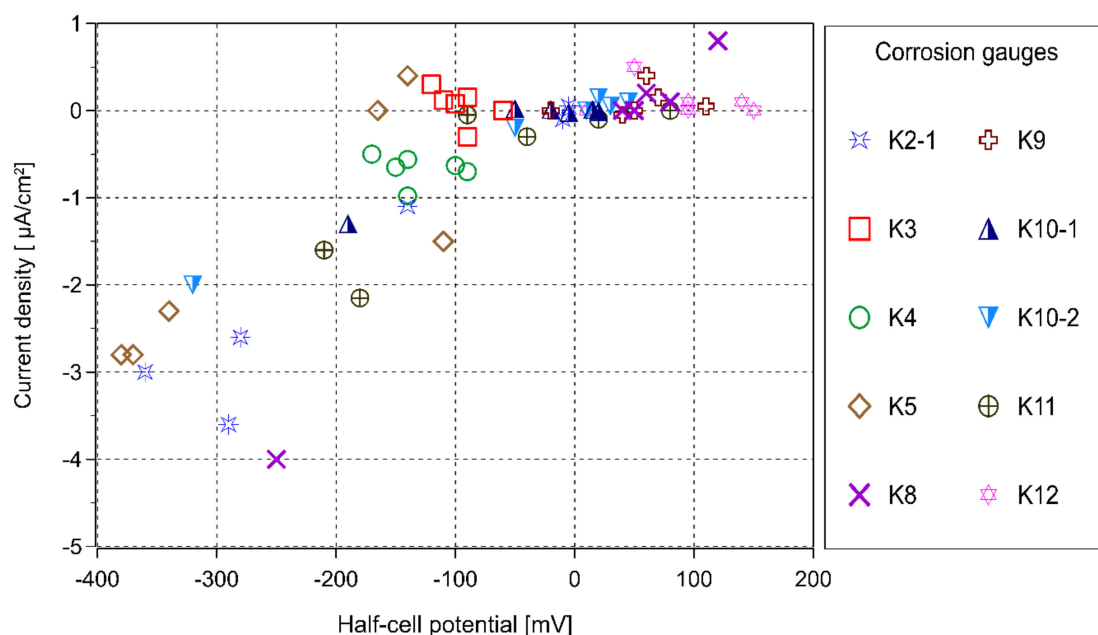
The corrosion monitoring results obtained in 2014 after the repair and recommissioning of the corrosion measurement devices are shown in Figure 3 [25]. Six values of electrical potential and current density were recorded for each sensor. The electrical potential ranges from +100 mV to  $-400$  mV, while the current density varies from  $0.7 \mu\text{A}/\text{cm}^2$  to  $-4.0 \mu\text{A}/\text{cm}^2$ . The lowest corrosion risk with the lowest absolute values of corrosion rates and half-cell potential in all six measured depths was observed at the following three sensors: K3, on the top of the main girder; and K9, and K12, on the bottom part of the arch at 65 m and 40 m above sea level. The highest risk of corrosion is observed at the locations with the lowest values of half-cell potentials ( $\leq -250$  mV) and current densities ( $\leq -2.0 \mu\text{A}/\text{cm}^2$ ): at the lower part of the main girder (K2-1) and arch (K10-2) at the position of the arch crown (more than 70 m above sea level), at the lower part of the portal pier P10 (K5), and at the lower part of the arch (K8) at pier P8. At the lower part of the arch crown (K10-2) and the arch segment 40 m above sea level (K8), a lower half-cell potential and current density were measured only at the anodes closest to the concrete surface, while the current densities at deeper layers of the concrete cover were negligible. However, 10 m above the arch crown, on the lower part of the main girder (K2-1), and the lower part of the portal pier P10 (K5), high current densities were detected, even in deeper concrete layers [25].

**Figure 3.** Results of corrosion monitoring after 17 years of exposure to the maritime conditions.

The repaired sensors installed on the arch (K8-K12) measured different values of current density and half-cell potential. A negligible corrosion risk on the arch was observed at sensors K9 (east coast, 50 m a.s.l.) and K12 (west coast, 20 m a.s.l.), while the most unfavorable values for reinforcement corrosion were measured at sensors K8 (east coast, 30 m a.s.l.) and K10 (at the arch crown, 70 m a.s.l.).

Sensors K3 and K2-1 are located on the superstructure; while sensor K-3 on the upper part at the pier P10 measured the minimum values of current densities, sensor K2-1 on the bottom part of the girder above the arch crown showed a significantly higher risk for corrosion. At almost the same height above sea level, different corrosion rates were measured at the main girders. Therefore, no correlation with the height above sea level can be established.

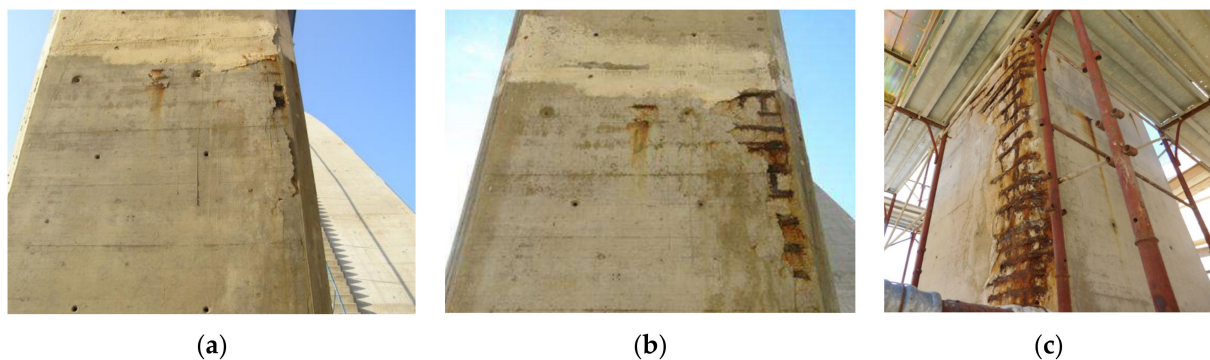
A visual inspection in 2006 revealed corrosion-related damage to piers, piers foundations, the arch, and abutments (Figure 4a). In addition to the maritime environment, the causes include inadequate concrete cover, poor construction quality, and lack of maintenance [22]. Besides cracks generated during or immediately after construction, structural cracks and concrete layering were observed on the pier P2. The worst damage was found on pier P3, especially on the surface exposed to the NE bora wind. There was no significant visible damage to the abutments and the lower part of the superstructure, but there was water leakage through the expansion joint [22].

**Figure 4.** Propagation of corrosion of the reinforcement on the pier P3 in different periods: (a) 2006, (b) 2010; (c) 2017—shortly before repair.

A detailed visual inspection in 2010 and additional testing in 2012 confirmed further deterioration of the bridge (Figure 4b). Defects during construction and water leakage through the expansion joint were noticed on the abutments. Piers, particularly those above the arch abutments (P3 and P10) were in the worst condition and need repair. There were defects during construction, cracks, and delamination of concrete cover. Similar damage, but at a lower level, was noted on the exterior surface of the arch. Rainwater was seeping through the built-in openings in the arch boxes, while the stairs for inspection were completely damaged. Insufficient concrete cover and corrosion-induced damage was also noticed on the arch abutments [23]. On the main girders, a protective coating was damaged, while other defects were localized. The asphalt pavement was damaged and deteriorated, as it was not renewed after the opening of the bridge. There was also minor damage to the

Unfortunately, it was a poor decision by the designer not to include these pier foundations in the repair. As can be seen in Figure 4, the structural element corrodes rapidly once active corrosion of the reinforcement begins. Only 11 years have passed since the first visible signs of corrosion (brown spots, Figure 4a) to the spalling of the concrete cover and the reduction in the reinforcement cross-section (Figure 4c).

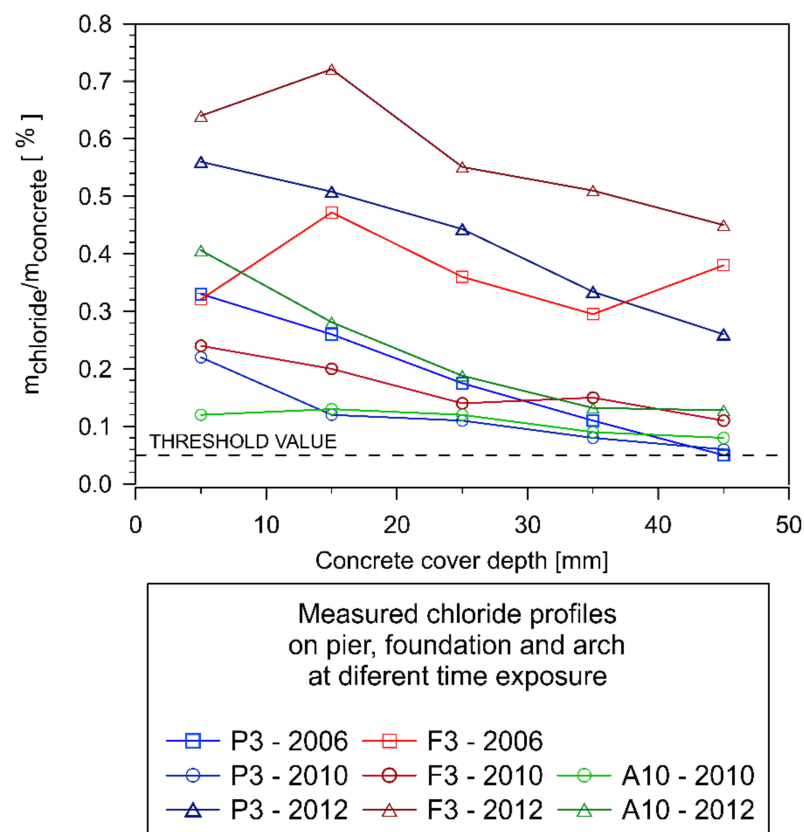
Testing in 2006 showed that the threshold chloride content of 0.4% of the mass of cement or 0.05% of the mass of concrete had been reached at the reinforcement level on 10 of the total of 14 measuring locations on piers and exposed parts of the pier foundations. More extensive results were obtained four years later, showing that the measured locations on girders, piers, the arch, and pier and arch foundations, exposed to the dominant bora wind from the north, reached the threshold chloride value at the reinforcement level; however, on the opposite sides of the same structural elements, sheltered from the wind, chloride content at the reinforcement level was low, on average 0.01% of the concrete mass. Measurements in 2012 were focused on the most vulnerable surfaces on piers, the arch, and pier and arch foundations. On all 16 samples, chloride content at the depth of 5 cm not only reached the threshold value but surpassed it by almost 10 times (Figure 5).

**Figure 5.** Measured chloride profile on pier P3 (15 m above sea level, surface exposed to NNE), joint pier P3 and arch foundation F3 (10 m above sea level, surface exposed to ENE), and arch segment close to the arch foundation at pier P10 (10 m above sea level, surface exposed to ENE) in different time periods: 2006, 2010 and 2012.

In Figure 5, measured chloride profiles are presented on three groups of elements: pier P3 (15 m above sea level, surface exposed to NNE), joint pier P3 and arch foundation F3 (10 m above sea level, surface exposed to ENE), and the arch segment close to the arch foundation at pier P10 (15 m above sea level, surface exposed to ENE) in different time periods: 2006, 2010 and 2012. According to the measured values, it can be concluded that reinforcement depassivation had already started in 2006, after 9 years of exposure to the maritime environment. Active corrosion of steel reinforcement caused cracks and damage

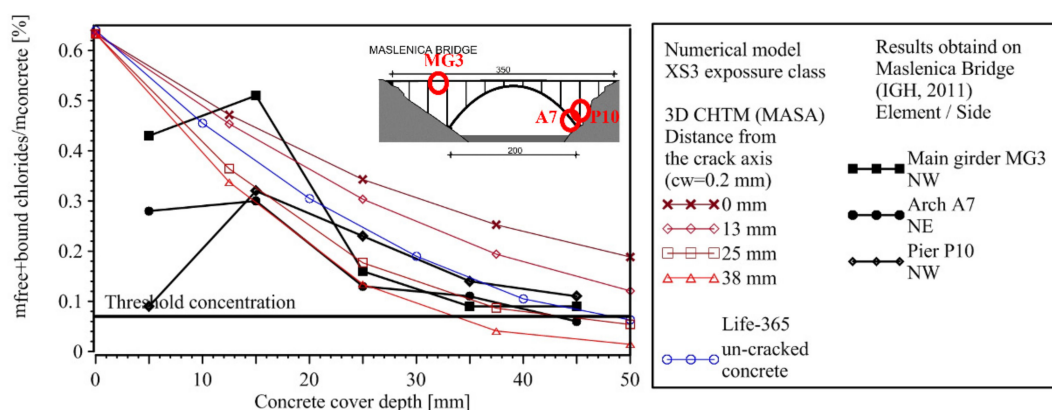
Chloride penetration in concrete is analyzed again after 13 years of exposure using two models for service life prediction, Life-365 and 3D chemo-hygro-thermo-mechanical (3D CHTM) model [41,42]. In addition, two environmental exposure conditions XS1 (airborne chloride) and XS3 (splash zone), were considered according to the European Standard EN 206:2013. The assumed surface chloride concentration for both models is 0.25% and 0.64% of the concrete mass for exposure classes XS1 and XS3, respectively. The initial chloride diffusivity is relatively low and the same for both models:  $7.94 \times 10^{-12} \text{ m}^2/\text{s}$  for the Life-365 and  $5.50 \times 10^{-12} \text{ m}^2/\text{ s}$  for the 3D CHTM model. The comparison with measured data (Figure 6) led to the conclusion that both models are able to realistically predict the chloride concentration in concrete after a long period of time (more than 10 years). However, the 3D CHTM numerical model, which considers cracks in the concrete, predicts the depassivation time much more accurately [18,39,40]. Life prediction analysis combined with other testing methods leads to the conclusion that a service life of 100 years can be achieved with the designed concrete quality and concrete cover depth. However, cracks and damage in the concrete that occur during construction and exploration shorten the depassivation time to less than 10 years [18,39,40].

**Figure 6.** The total chloride content in concrete after 13 years of sea exposure: comparison of the numerical results and measured values on the Maslenica Bridge (reproduced with permission from [40], IOP Proceedings, 2019).

It should be noted that both models assume constant boundary conditions: surface chloride concentration, water saturation, relative humidity, and temperature, while chlorides penetrate into concrete by diffusion. Therefore, the effects of climate change, seasonal and long-term weather variations, as well as wetting–drying cycles, effects of precipitation, and other types of chloride transport are not considered, although their influence can be significant [46,51–53]. However, the focus of the analysis is on demonstrating the impact of cracks on chloride concentration in cracked and the local uncracked concrete.

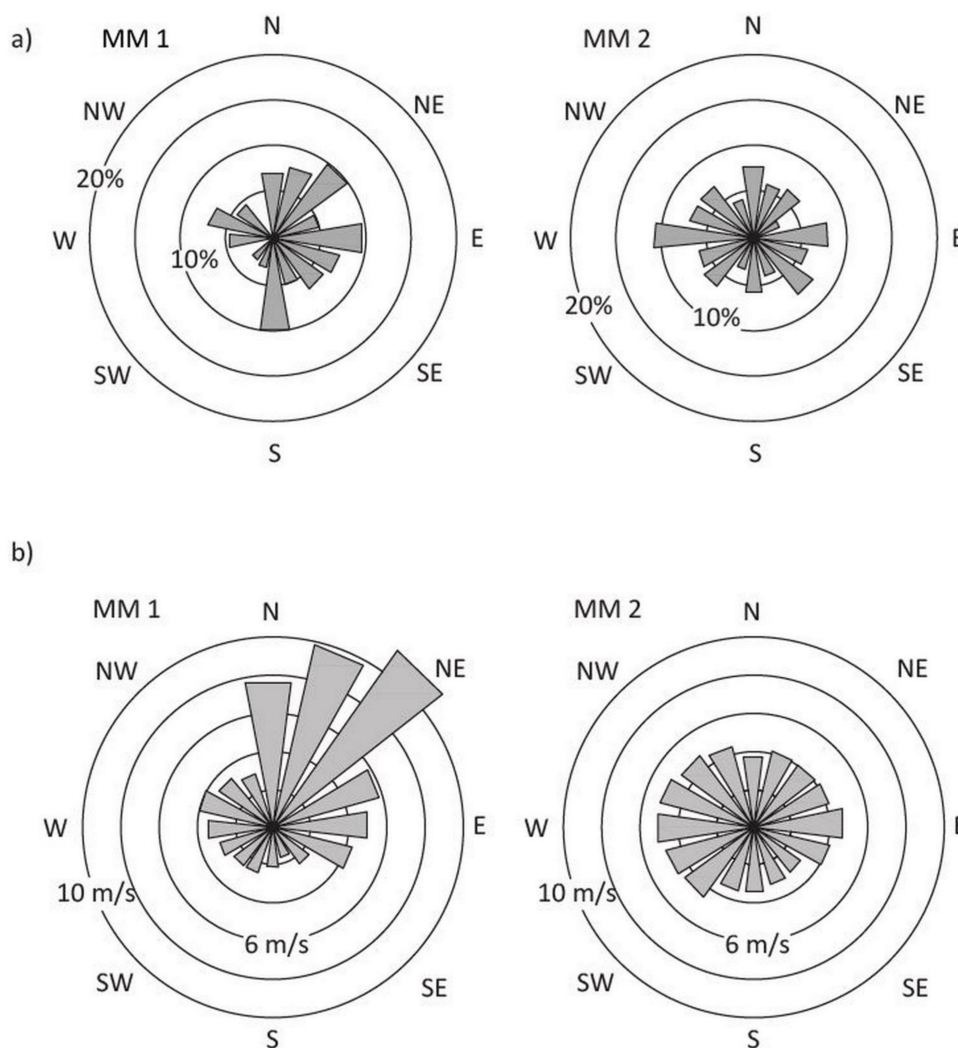
The distribution of wind direction and speed is the first indicator of the airflow regime at a location. The wind roses (Figure 7) near the Maslenica Bridge show that the flow regime on both sides of the bridge differs significantly. On the Zadar side of the Maslenica Bridge (MM1), winds from the N–NE–E directions (bora), with an average speed of more than 10 m/s, predominate. Although the meteorological station MM2 is located a small distance from MM1, the differences in the airflow regime are significant. The winds from the W–NW and SE–S are much more frequent, and the wind direction is determined by the provision of the sea channel, which significantly affects the wind at the MM2 site [43].

**Figure 7.** Distribution of (a) frequencies and (b) medium speed of wind direction at the observed meteorological stations for the periods 1998–2002 (for MM1) and 2000–2002 (for MM2) (adapted with permission from [43], Croatian Association of Civil Engineers, 2003).

A gale-force wind (bora wind) with an average hourly speed of more than 17.1 m/s is registered at MM1 in 4% of cases per year, which is the highest recorded frequency of strong winds in Croatia [43].

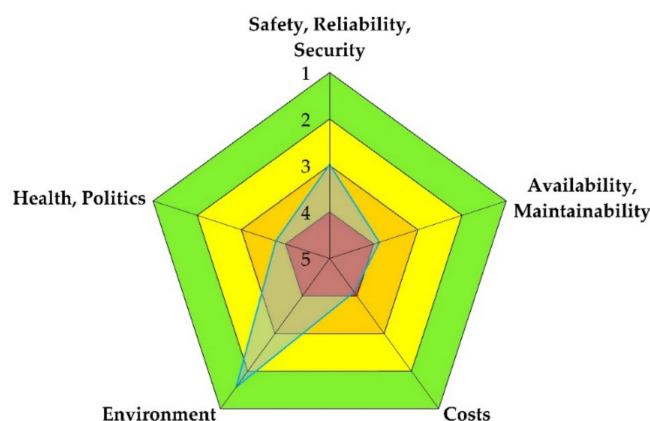
The final results of all assessed KPIs are in the form of a colored spider diagram (Figure 8) and Table 13. The spider diagram is represented by traffic light colors: green areas represent the most favorable rate, yellow and orange areas should warn the bridge operator, while red areas require immediate intervention [55–57].

Figure 8. Spider diagram of all KPI rates.
