# Fatigue Behaviour of Aluminium Members with Different Notch Root Shapes

*Source / Izvornik:* **Buildings, 2022, 12(5)**

**Keywords:** notch; aluminium profile; fatigue; wind action; stress concentration; unitised curtain wall

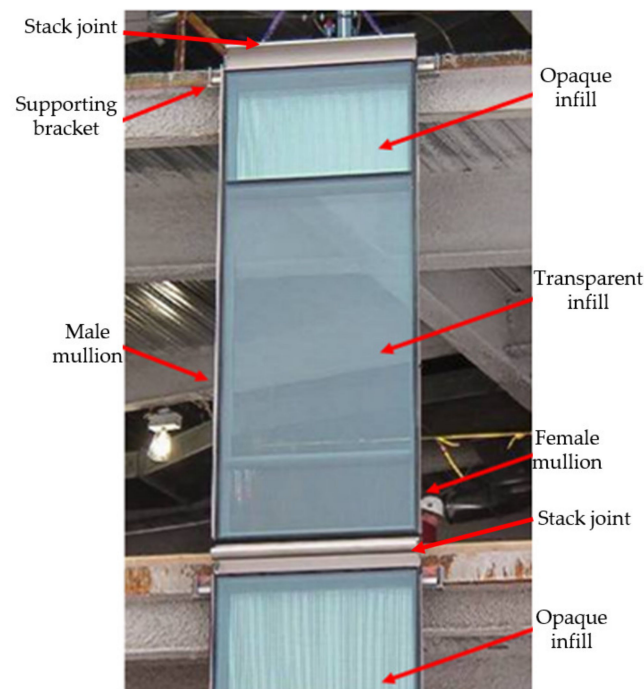
**Figure 1.** Typical curtain wall unit.

Aluminium structural alloys are applied in a wide field within the construction industry [1]. One of their major applications in buildings is related to façades constructed as unitised curtain walls, which substitute for traditional external walls. A curtain wall consists of prefabricated units, typically one floor high, composed of loadbearing aluminium frames and infill, and completed with an external and internal finish (Figure 1). Units are interlocked horizontally with male/female mullion halves.

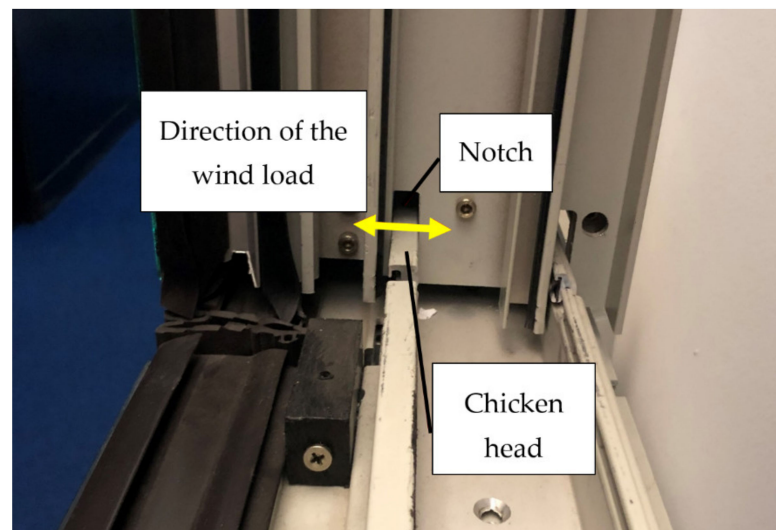
**Figure 2.** Stack joint between vertical units of a curtain wall.

The deadload of each unit is supported by brackets fixed to the main structural frame of the building at the floor level: one row of brackets per one row of units. In order to avoid the transfer of vertical loads from the main structure into the curtain wall, each horizontal row of units is connected to other rows by stack joints, allowing vertical movements independently of other rows by using available movement gaps between rows. The transfer of horizontal loads, mainly caused by wind pressure and suction, from the upper row to the lower row relies on interlocking between units at stack joints, thus creating a Gerber beam over the height of the building.

One of the common interlocking principles is the engagement of a “chicken head” feature in the transom of the lower unit into the notch in the mullion of the upper unit. The notch is exposed to the horizontal load at its tip, where the load (Figure 2) is transferred through the contact point from the vertical mullion of the upper unit to the chicken head of the lower unit. The notch is a stress riser, and the highest stress concentration occurs at the root of the notch.

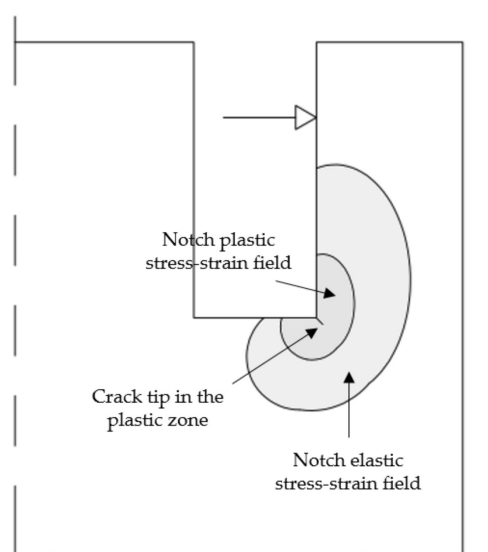
**Figure 3.** Phenomenology of crack growth through a notch stress–strain field.

A crack may nucleate from a sharp notch rather quickly due to elevated stress at the notch root. Since the deformation at the notch root is plastic, the crack initiates under conditions of local plasticity. For cracks growing into the plastic stress–strain field of a notch, the rate of the crack growth is initially high, but decreases as the crack grows further away from the notch root. As the crack exceeds 10–20% of the notch radius, the notch geometry has little influence on the stress–strain field of the advancing crack and can stop growing once it has grown out of the notch-influenced region [6]. If the crack keeps growing, it may grow into the elastic zone (Figure 3). Crack growth through a notch stress–strain field may represent a major or minor portion of the total fatigue life [7]. After the crack grows out of the plastic zone, it may grow to become significantly long.

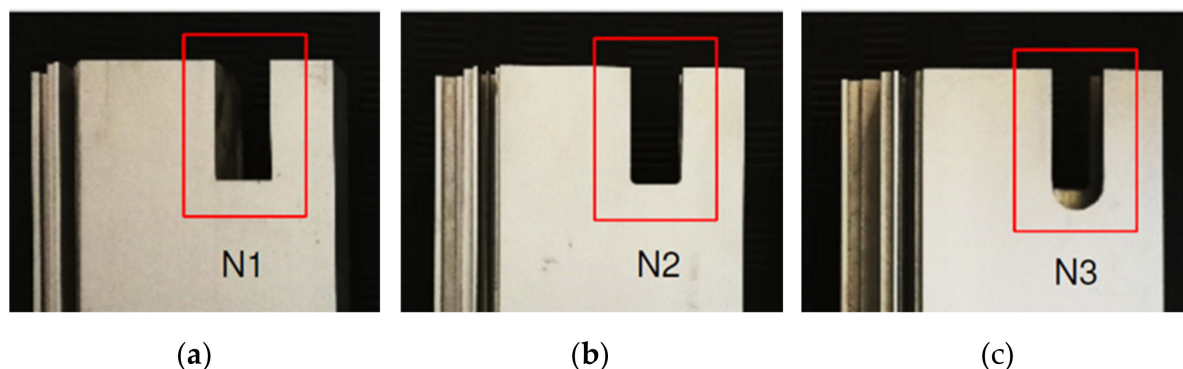
**Figure 4.** Shape of root notch: (a) sharp, N1, (b) rounded, N2, (c) semi-circular, N3.

It was known that the most structurally resilient root shape in this case would be a semi-circle with a diameter equal to the width of the notch (Figure 4c). Due to a requirement to minimise the cross-section of the frame, the semi-circular root was not practical, as it would reduce the available vertical gap for the movement, as discussed later. Hence, root corners were rounded with a radius equal to the radius of the milling bit, typically close to the thickness of the aluminium wall (Figure 4b), which corresponds to the diameter of the

smallest bit typically used for the milling of aluminium. Machining by sawing results in sharp corners on the notch (Figure 4a), which is known to be the worst condition for stress concentration. All three geometries of the notch (Figure 4) were tested, and the results were compared to numerical models. It is important to note that the width of the notches was constant, but the shape of the root of the notches was variable: sharp corners, rounded corners, and the full semi-circular root.

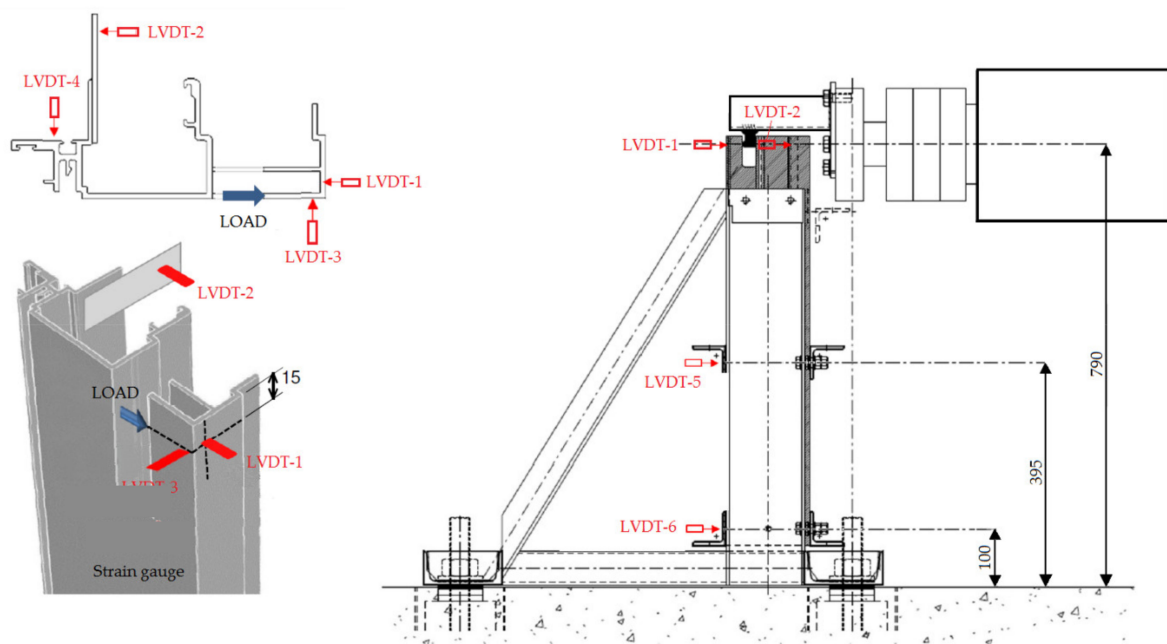
Figure 9. Positions of LVDTs.

The deformation of the specimen was measured in 6 positions. The measurement data was collected using a datalogging device that recorded all measurements at 0.01 s intervals. Displacements were measured using Linear Variable Displacement Transducers (LVDT) with an accuracy of 0.2%, as shown in Figure 9.

- LVDT-1,2,3,4 were located at the level of the application of the load.
- LVDT-1—absolute displacement at the back of the profile behind the notch in the direction of the load.
- LVDT-2—absolute displacement at the tip of the specimen in the direction of the load
- The differential of LVDT-1 – LVDT-2 measures the opening of the notch under the load.
- LVDT-3—absolute displacement at the back of the profile behind the notch perpendicular to the direction of the load.

- LVDT-4—absolute displacement at the top end of the specimen perpendicular to the direction of the load.
- The differential of LVDT-3 – LVDT-4 measures the rotation of the tip of the specimen under load.
- LVDT-5—absolute displacement of the upper support of the specimen in the direction of the load (upper angle in the steel frame).
- LVDT-6—absolute displacement of the lower support of the specimen in the direction of the load (lower angle in the steel frame).
- The displacements of LVDT-5 and LVDT-6 are used to confirm the sufficient stiffness of the supporting steel frame.
- The differential of LVDT-5 – LVDT-6 determines the rotation of the supporting steel frame in order to distinguish between movement at the tip of the specimen due to the rotation of the support and movement due to the bending of the specimen.

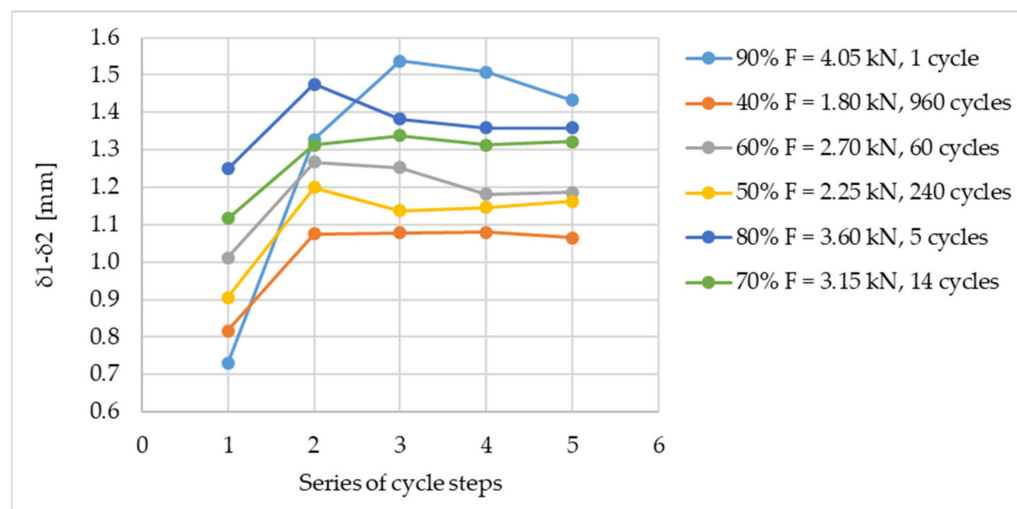
**Figure 11.** Opening of the notch, sharp notch specimen C\_N1\_1.

Figure 11 shows the diagram of the maximal opening of the notch, expressed as the difference between deflections  $\delta_1$  and  $\delta_2$  (readings of LVDT\_1 and LVDT\_2, respectively) for each set of cycles (single  $F_i$ ) in each series for the specimen with the sharp notch (C\_N1\_1). It can be noted that there was a slight increase in the opening of the notch ( $\delta_1 - \delta_2$ ) after the first series for  $F_i = 90\%$  F and  $F_i = 40\%$  F load cycles. This could be caused by the onset of the crack in the root of the notch, but this pattern was not observed on other specimens and there is no definite proof of that hypothesis. For subsequent series of cycle steps, it can be observed that a stable value of measured deflections and slight fluctuations were attributed to the tolerance of the applied force due to the precision limits of the hydraulic press.

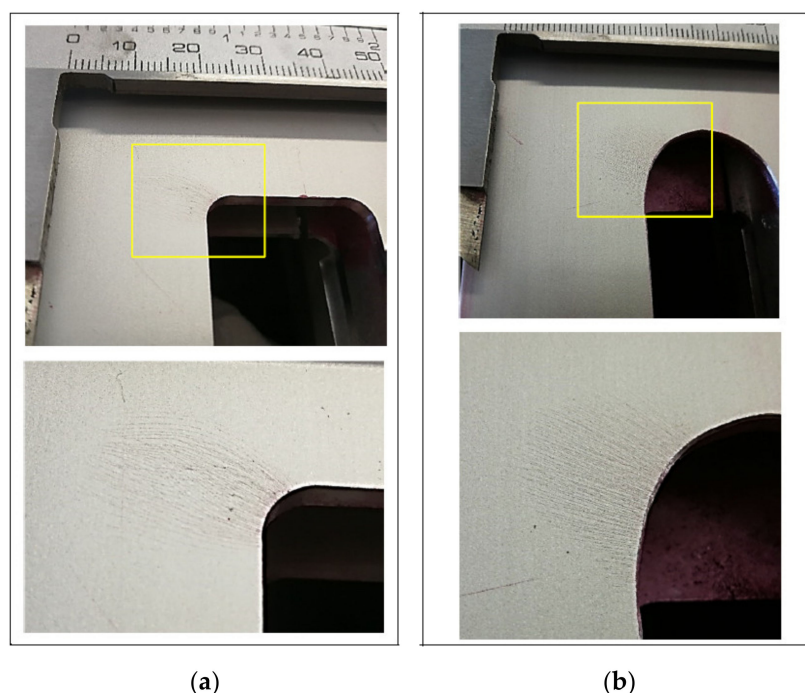
**Figure 13.** Microcracking of the surface of specimens with the rounded and semi-circular root: (a) C\_N2\_1; (b) C\_N3\_1.

Cracking of the specimens with the rounded (Figure 13a) and semi-circular roots (Figure 13b), did not occur. In the zone approximately 20 mm around the crack, a net of microcracks radiating from the internal corner of the notch was visible. It is important to note that all specimen surfaces were anodized with aluminium trioxide, which has a higher modulus of elasticity and higher hardness than the parent material below. For high strains, the anodized surface will crack before the alloy material below. It is not uncommon for anodized surfaces with a thickness of around 30  $\mu\text{m}$  or more to experience microcracking caused by the temperature expansion of the parent material. Such a surface becomes “crazed” with crisscrossing lines. This also happened in this test, but due to the high strain. Microcracks are present only in the surface finish (anodization), while the material below was not cracked, apart from a main crack that grew through the full thickness of the aluminium wall and was observable from both sides of the aluminium wall.

This microcracking of the surface finish was also visible on specimens with rounded roots and with semi-circular roots. However, on these specimens, no cracks in the aluminium alloy wall occurred. The aluminium material around the root of the notch did under-go a yield, observable from the residual deformation, which is approximately 1 mm at the opening of the notch, but without initiating cracks (Figure 13a,b).

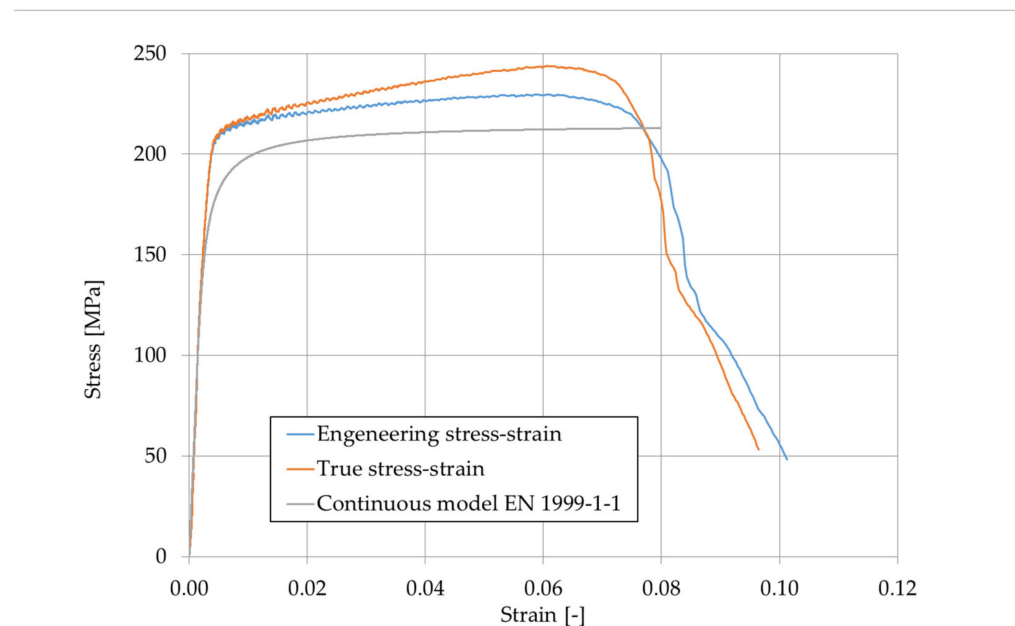
**Figure 14.** Engineering, true and standardised stress–strain curves for Al1.

Engineering and true stress–strain curves for the dog-bone coupon Al1 are shown on Figure 14. The standardised stress–strain curve for alloy EN AW 6063 T6, defined by [18] (E.2.2.2), is included.

The analysis was performed using material nonlinearity. Two strain–stress curves were used, one true, calculated from tested dog-bone coupon Al1 (chosen, conservatively, for having the lowest strength of all 3 coupons), as per Figure 14, and the other as provided by [18] (E.2.2.2).

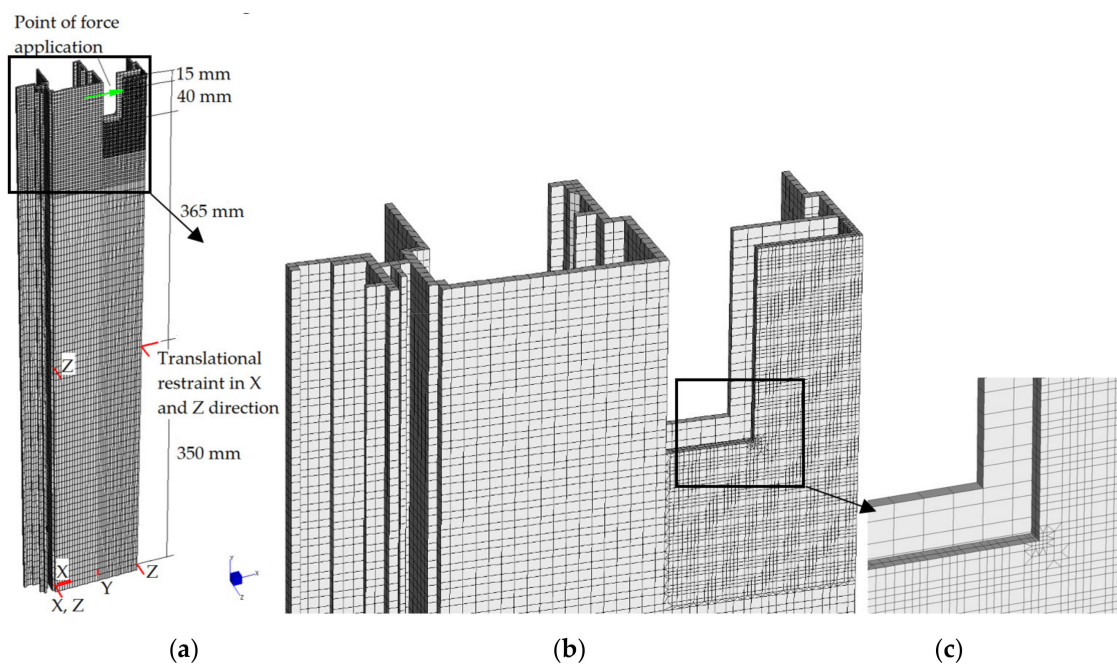
**Figure 15.** Element mesh: (a) entire model, (b) upper part, and (c) mesh around the root of the notch.

Specimens with all 3 notch geometries were numerically modelled by FEM software Straus7 R2.4.6–Strand7 [19] using solid, 8-node brick elements. The size of elements was 2.5–5 mm, with one element through the thickness of the profile wall (Figure 15a), maintaining the aspect ratio of elements in the zone around the root of the notch higher than 0.4 [20]. In the zone around the notch, the density of the mesh was increased to 2 elements in the thickness of the aluminium wall and the size of the elements was reduced to 0.5–2.5 mm (Figure 15b).

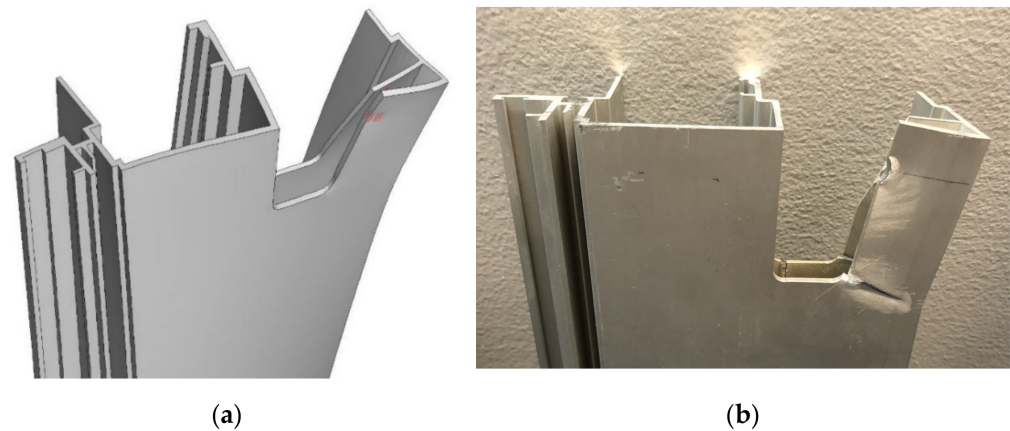
**Figure 16.** Deformed shape of the specimen N1: (a) numerically and (b) experimentally obtained.

The deformed shape obtained by numerical simulation is shown on Figure 16a, and the deformation of the profile obtained by testing is shown in Figure 16b.

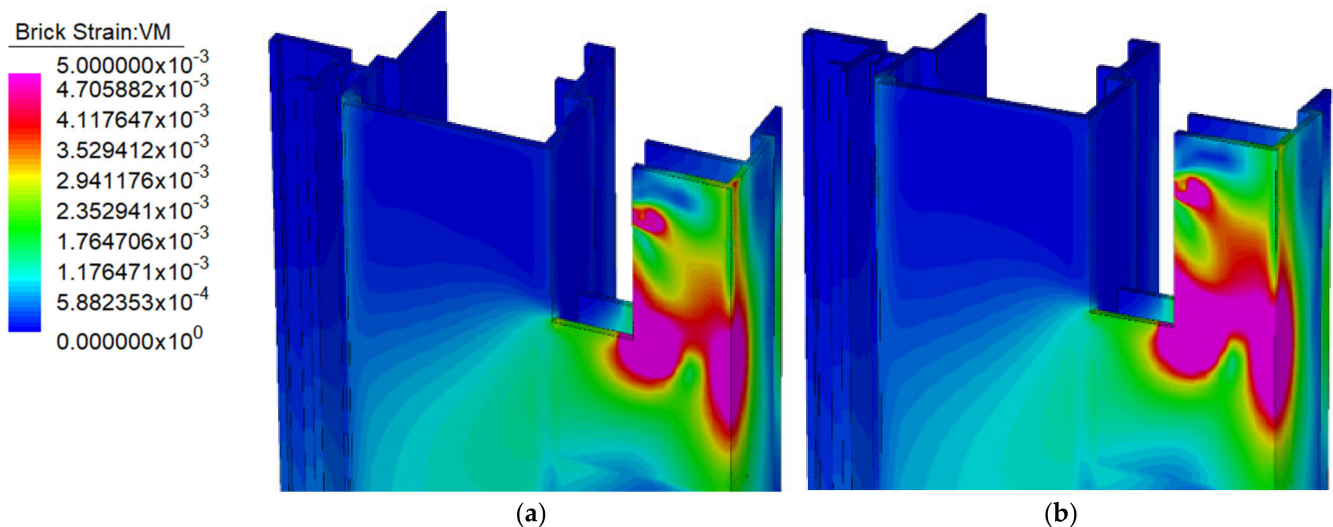
**Figure 17.** Strain in the model of the sharp notch: (a) True stress–strain curve (coupon A11), load 5.5 kN; (b) standardised stress–strain curve (alloy EN AW 6063 T6), load 5.0 kN.

The highest achieved force for models using the true stress–strain curve was 5.5 kN, and the highest achieved force for models using the standardised stress–strain curve (alloy EN AW 6063 T6) was 5.0 kN. Models of the semi-circular notch at 67.5 mm achieved 0.5 kN less force: 5.0 kN and 4.5 kN. The distribution of the strain for all models is shown in Figures 17–20. The wide area of the yielding can be seen (magenta) around the root of the notch.

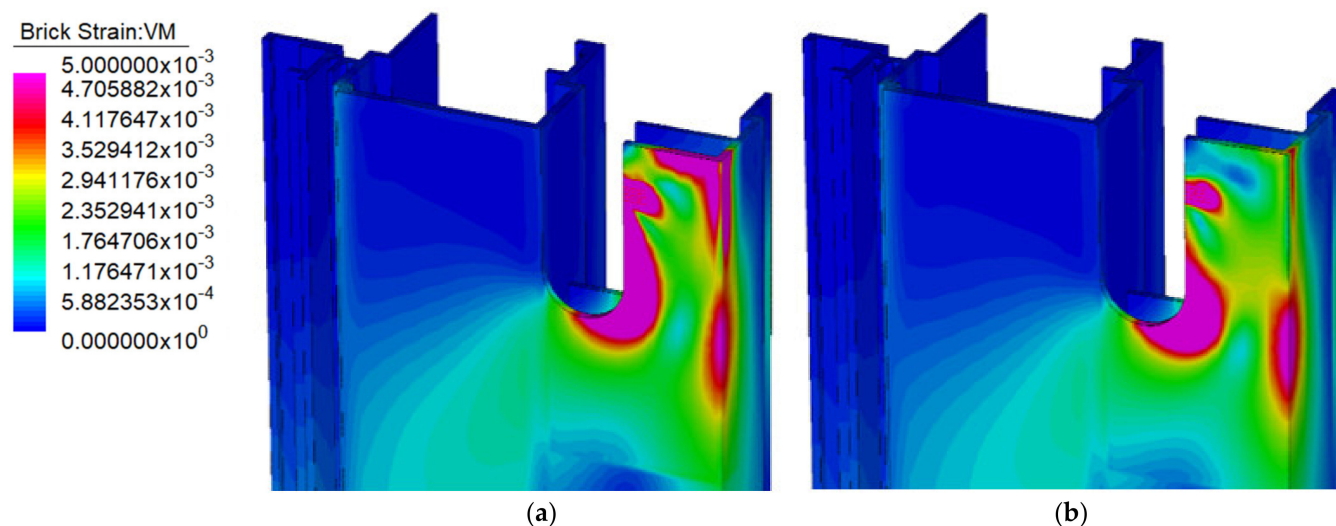
**Figure 19.** Strain in the model of the semi-circular notch 55 mm: (a) True stress–strain curve (coupon A11), load 5.5 kN; (b) nominal stress–strain curve (alloy EN AW 6063 T6), load 5.0 kN.

For the semi-circular notch, two different geometries were modelled, Figures 19 and 20. The difference between them was the total depth of the notch. Tested specimens had an initial depth of 55 mm, to which a semi-circular machining with a radius of 12.5 mm was performed, resulting in a total depth of 67.5 mm. In order to match the total depth of the other two geometries, an additional model with a semi-circular root was created, which had a total depth of 55 mm, including the semi-circular part, equal to the sharp and rounded notches. Hence, a 67.5 mm notch was representative of tested specimens, whereas a 55 mm notch had the same notch depth as other tested geometries.

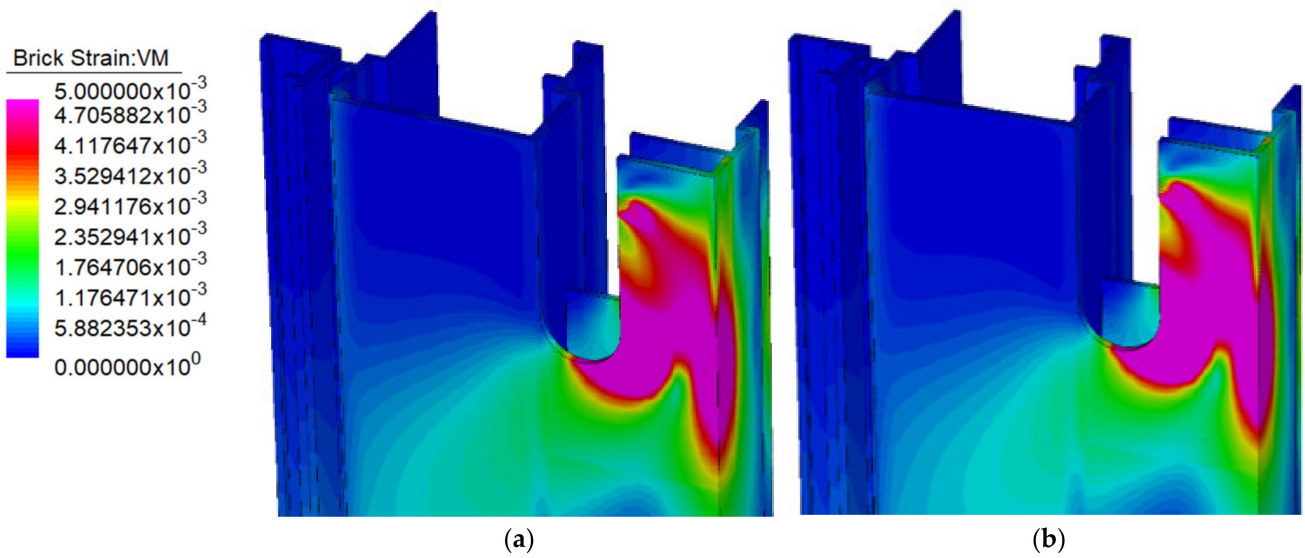
**Figure 20.** Strain in the model of the semi-circular notch 67.5 mm: (a) True stress–strain curve (coupon AL1), load 5.0 kN; (b) nominal stress–strain curve (alloy EN AW 6063 T6), load 4.5 kN.

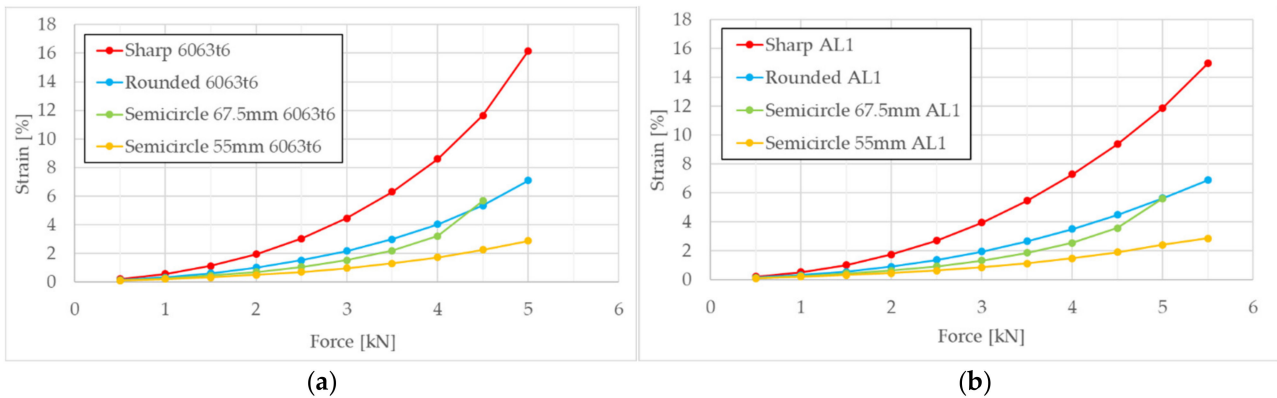
**Figure 21.** Strain-force curves for the (a) nominal and (b) true stress–strain curve.

Figure 21 shows that, when a standardised stress–strain curve was used, the highest maximal strains occurred at the sharp notch and the lowest maximal strains occurred at the semi-circular notch.

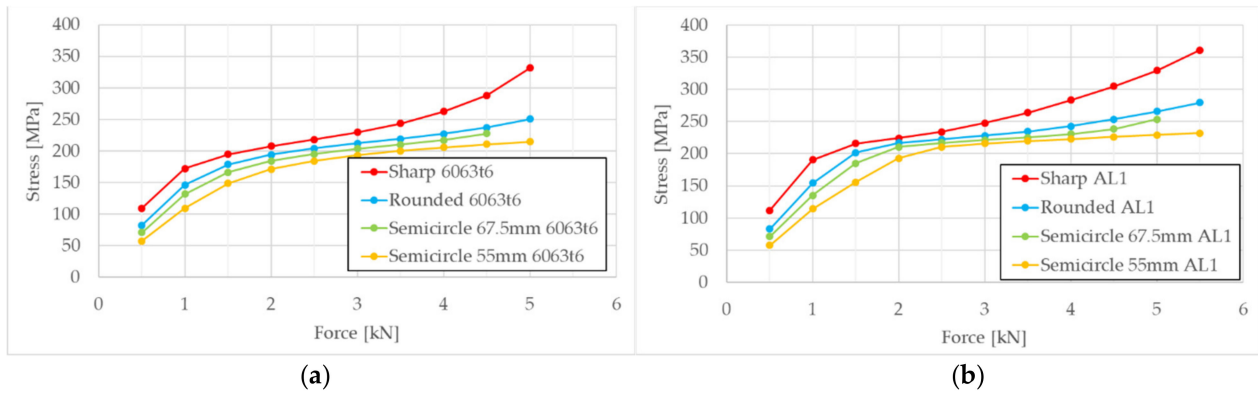
Figure 23. Von Mises stress–strain curves for the (a) nominal and (b) true stress–strain curves.

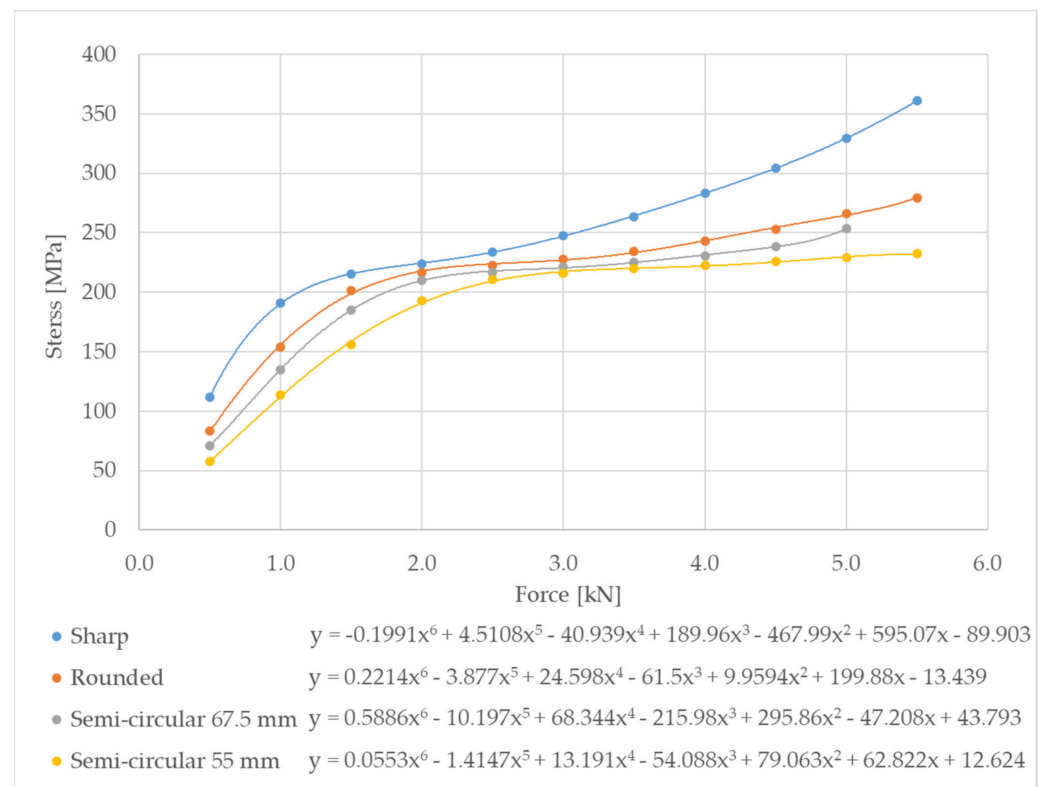
Figure 24. Von Mises stress–strain regression curves for  $\Delta\sigma_i$ .

Numerical simulations were performed for the load in steps of 0.5 kN, which did not necessarily match the values of the load used for the cyclic testing (Table 3). In order to assess the hotspot stress range ( $\Delta\sigma_i$ ) for each cycle, the resulting von Mises stresses from the numerical model were used to generate stress–strain curves through the polynomial regression of each notch type. Figure 24 shows the regression curve for the sharp notch. Hotspot stress ranges ( $\Delta\sigma_i$ ) for each cycle were assessed from the obtained curves. Models with the true stress–strain curve for dog-bone coupon A11 were used.

For each geometry of the notch, the hotspot stress ( $\Delta\sigma_i$ ) for each cycle was assessed from the respective regression curve. The endurance ( $N_i$ ) for each cycle was calculated using Formula (7), and the total damage for each cycle was calculated using Formula (8). The results of this procedure for the sharp notch are shown in Table 9.
