# Fatigue Behaviour of Aluminium Members with Different Notch Root Shapes

*Source / Izvornik:* **Buildings, 2022, 12(5)**

**Keywords:** notch; aluminium profile; fatigue; wind action; stress concentration; unitised curtain wall

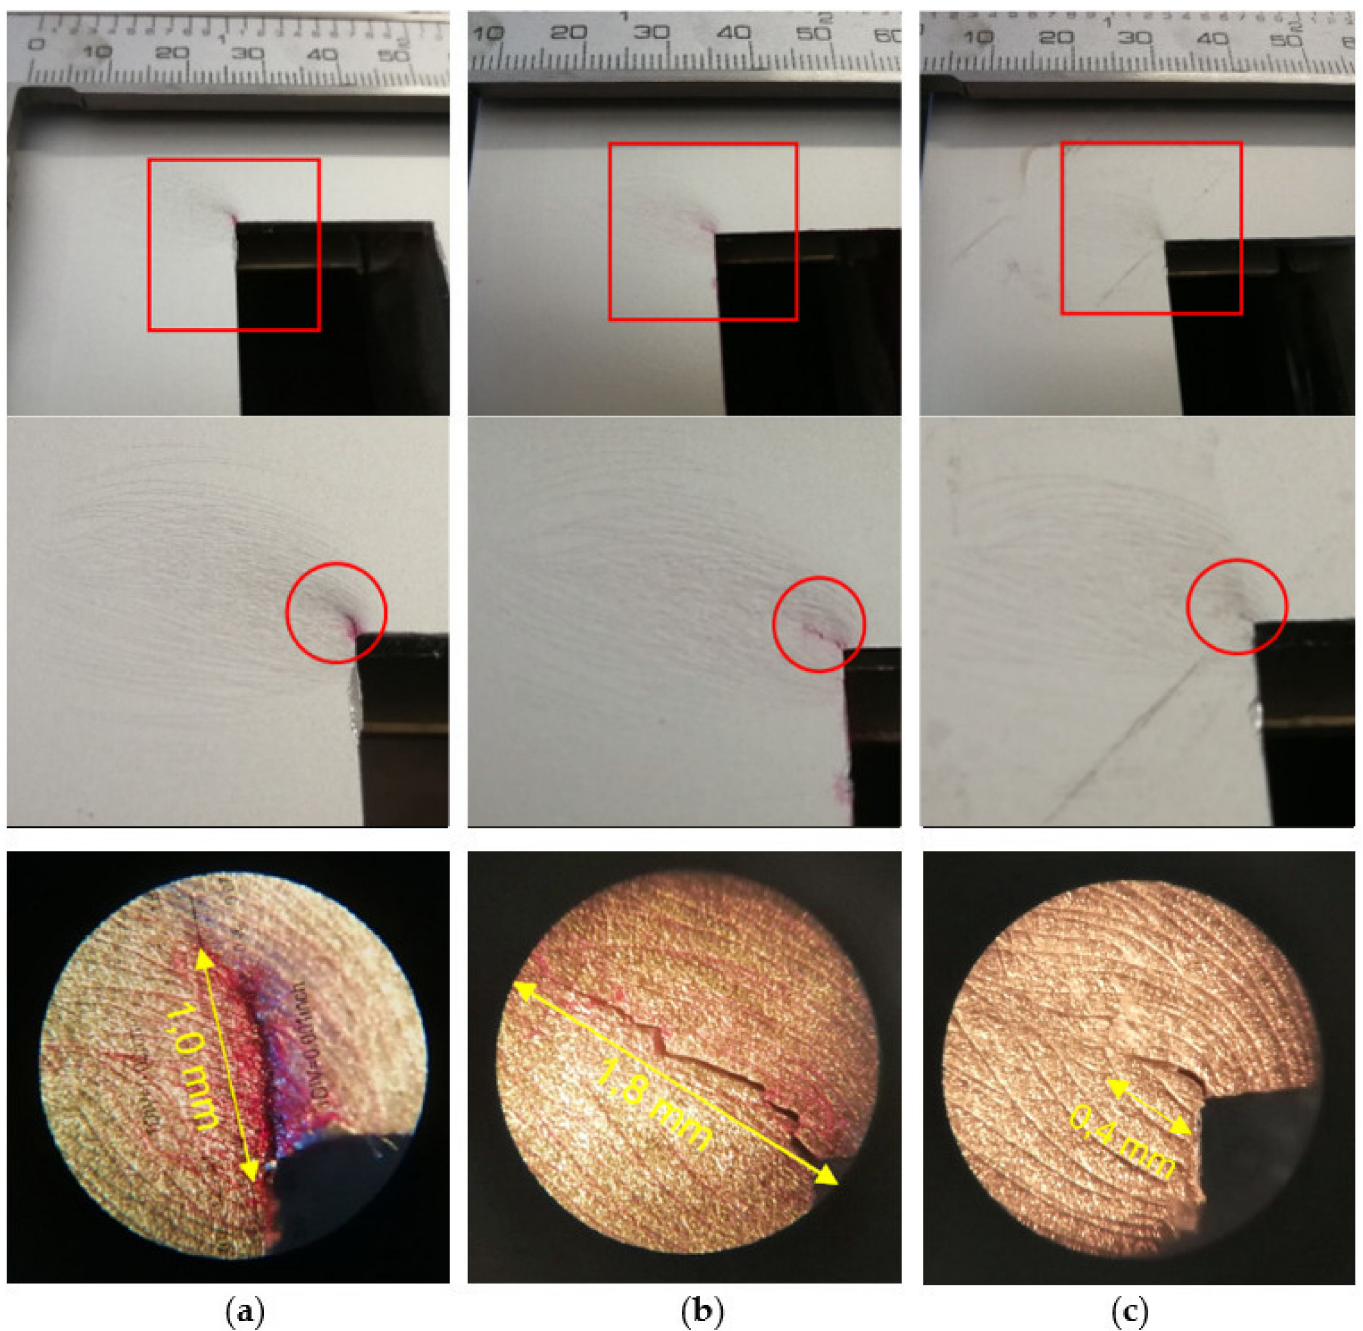
**Figure 12.** Cracks in specimens with the sharp root: (a) C\_N1\_1, (b) C\_N1\_2, (c) C\_N1\_3.

In all 3 specimens with the sharp root notch (C\_N1\_1, C\_N1\_2 and C\_N1\_3), a crack developed at the root of the notch (Figure 12). The stress concentration during the cyclic loading caused the crack propagating 1–2 mm in the direction bisecting the internal corner of the notch, which was in the range of  $35^\circ$  to  $55^\circ$ . The length of the fracture was measured using a microscope Elcometer 900 graduated  $\times 50$ . It was not possible to identify the cycle at which the crack appeared nor its propagation rate. The apparent slight differences in the colour of surfaces in Figure 12, enlarged details, are due to the light conditions and to residues from the red liquid penetrant used to emphasise surface irregularities; in fact, all samples had the same surface finish.

In tested specimens with a sharp notch, this behaviour was observed. The nucleation of the crack happened early during the test, but throughout the entire cycling, it remained stable. It is assumed that the crack remained within the plastic zone (Figure 3), and did not grow out of it. This was confirmed by numerical modelling, which showed that the plastic zone was much deeper (20–40 mm) than the length of the cracks, which were experimentally determined in the range of 1–2 mm; see Figure 12.

All specimens with the sharp root notch exhibited full-penetration cracks propagating at 45° for a length of 1–2 mm. The crack geometry was consistent in shape for all 3 specimens. It should be noted that the propagation of cracks was very limited to the vicinity of the sharp internal corner and the length of cracks was lower than the thickness of the aluminium wall (2.5 mm). This indicates that such a situation should remain stable for the duration of the building's design service life and that repeated loading would not result in progressive collapse of such a detail. Thus, specimens with a sharp notch fulfil the requirements for the damage-tolerant design according to [21]. Buildings with such a notch design can be deemed safe for use. This reasoning does not take into account other non-structural performance requirements, such as possible breach of the air barrier, possible water penetration, or aesthetic issues related to such a crack.

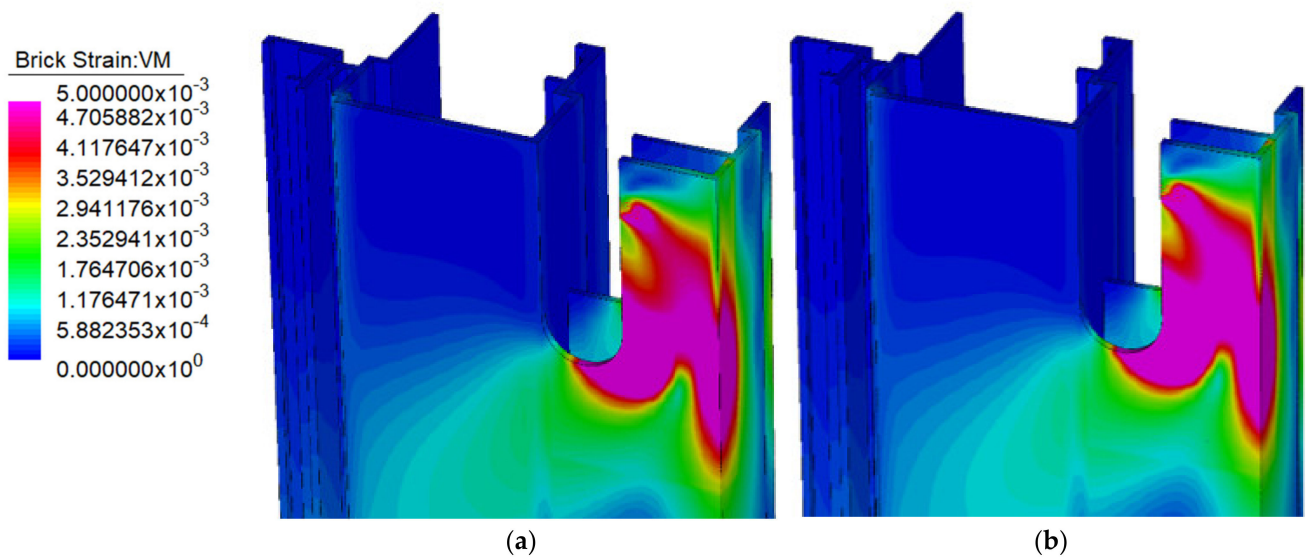
**Figure 20.** Strain in the model of the semi-circular notch 67.5 mm: (a) True stress–strain curve (coupon AL1), load 5.0 kN; (b) nominal stress–strain curve (alloy EN AW 6063 T6), load 4.5 kN.

For the semi-circular notch, two different geometries were modelled, Figures 19 and 20. The difference between them was the total depth of the notch. Tested specimens had an initial depth of 55 mm, to which a semi-circular machining with a radius of 12.5 mm was performed, resulting in a total depth of 67.5 mm. In order to match the total depth of the other two geometries, an additional model with a semi-circular root was created, which had a total depth of 55 mm, including the semi-circular part, equal to the sharp and rounded notches. Hence, a 67.5 mm notch was representative of tested specimens, whereas a 55 mm notch had the same notch depth as other tested geometries.

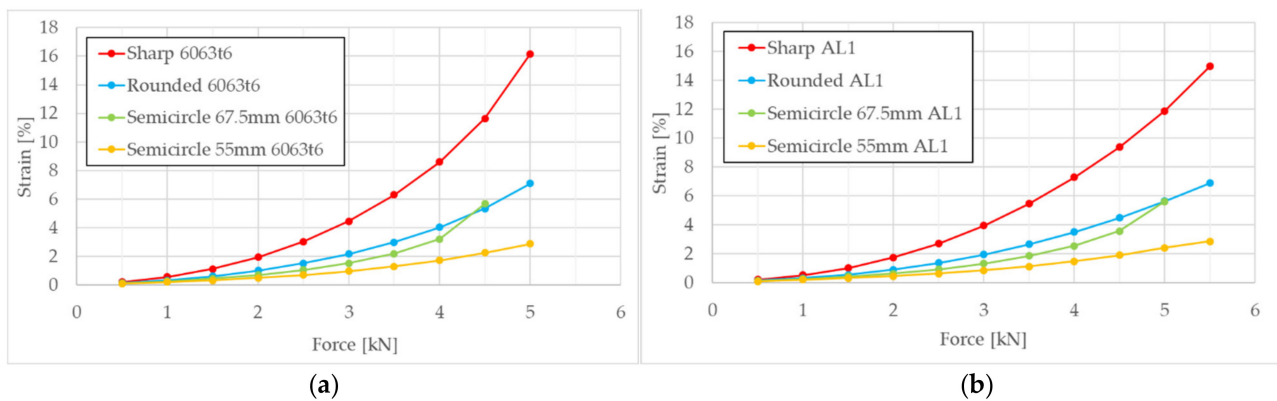
**Figure 21.** Strain-force curves for the (a) nominal and (b) true stress–strain curve.

Figure 21 shows that, when a standardised stress–strain curve was used, the highest maximal strains occurred at the sharp notch and the lowest maximal strains occurred at the semi-circular notch.

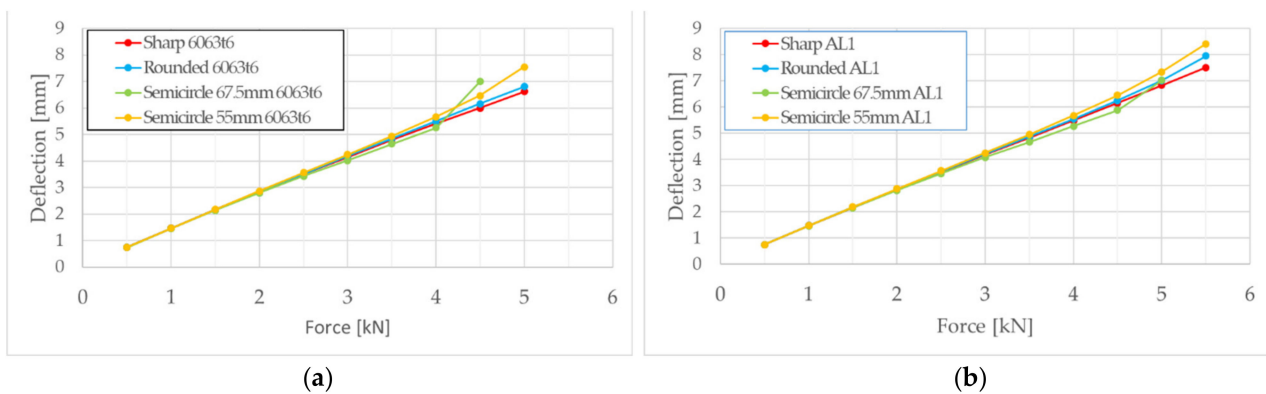
**Figure 22.** Deflection-force curves for the (a) nominal and (b) true stress–strain curves.

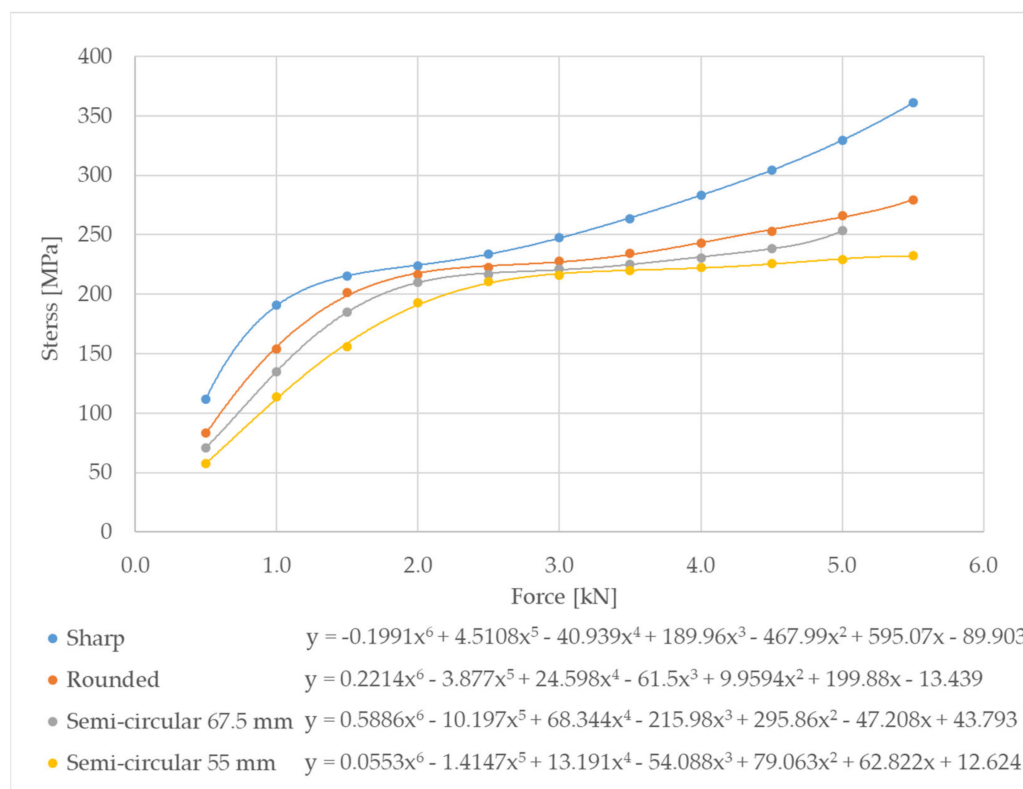
Figure 24. Von Mises stress–strain regression curves for  $\Delta\sigma_i$ .

Numerical simulations were performed for the load in steps of 0.5 kN, which did not necessarily match the values of the load used for the cyclic testing (Table 3). In order to assess the hotspot stress range ( $\Delta\sigma_i$ ) for each cycle, the resulting von Mises stresses from the numerical model were used to generate stress–strain curves through the polynomial regression of each notch type. Figure 24 shows the regression curve for the sharp notch. Hotspot stress ranges ( $\Delta\sigma_i$ ) for each cycle were assessed from the obtained curves. Models with the true stress–strain curve for dog-bone coupon A11 were used.

For each geometry of the notch, the hotspot stress ( $\Delta\sigma_i$ ) for each cycle was assessed from the respective regression curve. The endurance ( $N_i$ ) for each cycle was calculated using Formula (7), and the total damage for each cycle was calculated using Formula (8). The results of this procedure for the sharp notch are shown in Table 9.
