# Post-Earthquake Dynamic Performance of Intact Masonry Building Based on Finite Element Model Updating

Source / Izvornik: **Applied sciences (Basel)**, 2023, 13, 1 - 19

As a case study, a building of a high school in Sisak (Figure 1) built in 1935 was taken. The building has four floors: basement, ground floor, and two upper floors. In the central part of the building there is a three-legged staircase with a landing. The foundations are constructed as a reinforced concrete slab. The load-bearing part of structure consists of walls made of solid bricks of 29(39) cm × 15 cm × 6.5 cm, floor slabs and reinforced concrete ribbed floor slabs. The thickness of the load-bearing walls in the basement is 60 cm and 75 cm, and 50 cm and 60 cm on the ground floor and upper floors. The partition walls are 15 cm, 18 cm, 25 cm or 30 cm thick and are made of hollow blocks. The floor slab is 25 cm thick and the reinforced concrete ribbed floor slab has a total height of 33 cm. The clear distance between the ribs is 60 cm, the width of the ribs is 13 cm, and the height is 23 cm. At the entrance of the building on the first and second floors, there is a load-bearing part of the structure that rests

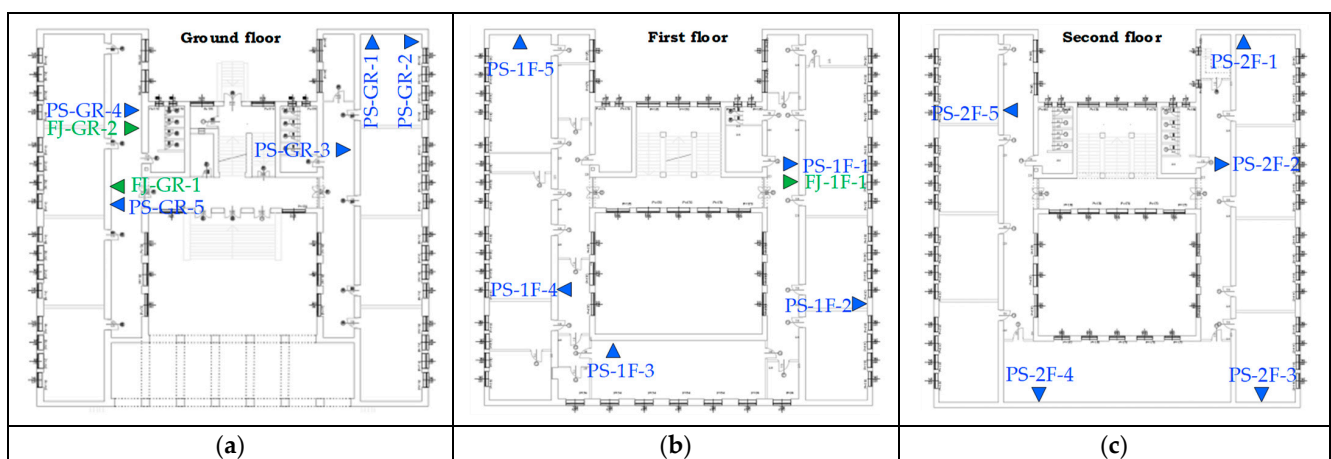
**Figure 2.** Measurement points for determination of mechanical properties of walls on the (a) Ground Floor (b) First Floor (c) Second Floor.

Within the experimental investigation of case study determination of mechanical properties (Figure 2) of the masonry walls and operational modal analysis (OMA) were considered in addition to visual inspection (Figure 3).

To determine the mechanical properties of bearing walls, a shear test and flat jack test were performed. As a result of conducted shear test [8], the shear strength,  $f_v^{exp}$ , with the contribution of normal compressive stress,  $\sigma_0^{exp}$ , is obtained. On the observed structure, a total of 15 measurement locations were selected (Figure 2), 5 at each floor in which the shear strength test was performed. The obtained test results are shown in Table 1.

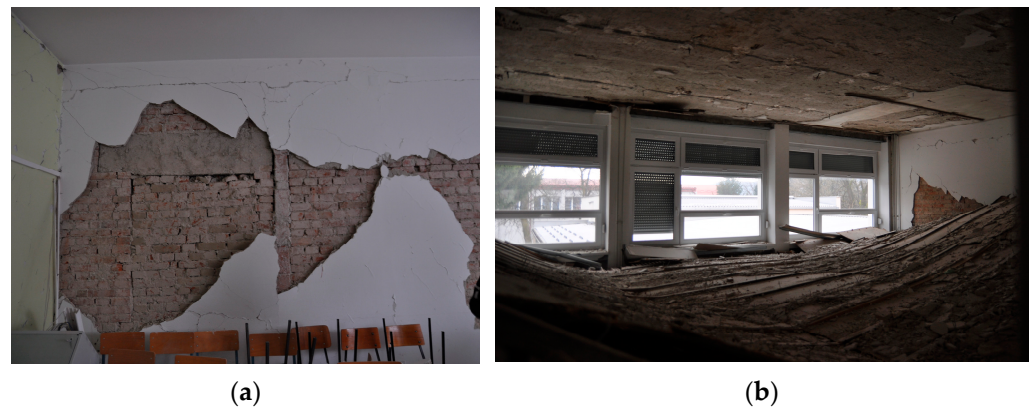
**Figure 4.** Observed damage on (a) the partition wall and (b) the ceiling.

A detailed visual inspection was performed to visually evaluate the structure. During the inspection, some guidelines of the RVS (Rapid Visual Screening) method were applied [36]. The building was inspected by a team of four engineers. The inspection lasted approximately six hours. During the inspection, damage on load bearing and partition walls was observed on the ground floor and first floor. Special attention was paid to crack widths on structural and non-structural elements, separation between structural elements, and displacement of structural components. The cracks were generally diagonal and occurred both in the mortar joints and in the masonry units themselves. Some characteristic and specific damage can be seen in Figure 3. There was frequent evidence of crushing and spalling on many non-structural elements, seen in Figure 4a. Extensive detachment of the surface layer was evident on some parts of the ceiling, seen in Figure 4b. Considering the observation during the visual inspection, the finite element model of the structure in the updating phase is adapted to the found state.

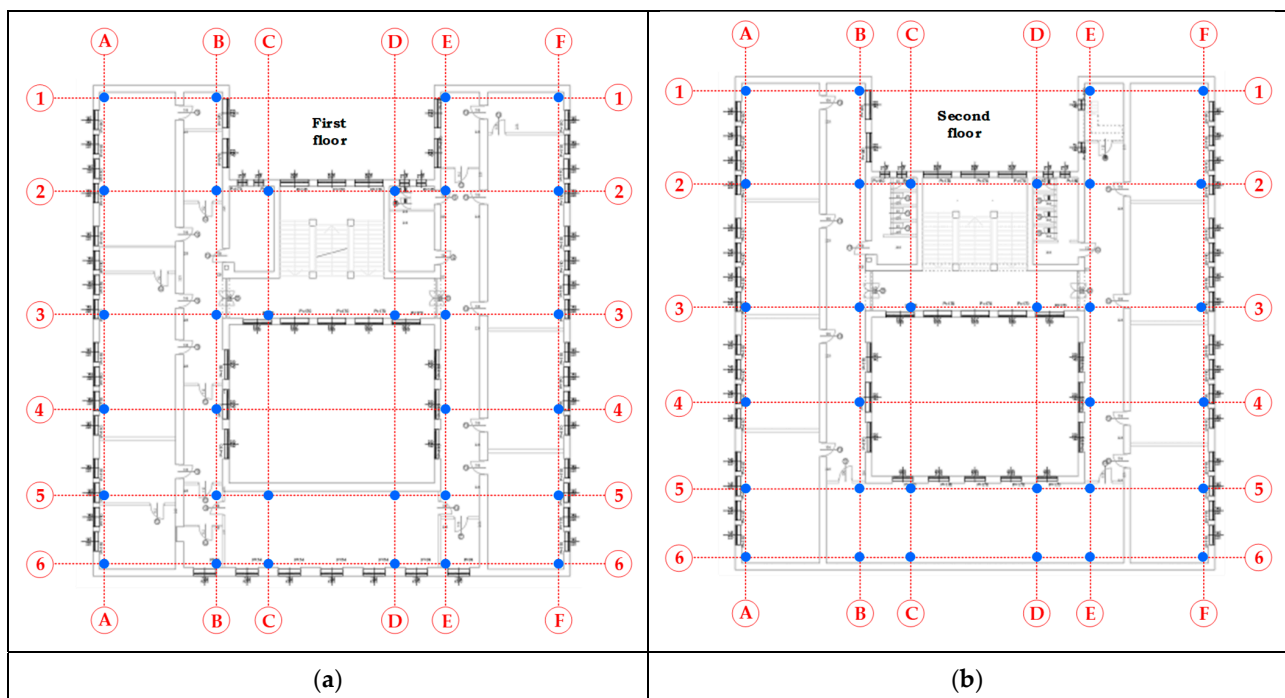
**Figure 5.** Arrangement of measurement points for determination of the structural dynamic properties at the (a) first and (b) second floor.

As a part of OMA, structural dynamic properties were obtained. In the following section, each test is described in detail. Operational modal analysis was performed by using piezoelectric accelerometer (PCB Piezotronics, type 393B31) with the nominal sensitivity of 10 V/g (PCB Piezotronics, Depew, NY, USA) an analyzer (Brüell&Kjaer, type 3560C, Brüell&Kjaer, Naerum, Denmark) and associated software. The measurement was performed in total 64 points, 32 points per floor (1st and 2nd) in two perpendicular, x and y, directions (Figure 5) during 128 s in each point. In this way, 128 degrees of freedom were obtained, the sum of which corresponds to two horizontal directions.

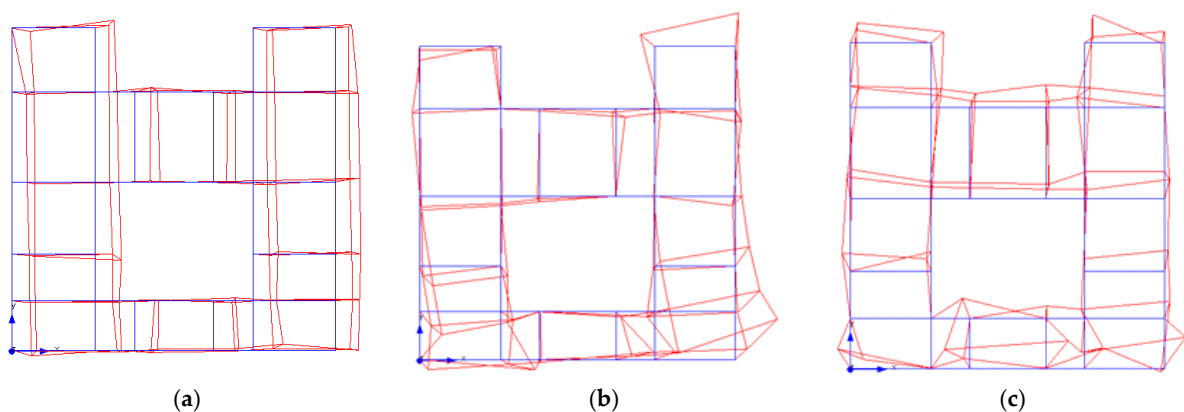
**Figure 7.** Experimentally determined (a) first (b) second and (c) third mode shape. The blue lines represent the undeformed shape, while the red line represent deformed shape.

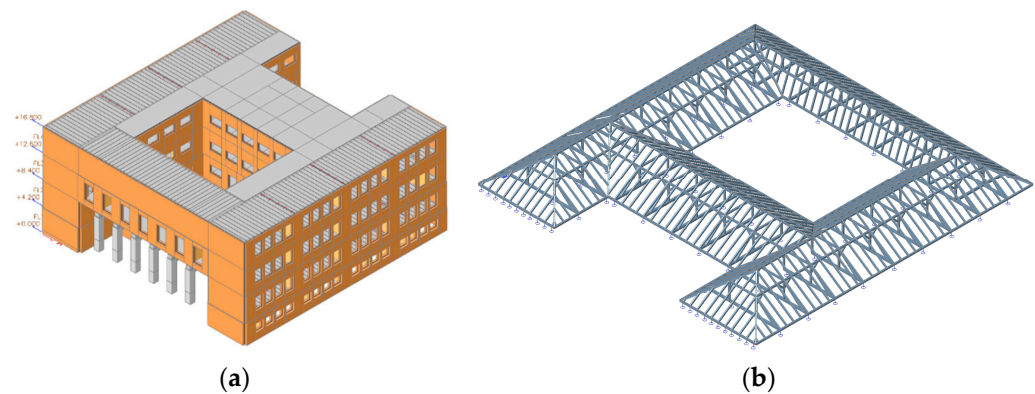
**Figure 8.** Numerical model of the case study: (a) 3D model and (b) 3D sub-model of the roof.

Experimentally obtained results were used to update the numerical model of the high school (Figure 8a). The model was developed in the commercial software SCIA Engineering 22 [19]. Considering the fact that the determination of the dynamic parameters is based on the ambient excitation in the vicinity of the real structure, with respect to a very low (hardly measurable) vibration level, it is sufficient for the comparison of the experimentally

To consider the effect of the roof, i.e., its weight, a sub-model was created (Figure 8b). The basic mechanical properties of the material are taken from the experimental investigation, while the dimensions are defined according to the available drawings. The elements of the roof are modelled using the beam elements. By calculating the sub-model of the roof,

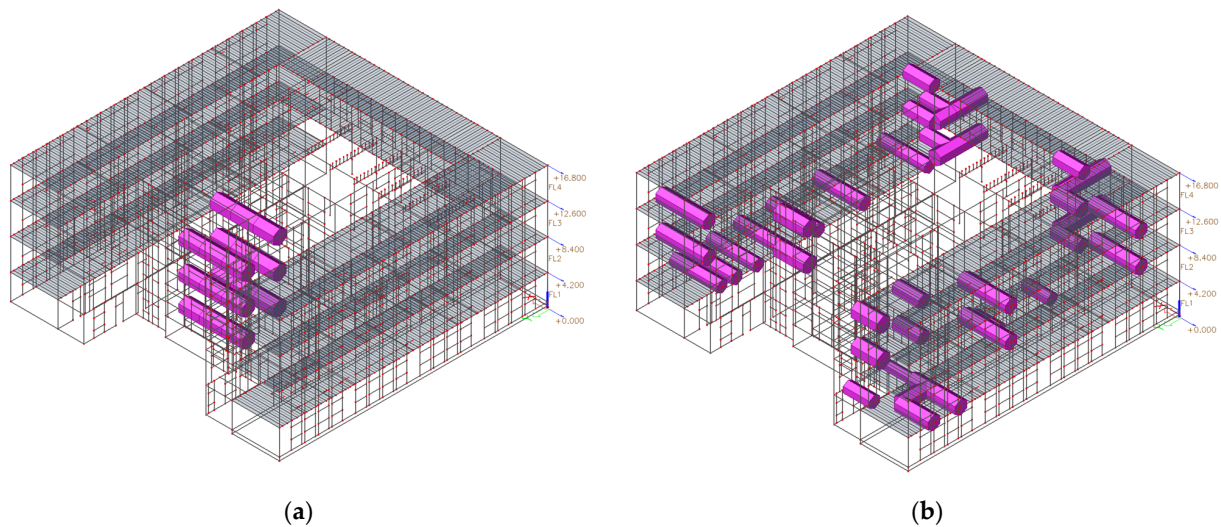
**Figure 9.** Initial numerical model of the case study: (a) mass of the staircase and (b) representation of the mass of partition walls in the numerical model.

reactions from the self-weight were obtained, which were transferred to the 3D model of the structure. Staircases are entered into the 3D model of the structure in the same way (Figure 9a). Since all partition walls were damaged in the earthquake, it was assumed that they did not contribute to the structural stiffness and are introduced to numerical model as additional mass (Figure 9b). The mezzanine structure is modeled as a ribbed slab with additional layers.

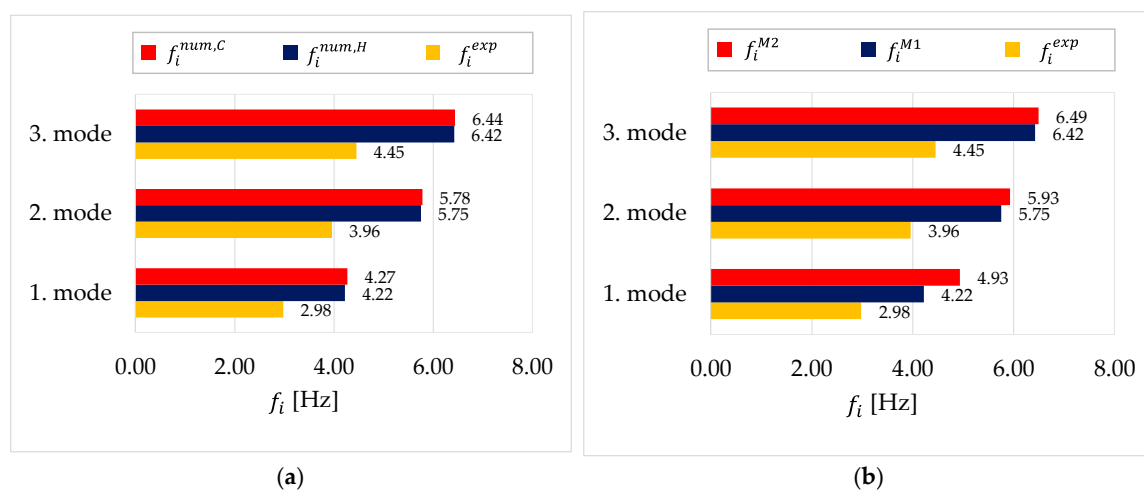
**Figure 10.** Graphical comparison of the experimentally obtained natural frequency values ( $f_1^{exp}$ ) with the frequencies obtained for hinge ( $f_1^{num,C}$ ) and clamped ( $f_1^{num,H}$ ) boundary conditions for (a) Model 1 and (b) Model 2.

To determine the influence of the boundary conditions on the change in the value of the natural frequencies of the structure, a model with fixed and clamped boundary conditions was developed. In the numerical model, the values of the entered masses of partition walls, roofs, and staircases were retained. A graphical comparison of the experimentally obtained natural frequency values with the frequencies obtained for both clamped ( $f_1^{num,C}$ ) and hinge ( $f_1^{num,H}$ ) boundary conditions is given in the Figure 10.

Based on the analysis of the influence of the boundary conditions on the first natural frequency values, it can be seen and concluded from the graphical representation (Figure 10a) that there are no differences between the natural frequency values for the hinge ( $f_1^{num,H}$ ) and clamped ( $f_1^{num,C}$ ) boundary conditions, i.e., boundary conditions do not affect the natural frequency values. A clamped boundary condition, also known as fixed or fully restrained boundary condition, means that a structure is completely fixed or immobilized at a particular boundary. A hinge boundary condition, also referred to as a pinned or simply supported boundary condition, allows rotation at a specific boundary while preventing translation. Based on this observation and conclusion, for the further analysis and updating steps, the numerical model with hinge boundary conditions is considered. For the sake of simplicity, the selected model is referred to as M1 in the following text.

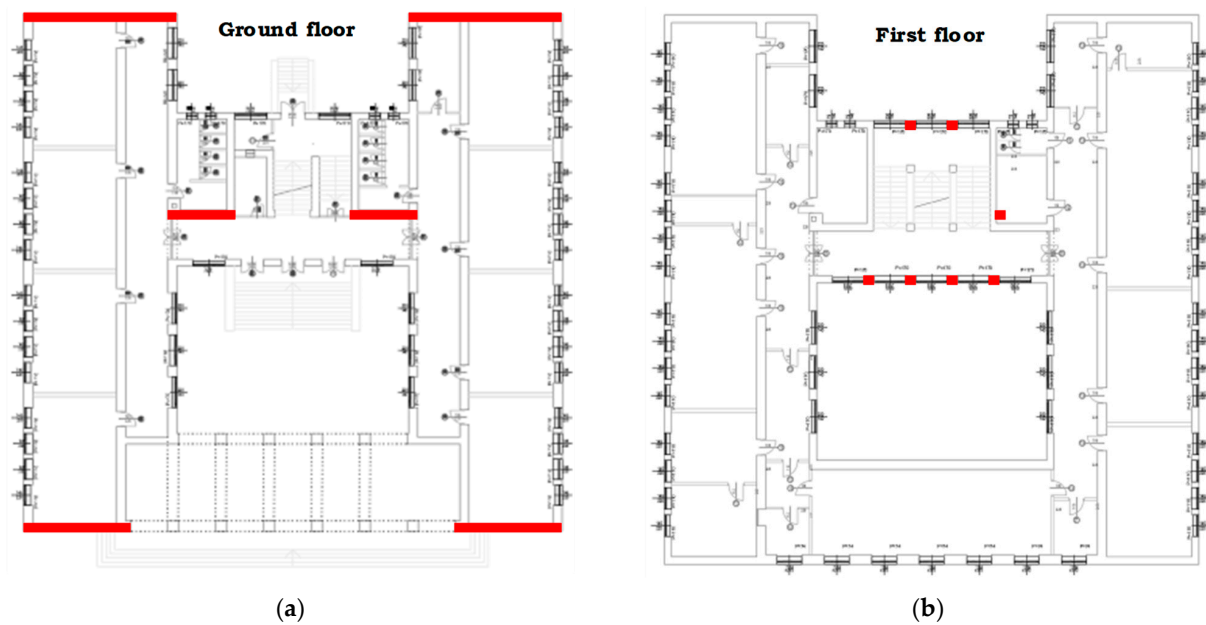
**Figure 11.** The elements of the model with a reduced modulus of elasticity (red bars) at the (a) ground and (b) first floor.

To be able to numerically predict the real structural behavior, the damaged structural elements in this step of analysis are modelled with reduced elasticity modulus. These elements were selected based on a visual inspection and their positions are marked in Figure 11.

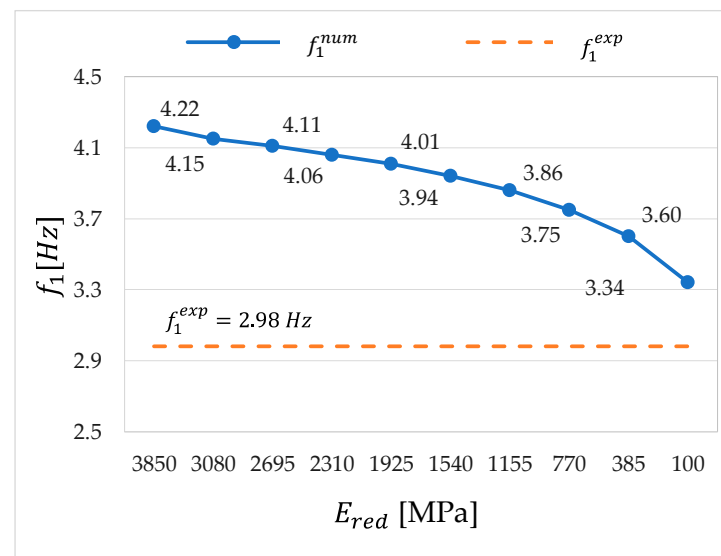
**Figure 12.** Changes of the first natural frequency of the numerical Model 3 ( $f_1^{num}$ ) for different levels of modulus of elasticity reduction ( $E_{red}$ ) with the comparison of the experimentally obtained natural frequency ( $f_1^{exp}$ ).

Based on the analysis (Figure 12) of the elasticity modulus reduction for the damage construction elements ( $E_{red}$ ), a decrease in the first natural frequency ( $f_1^{num}$ ) can be noticed. However, by imitating the damaged parts of the structure with finite elements with a reduced modulus of elasticity, satisfactory results were not achieved. Regardless of the fact that the previous iteration and analysis did not provide satisfactory results (matching values of numerically predicted and experimentally measured natural frequencies), in the next iteration, the simulation of damages in the specified load-bearing walls is retained.

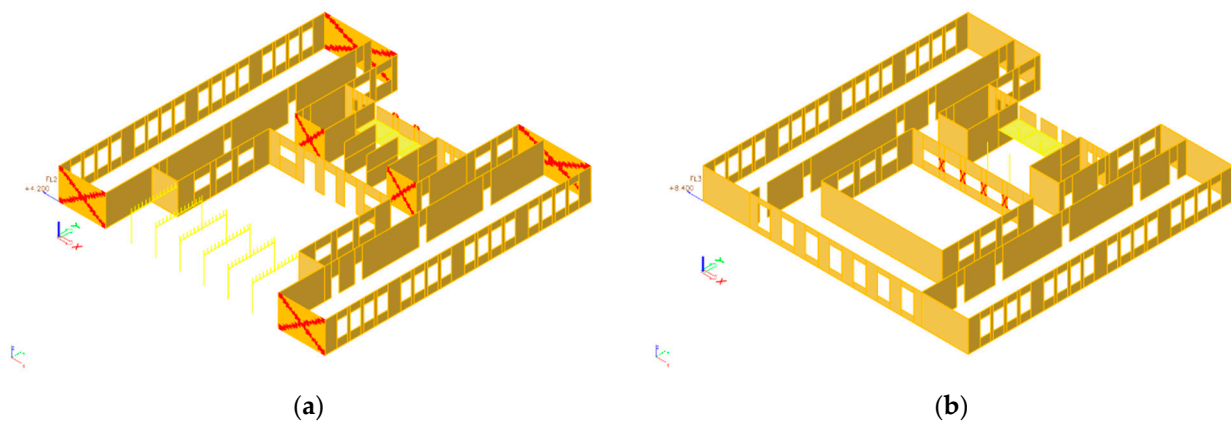
**Figure 13.** The finite elements of the model with a reduced modulus of elasticity at the (a) ground and (b) first floor.

Since the behavior of the structure obtained by experimental testing was not achieved with the previously analyzed updated numerical models, the numerical analysis was carried out on the new model (Model 4). The new model is developed in such a way that the finite elements of the initial numerical model, whose locations correspond to the location of the diagonal cracks determined by visual inspection (Figure 13), were associated with a modulus of elasticity close to 0 (in order to avoid errors in calculation).

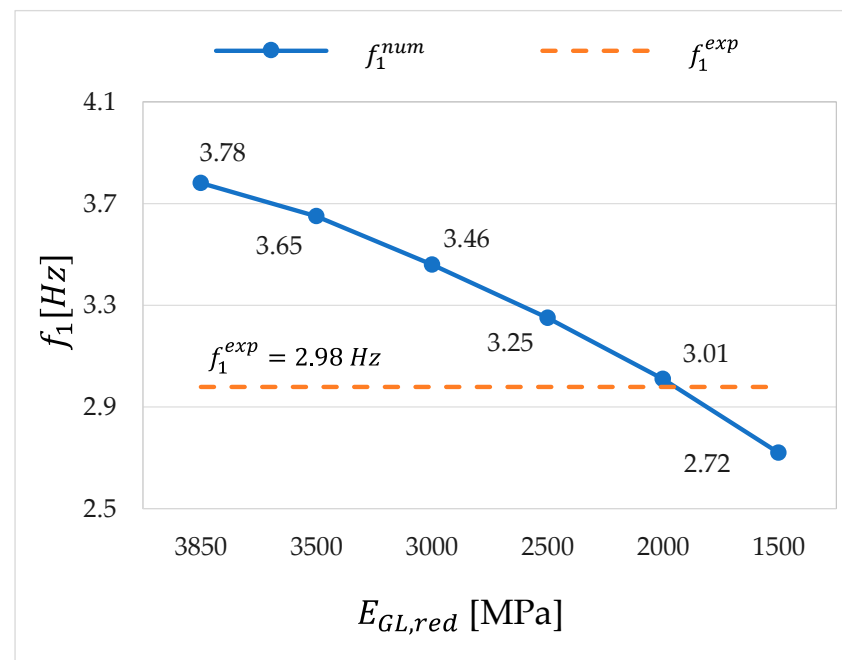
**Figure 14.** Changes of the first natural frequency of the numerical Model 5 ( $f_1^{num}$ ) for different levels of global modulus of elasticity reduction ( $E_{GL,red}$ ) with the comparison of the experimentally obtained natural frequency ( $f_1^{exp}$ ).

The changes in the natural frequency values obtained by numerical modal analysis with respect to the experimental values are visible. The modulus of elasticity around the 2000 MPa gives a very small difference compared to the experimentally obtained results. The next table (Table 8) shows a comparison of the experimentally determined values of the natural frequencies with the frequencies obtained by the numerical modal analysis of Model 5, to which the global modulus of elasticity in the amount of 2000 MPa is assigned.

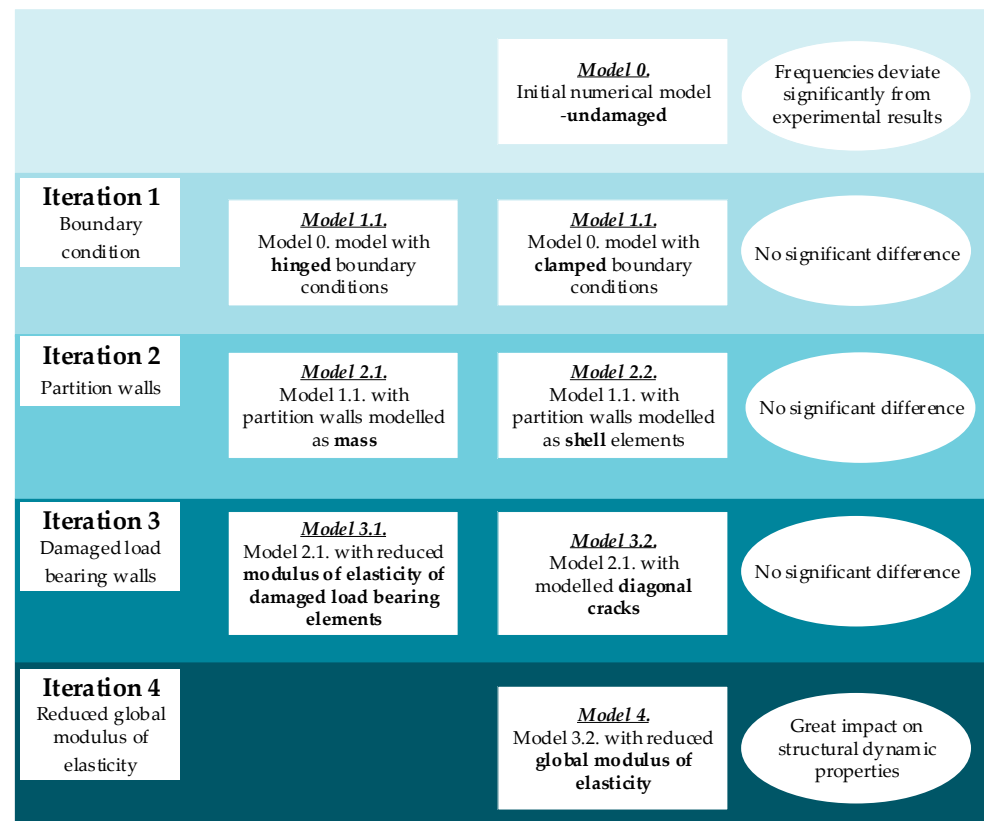
**Figure 15.** Flowchart of numerical model iteration.

jack method also has a value that is not specific for this type of construction. Considering the overall picture of the determination of the mechanical properties of masonry walls, it is necessary to be extremely careful in the interpretation of the results, and the obtained values should be additionally controlled by numerical analysis (Figure 15).

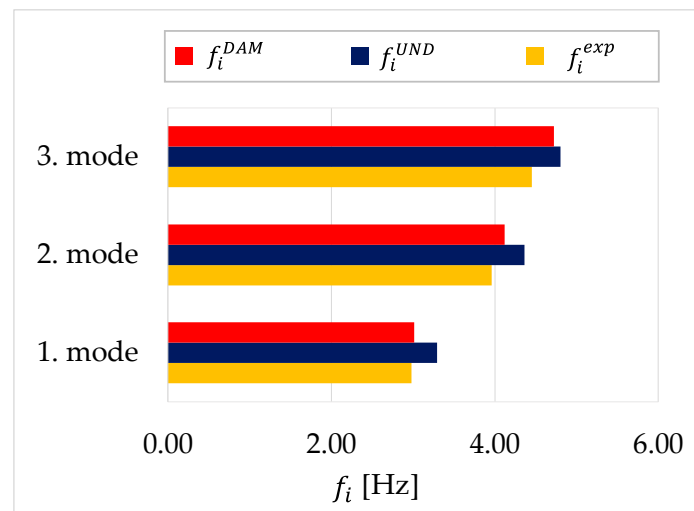
**Figure 16.** Comparison of experimentally obtained ( $f_i^{exp}$ ) and natural frequencies of numerical models for damage ( $f_i^{DAM}$ ) and undamaged state ( $f_i^{UND}$ ).

The comparison shows approximately equal results of the undamaged numerical model compared to the experimental results for the first three experimentally determined mode shapes, Figure 16. The difference in the natural frequency of the damaged and undamaged state is 9% for the first, 6% for the second, and 2% for the third mode shape. The ratio between the frequency of the numerical model before the earthquake and the frequency of the final numerical model shows the greatest difference in frequency results for the first mode, so it can be assumed that the greatest damage occurred in the first mode shape.
