Source / Izvornik: **Case studies in construction materials, 2023, 19**

# Case Studies in Construction Materials

## Correlation between sonic pulse velocity and flat-jack tests for the estimation of the elastic properties of unreinforced brick masonry: Case studies from Croatia

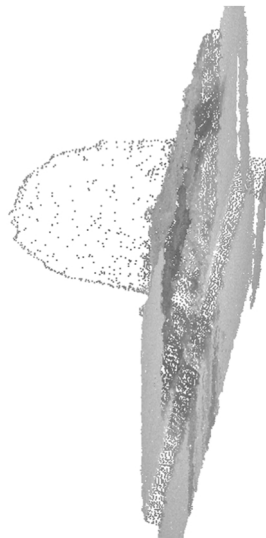
Fig. 1. Point cloud of the drilled hole in the wall.

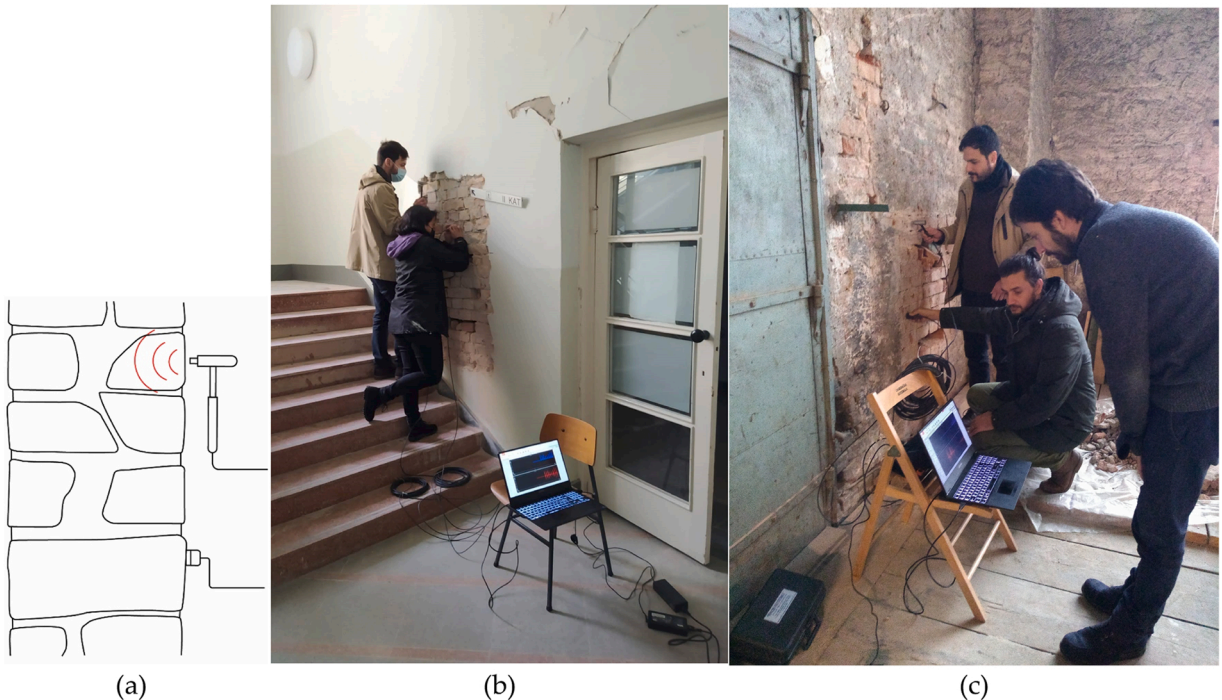
Fig. 4. (a) Typical indirect sonic test transmission method; and (b,c) on-site application of sonic tests.

There are two main types of transmission methods that are typically used when performing a sonic test: direct and indirect (Fig. 4). Direct tests consist of aligning the hitting device with the accelerometer in two opposite surfaces of the investigated element. For indirect tests, the hitting device and accelerometer are placed on the same surface of the construction element (Fig. 4a). The latter is the most appropriate configuration to adopt when the objective is to estimate the elastic properties of the masonry because it allows to estimate the properties for different loading directions, which, in the case of masonry, an anisotropic material, can be important. For example, when testing a masonry wall, the test should be done in the vertical direction, allowing to evaluate the vertical load bearing properties. Moreover, this is also a convenient configuration for on-site measurements because many times there is no access to opposite surfaces of the construction element.

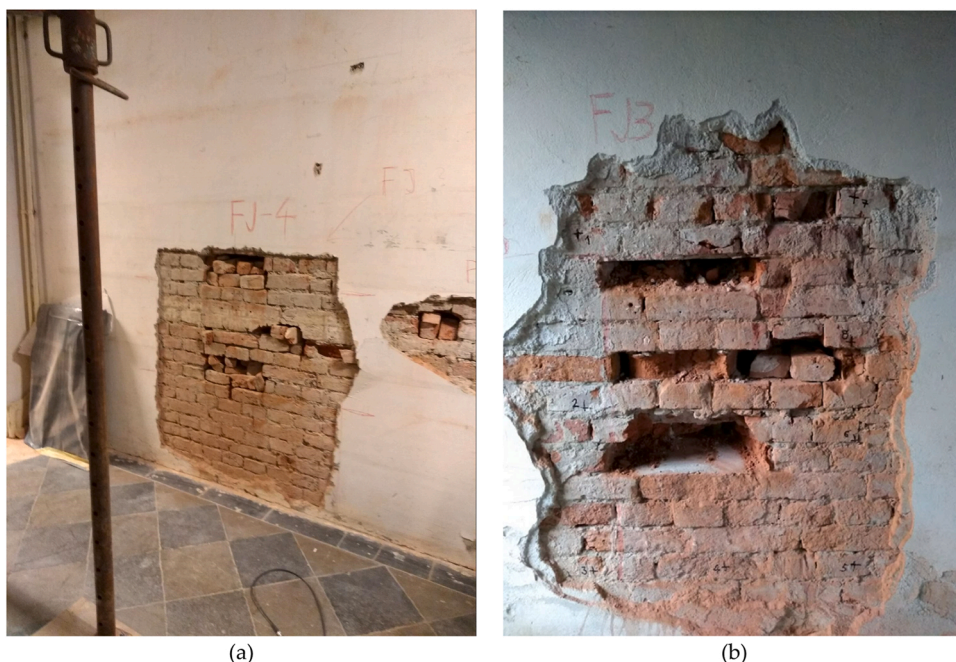
Fig. 5. Sonic tests were carried out at the same location of flat-jack tests: (a) Museum of Arts and Crafts; (b) Zagreb cathedral.

Sonic tests were performed in all buildings described in Table 1. Taking advantage of the previous works carried out to perform the flat-jack tests (e.g. plaster removal), we performed sonic tests at the exact same locations (Fig. 5). Note that the removal of the plaster was important because indirect sonic tests should be carried out by placing the emitter and the receiver directly on the masonry surface. Otherwise, depending on the characteristics of the plaster (e.g. if the wave propagation velocity through the plaster is higher than the one through the masonry), the identified waves could travel through the plaster instead of the masonry. The sonic tests were carried out months after the flat-jack tests, avoiding locations with visible disruption (cracks or missing bricks). For example, tests in the location shown in Fig. 5a were carried out in the bottom area and, similarly, in the bottom right area at the location shown in Fig. 5b.
