Analysis of Tram Traffic-Induced Vibration Influence on Earthquake Damaged Buildings

Haladin, Ivo; Bogut, Marijan; Lakušić, Stjepan

Source / Izvornik: **Buildings, 2021, 11**

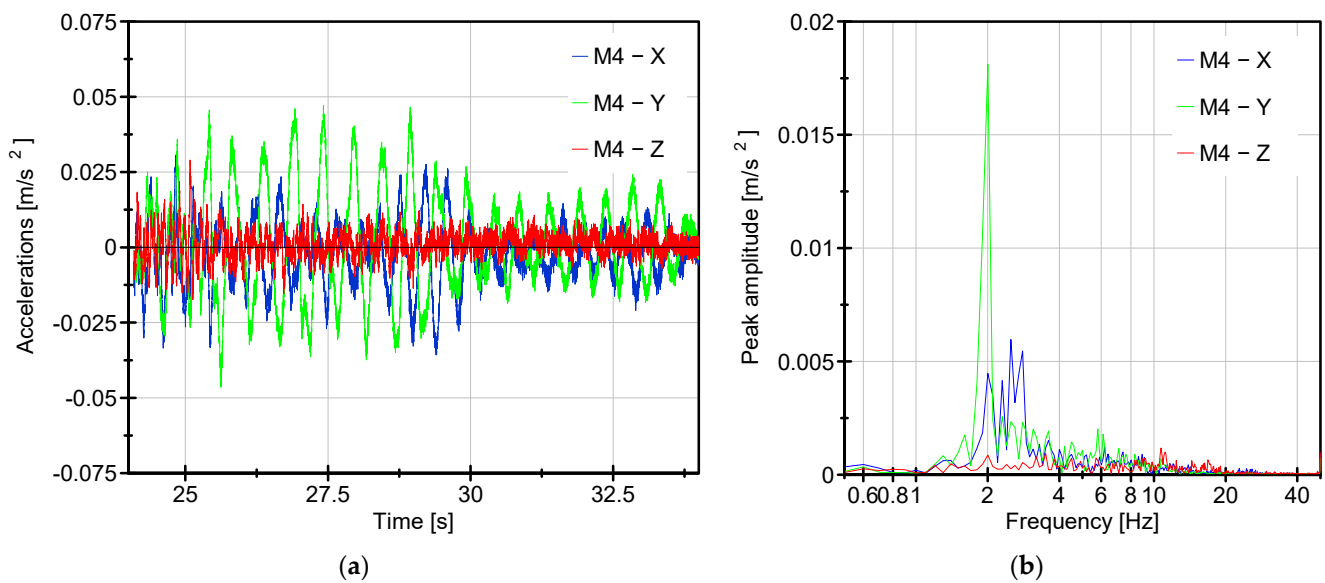
Figure 15. Accelerations represented in (a) time and (b) frequency domains, 3.1 (ML) earthquake structure response on the 3rd floor, M4.

If the 3.1 (ML) response is analysed in terms of PPV according to [19], a direct comparison to the acquired tram response can be made. The results presented for M1 to M5 clearly indicate how even small-intensity earthquake-triggered vibrations are considered harmful for historic masonry structures, Figure 16, while maximum tram vibrations trigger a much smaller response.
