Case-study of the out-of-plane wall failure of a typical downtown building in Zagreb

Source / Izvornik: **1st Croatian Conference on Earthquake Engineering 1CroCEE, 2021, 1557 - 1567**

Matea Sruk¹, Marija Demšić², Maja Baniček³

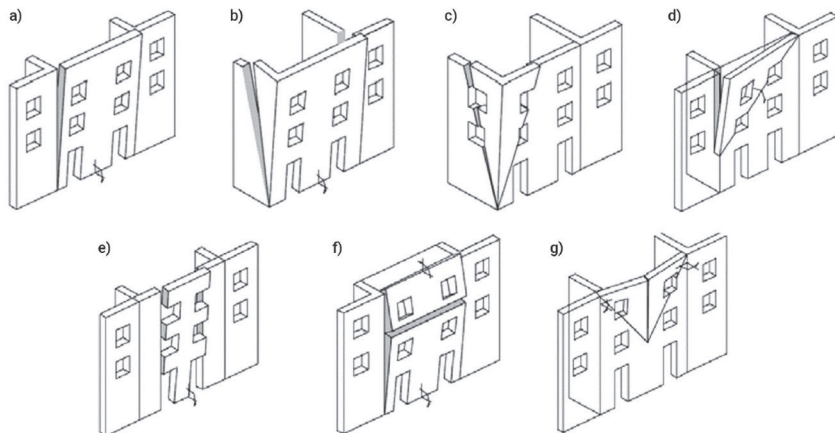
Figure 2. Out-of-plane failure patterns [2]

Separation of the walls from the rest of the structure due to cracks cause the formation of a mechanism that is susceptible to motion due to inertial action. In the analysis, for these walls is assumed that a kinematic chain is formed composed of rigid or semi-rigid blocks (Figure 3.a). The selection of the type of mechanism is based on engineering assessment and experience gained in previous earthquakes, inspection and analysis of cracks, and the typology of buildings in the area [6]. For example, connections with the vertical (perpendicular walls) and horizontal (floors) elements, material and type of connections between elements, weakening of elements such as smaller wall thickness at parapets, anchoring of elements, tension and friction, arch and roof induced horizontal forces and other specific influences. Direct observation of crack patterns to the buildings due to earthquakes helped to identify several characteristic mechanisms, which are shown in Figure 2 [2].
