# Post-earthquake assessment and documentation of timber roofs

## POST-EARTHQUAKE ASSESSMENT AND DOCUMENTATION OF TIMBER ROOFS

Mislav Stepinac<sup>1</sup>, David Andić<sup>2</sup>, Juraj Pojatina<sup>3</sup>

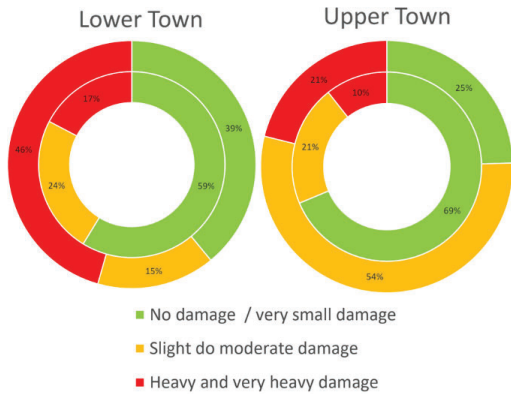
The damage methodology for the roof elements and structure was divided into five damage levels: no damage, very minor damage, moderate damage, significant damage, severe damage. Figure 2 shows the extent of damage to roofing and wooden roof structures in the historic districts of Zagreb. In Donji Grad (Lower Town), the buildings are larger in plan than in Gornji Grad (Upper Town); therefore, the structural systems are also different. In the Upper Town, single-family houses and villas predominate, while in the Lower Town, multi-family houses with mostly 7 to 9 housing units are the most common buildings. According to the engineers' decision, the total number of severely damaged roofs was 274 in the Lower Town and 189 in the Upper Town. Damage to roofing was found on 598 buildings in the Lower Town and 516 buildings in the Upper Town [4,13].

Figure 2: Statistical data about damage to roofs (inner circle: damaged roof systems, outer circle: damaged roof coverings)
