Seismic Retrofitting of Dual Structural Systems-A Case Study of an Educational Building in Croatia

Seismic Retrofitting of Dual Structural Systems—A Case Study of an Educational Building in Croatia

The building of the higher education institution in Petrinja, Croatia, was built in 1963 and underwent energy renovation in 2018. The building consists of the ground, 1st, and 2nd floors; the area on the ground floor is 1294.3 m² and on the upper floors 603.4 m². The total gross floor area of the building is 2501.1 m², while the useful heated area of the building is approximately 2130 m². The building has an irregular T-shaped layout and consists of three volumes connected into one whole (Figure 3). In the northwest–southeast direction (hereafter X-dir), there are two volumes that have only the ground floor. The volume marked as V1 is 3.84 m high, while the volume V2 in the southeastern part of the building is 5.52 m high and consists of a one large hall. The central volume V3 of the building is arranged in a northeast–southwest direction (hereafter Y-dir) and has three stories with a total height of 11.52 m.

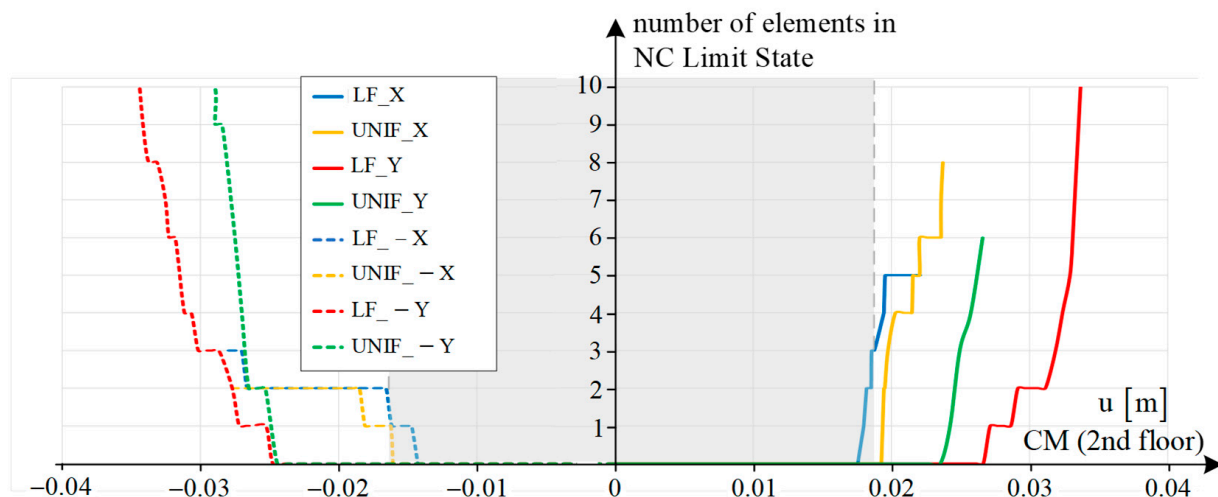
Figure 17. Cumulative number of elements in NC limit state.

Figure 17 shows a diagram that cumulatively represents the number of elements that have reached the limit state of near collapse. For the action in the X-dir, the elements begin to enter this region at a displacement of about 2 cm, while in the Y-dir, this occurs at a value of about 2.5 cm.

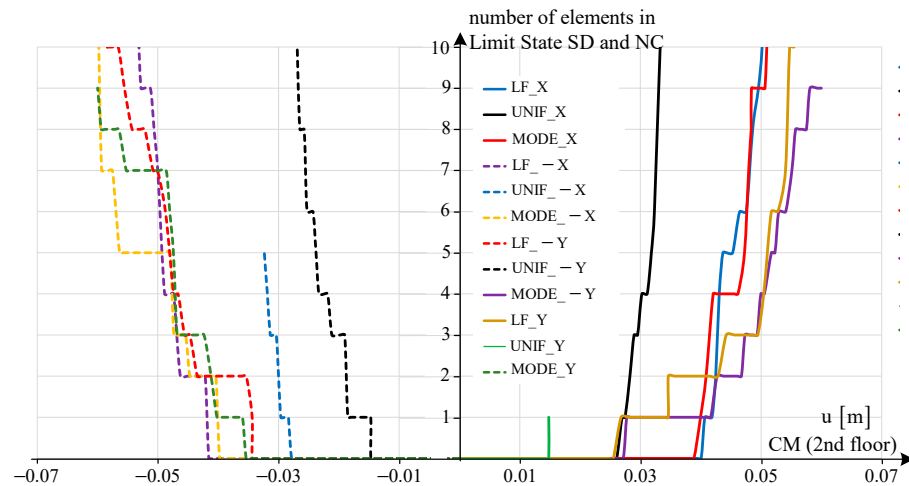
Figure 26. Cumulative number of elements in SD and NC limit state.

The diagrams that cumulatively show the number of elements that have reached the SD and NC limit state for different lateral load patterns are displayed in the Figure 26.

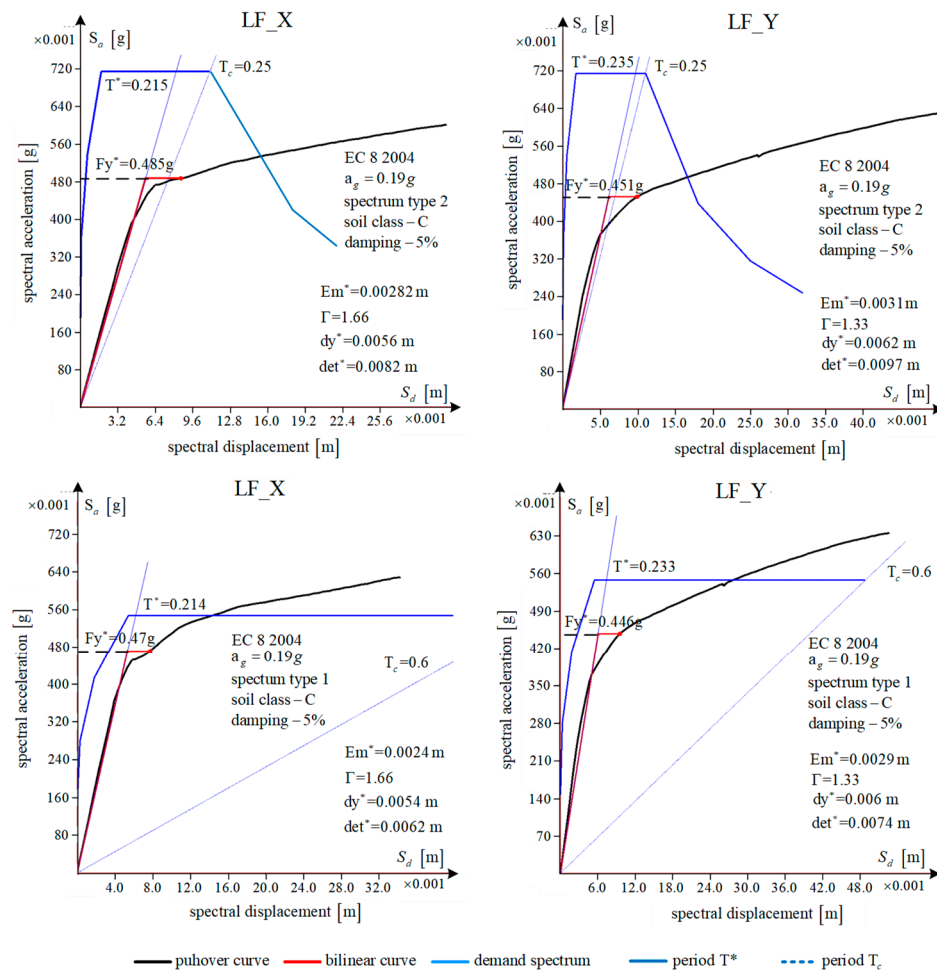
Figure 27. Capacity curves and displacement requirement of an equivalent 1DOF system.

Figure 27 shows the relevant idealized capacity curves of the equivalent system with 1DOF. The criterion is evaluated here using the spectra of type 1 and type 2 [35]. The results show that the building meets the criterion of maximum ground acceleration in both directions, according to the current regulation with an SDI of 1.06, which is higher than the minimum level 3 requirements according to CTRBS.

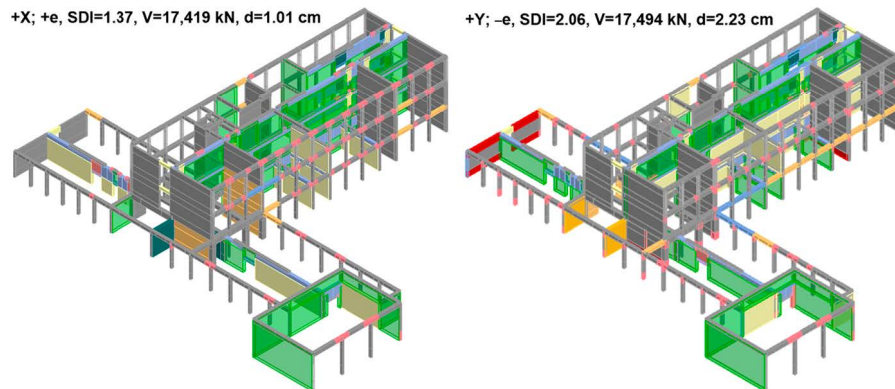
Figure 30. EFM results: pushover curves and corresponding damage mechanism of the retrofitted structure obtained using the static forces load pattern.

The pattern of load distribution by the lateral force method (Static forces, Figure 30) results in somewhat less favorable safety index values compared to a uniform distribution pattern. The most significant analysis for the X-dir results in an SDI of 1.37. The first significant damage occurs to the 1st floor RC wall on axis P13 and continues with the failure of the ground floor walls on axes P13 and P19. Additionally, in this case, the shear force is redistributed on the walls reinforced with the FRM on axes P12 and P15, reaching a maximum lateral force value of about 17,400 kN with a displacement of 1.01 cm. The edge frames are mostly damaged in the end nodes due to bending and there are also beams with shear failure. These are mainly beams connected with new and reinforced rigid elements. The corresponding analysis for the Y-dir shows almost the same failure mechanism as in the previous case, starting with the failure of the RC walls on the P1 axis, followed by the walls on the P8 and P11 axes. Ductility is maintained by the walls on the P9 axis, which are reinforced with the RC-jacketing. The minimum value of the SDI is 2.06, which is the

lowest value of all the analyzes performed with macroelements of the reinforced structural model in the Y-dir. The final utilization of the load-bearing capacity of the structure occurs at a force of approximately 17,500 kN and a displacement of 2.23 cm.

+X; +e, SDI=1.37, V=17,419 kN, d=1.01 cm

+Y; -e, SDI=2.06, V=17,494 kN, d=2.23 cm
