# Seismic Retrofitting of Dual Structural Systems—A Case Study of an Educational Building in Croatia

**Abstract:** On 29 December 2020, a devastating Mw6.4 earthquake struck near the town of Petrinja, Croatia. The main earthquake was preceded by a Mw4.9 foreshock the day before. The earthquakes caused extensive damage to buildings, especially historic buildings made of unreinforced masonry but also to buildings of other typologies and to critical infrastructure. Today, recovery efforts in Croatia focus primarily on reconstruction and seismic retrofitting. Family homes and public, cultural, educational, and other facilities are top priorities. In this paper, a comprehensive study of existing building in the educational sector is presented as a case study. The seismic performance of the building is evaluated using numerical methods, first for the as-built condition and then for the retrofitted building. For each condition, the collapse mechanisms of the building were determined and critical structural elements were identified. The presented retrofit strategy of the dual structural system consisting of RC frame system and masonry walls aims to reduce the displacements of the RC frame

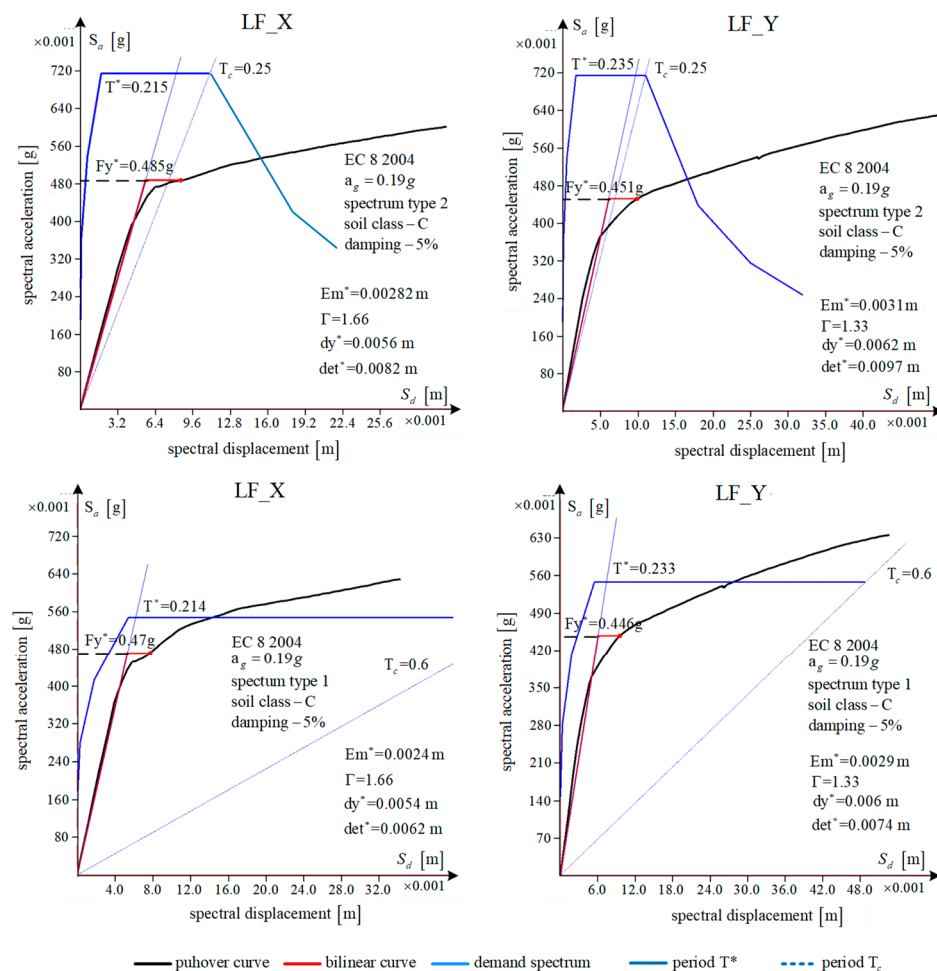
Figure 27. Capacity curves and displacement requirement of an equivalent 1DOF system.

Figure 27 shows the relevant idealized capacity curves of the equivalent system with 1DOF. The criterion is evaluated here using the spectra of type 1 and type 2 [35]. The results show that the building meets the criterion of maximum ground acceleration in both directions, according to the current regulation with an SDI of 1.06, which is higher than the minimum level 3 requirements according to CTRBS.

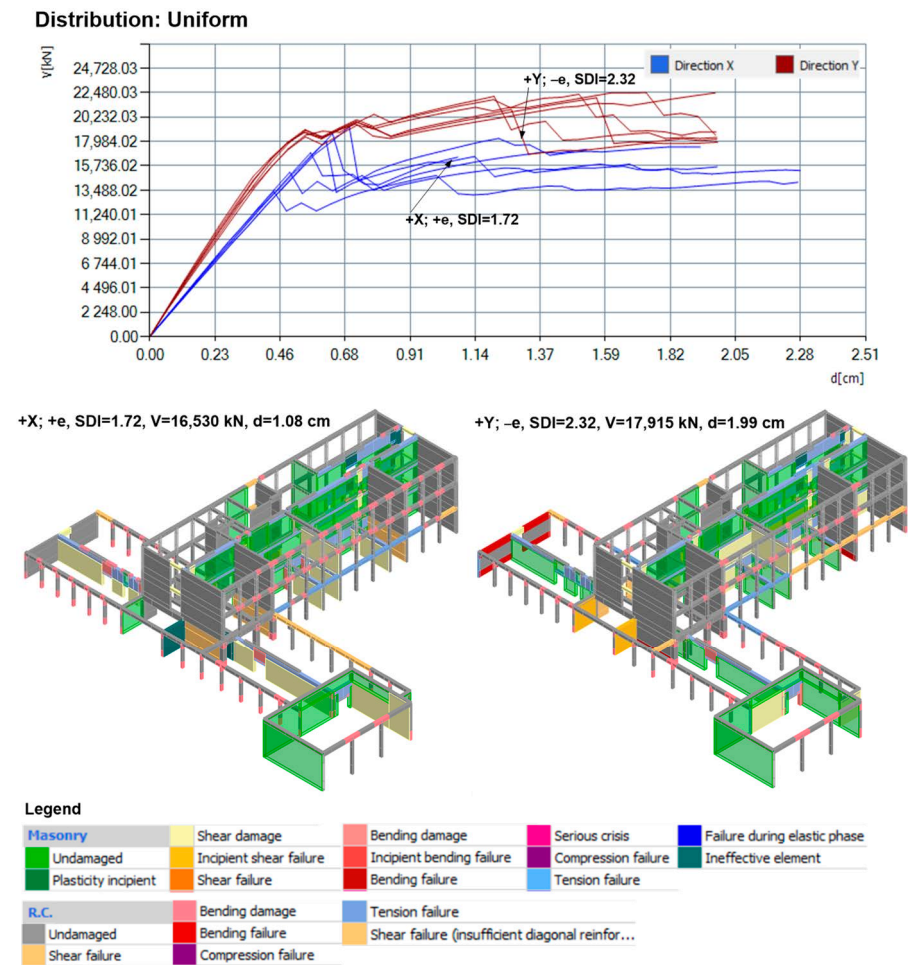
**Figure 29.** EFM results: pushover curves and corresponding damage mechanism of the retrofitted structure obtained using the uniform load pattern.

The results of the numerical model of the retrofitted structure show a significant improvement in the seismic performance. In the case of uniform distribution of the lateral force (Uniform, Figure 29), a significant increase in the load capacity in both directions is evident. The least favorable analysis for the X-dir of the lateral force gives an SDI of 1.72, which has a maximum load capacity of approximately 18,700 kN. This is almost four times the load capacity compared to the existing structure and the same lateral load pattern. Significant damage first occurs in the RC elements, walls on axes P7, P13, and P19 on the ground floor and then P24. On the edge frames, significant damage is mainly related to the beams on axes P2 and P13 on the ground floor. Furthermore, there is damage to the walls on the P12 axis, which are reinforced with the FRCM system, and the wall on the P15 axis, which is reinforced with RC-jacketing. Again, it is important to note that the program for RC elements uses ductile bending mechanism and fragile for the shear mechanism. This is the reason that the damaging mechanism differs in comparison to the finite elements model created in ETABS. In the analysis carried out for the Y-dir, it can be noted that the damage is mainly related to the elements on the ground floor of the building. The corresponding calculations show that the first significant damage occurs to

the new RC walls on the P1 axis, followed by the damage to the walls on the P8 axis, i.e., the walls of the staircase and the elevator core. These elements are the first to be damaged because they have high stiffness and a large part of the lateral force is supported by these elements. However, ductility is ensured by the walls on the P9 axis, which are strengthened with RC-jacketing, and to which a lateral force is redistributed after the failure of the RC elements. A significant drop in the bearing capacity is observed at a value of the lateral force of about 20,900 kN and a displacement of 1.27 cm, when the edge walls on axis P11 are significantly damaged, and damage also occurs in the walls of the large hall on axis P16. The most unfavorable SDI in the Y-dir is 2.32.

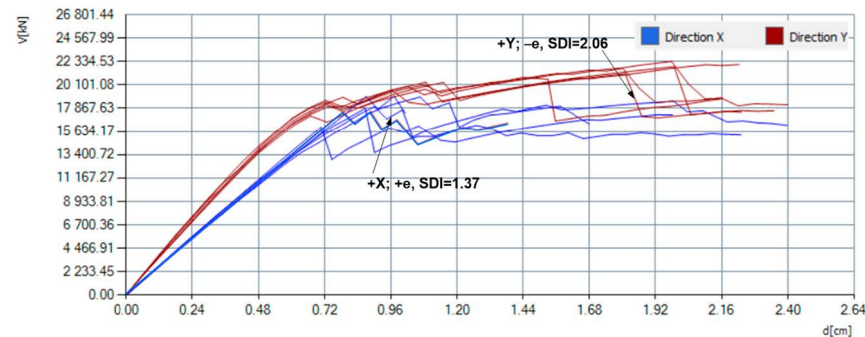
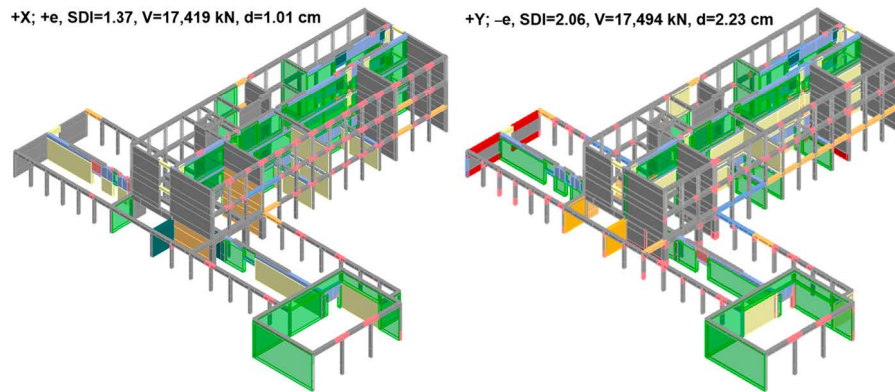
**Figure 30.** EFM results: pushover curves and corresponding damage mechanism of the retrofitted structure obtained using the static forces load pattern.

The pattern of load distribution by the lateral force method (Static forces, Figure 30) results in somewhat less favorable safety index values compared to a uniform distribution pattern. The most significant analysis for the X-dir results in an SDI of 1.37. The first significant damage occurs to the 1st floor RC wall on axis P13 and continues with the failure of the ground floor walls on axes P13 and P19. Additionally, in this case, the shear force is redistributed on the walls reinforced with the FRCM on axes P12 and P15, reaching a maximum lateral force value of about 17,400 kN with a displacement of 1.01 cm. The edge frames are mostly damaged in the end nodes due to bending and there are also beams with shear failure. These are mainly beams connected with new and reinforced rigid elements. The corresponding analysis for the Y-dir shows almost the same failure mechanism as in the previous case, starting with the failure of the RC walls on the P1 axis, followed by the walls on the P8 and P11 axes. Ductility is maintained by the walls on the P9 axis, which are reinforced with the RC-jacketing. The minimum value of the SDI is 2.06, which is the

lowest value of all the analyzes performed with macroelements of the reinforced structural model in the Y-dir. The final utilization of the load-bearing capacity of the structure occurs at a force of approximately 17,500 kN and a displacement of 2.23 cm.

+X; +e, SDI=1.37, V=17,419 kN, d=1.01 cm

+Y; -e, SDI=2.06, V=17,494 kN, d=2.23 cm

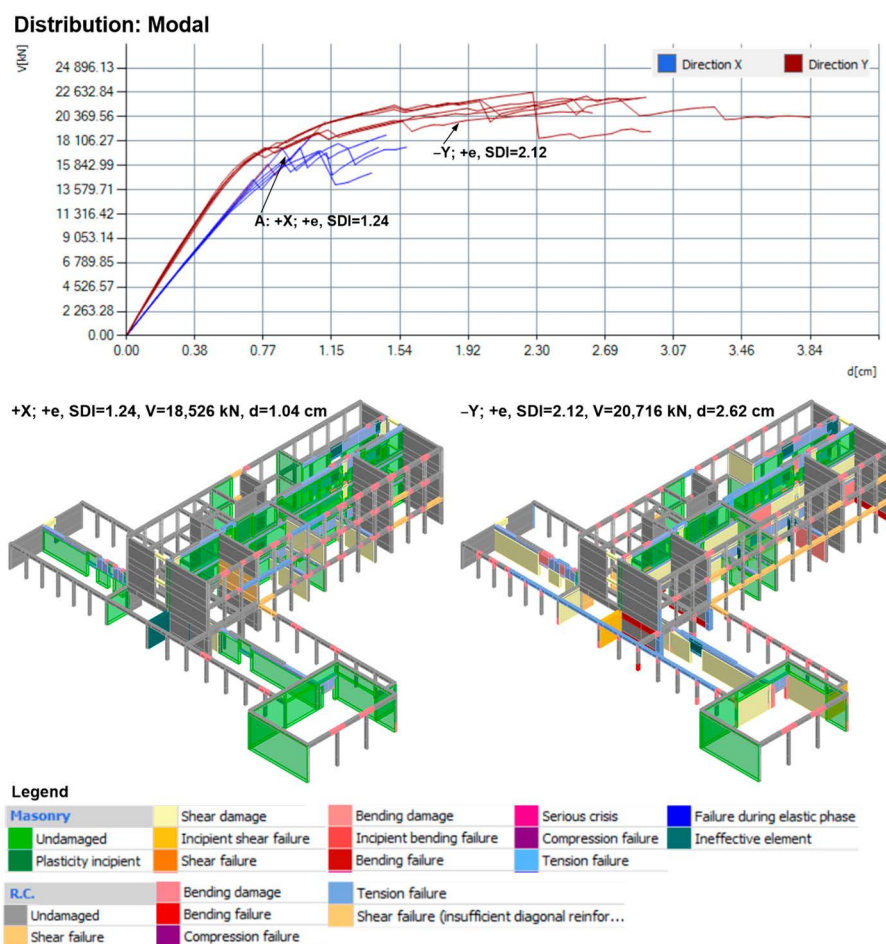
**Figure 31.** EFM results: pushover curves and corresponding damage mechanism of the retrofitted structure obtained using the modal load pattern.

The load pattern corresponding to the dominant mode of vibration (modal distribution, Figure 31) for the strengthened structure was also found to be critical for the X-dir of lateral force. However, the pushover curves show that the structure responds with a low degree of ductility and a high level of lateral force capacity. The lowest value of the SDI is 1.24. The damage mechanism of the structure was caused by a relatively early phase failure of the walls on the P3 and P24 axes. This failure mechanism is partly the result of a few load-bearing elements compared to the front part of the structure. However, the seismic safety condition is fulfilled and the lateral force carrying capacity exceeds 16,000 kN in all analyses. Moreover, the structure maintains greater ductility in the Y-dir for the distribution according to the dominant mode, which is visible in all pushover curves. The most informative analysis has an SDI of 2.12. The failure mechanism develops due to the shear failure of the RC walls on the P1 axis at the ground floor, followed by the walls on the P8 axis. In addition, the force is distributed to other walls on the P9 axis. Furthermore, torsional effects are visible in case, since the walls on the P3, P12, P13, and P19 axes are also damaged at the ground floor level. The collapse of the structure was caused by the failure of several walls reinforced with RC-jacketing on axis P9 on the ground floor.
